AMERICA'S CUP 36, AUCKLAND 2021

# Assessment of Coastal Environmental Effects Associated with the Development of AC 36 Facilities

## For Resource Consent Application, Wynyard Basin and Ferry & Fishing Industry Relocation Facility

Report Number: 1790454-004-Rev0

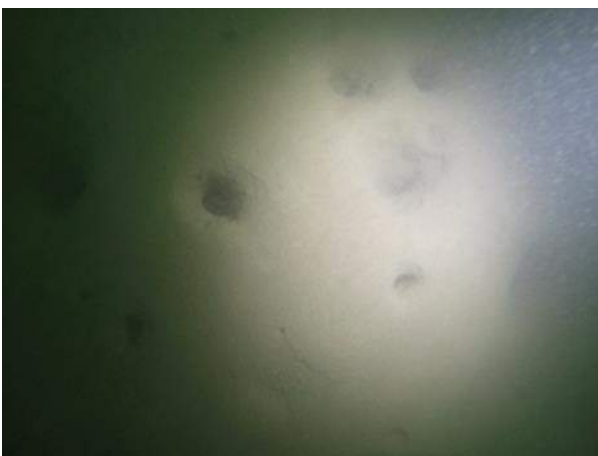
Station 6 outer Halsey Basin, November 2017

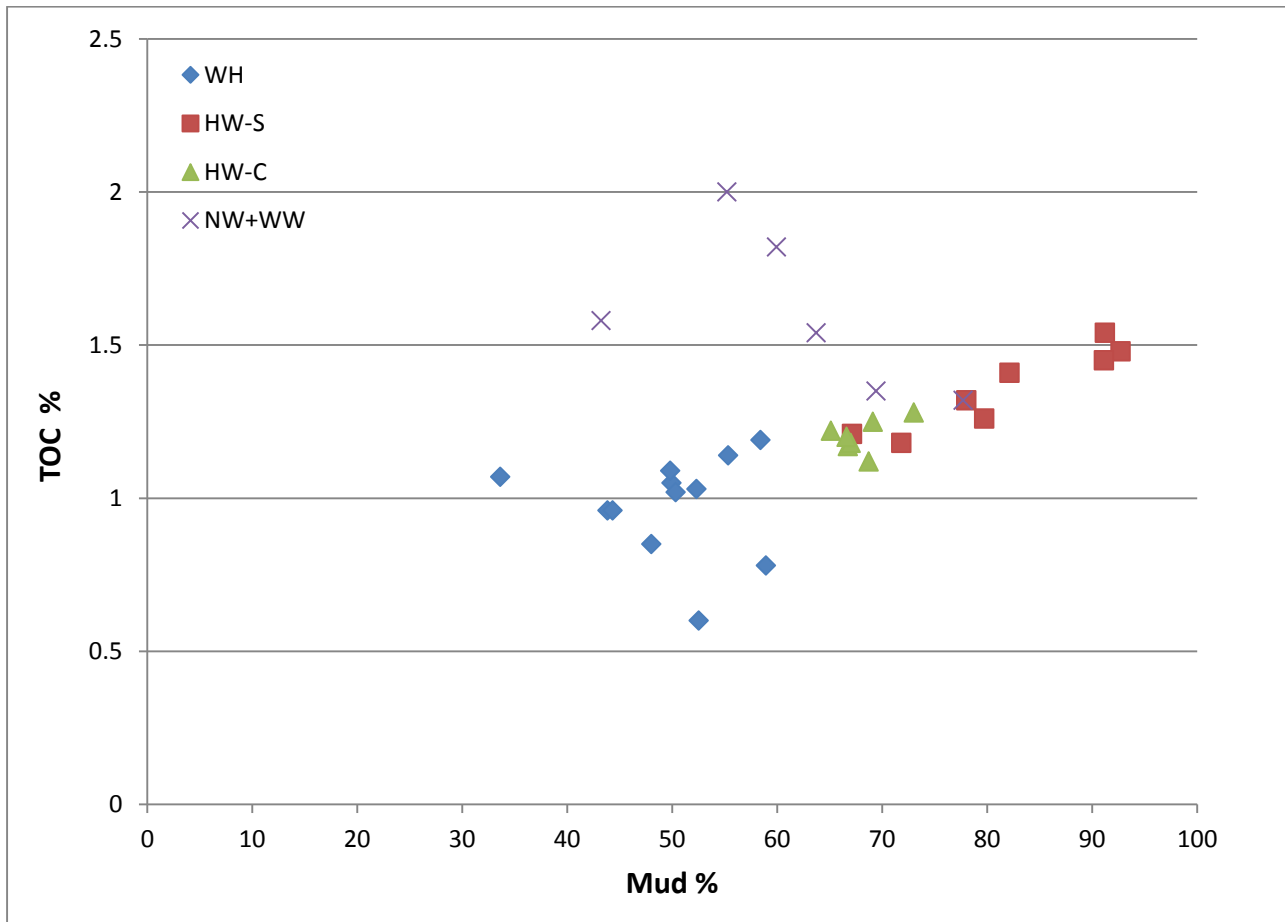
Figure 14: Mud and TOC relationship in Viaduct and FFIRF sediment samples (HW = Halsey Wharf, NW = North Wharf, WH=FFIRF).

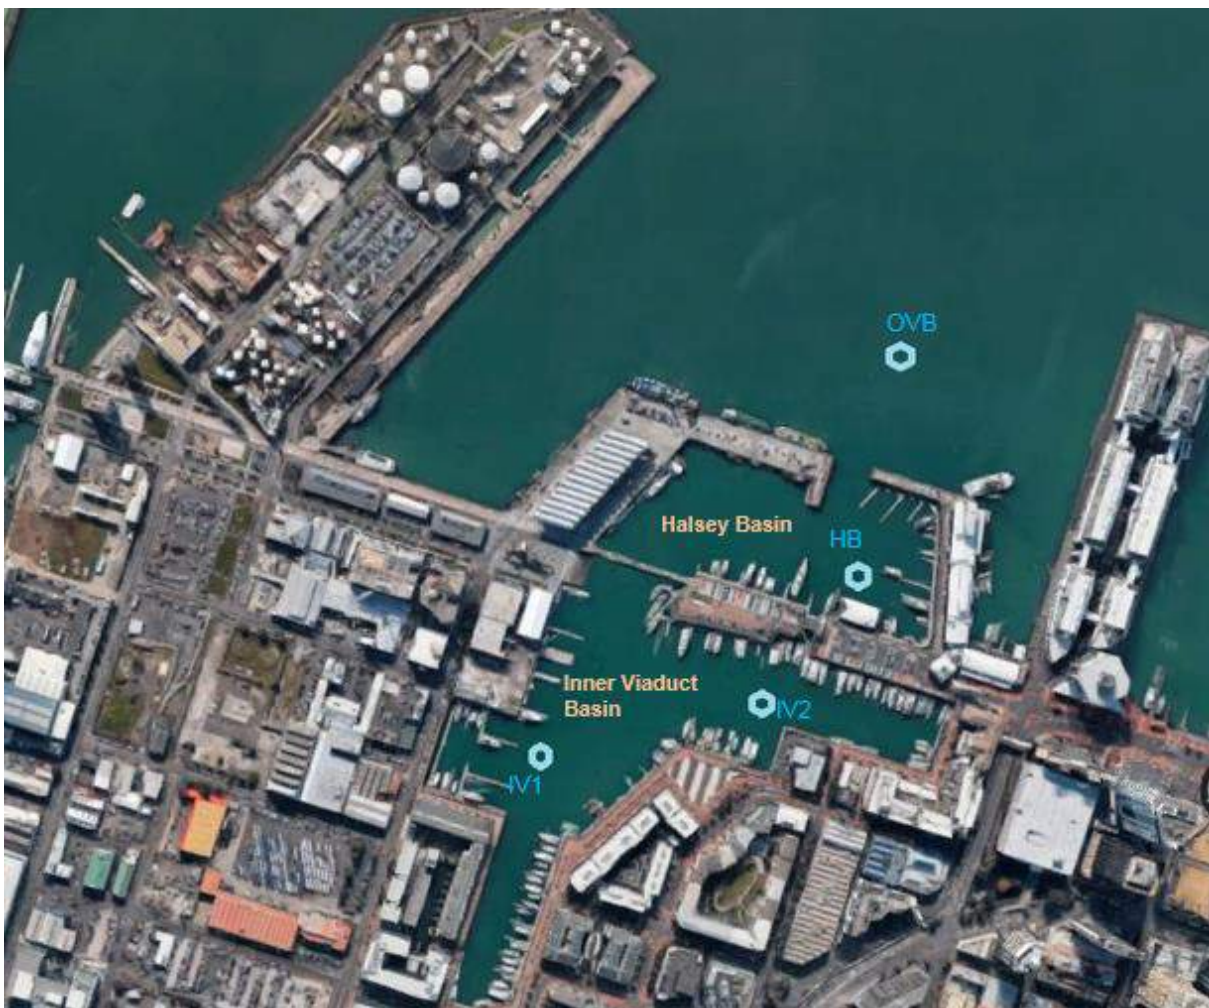
Figure 16: Water quality sampling locations.

Visual clarity, as determined by Secchi depth, was measured on site at each station. Mean Secchi depth was higher at the inner Viaduct Basin sites compared to the outer Viaduct Basin sites (Table 22), meaning that water in the inner Viaduct Basin was more clear than the outer Viaduct Basin. Similarly, turbidity was lower at the inner Viaduct Basin sites compared to the outer Viaduct Basin sites, ranging from 1.5 - 3.2 NTU in the inner Viaduct Basin to 3.5 - 6.0 in the outer Viaduct Basin. Turbidity at all four sites was similar to that reported for the Chelsea site during the 2015 monitoring period (range 1.90 - 5.60; Williams et al. 2017).

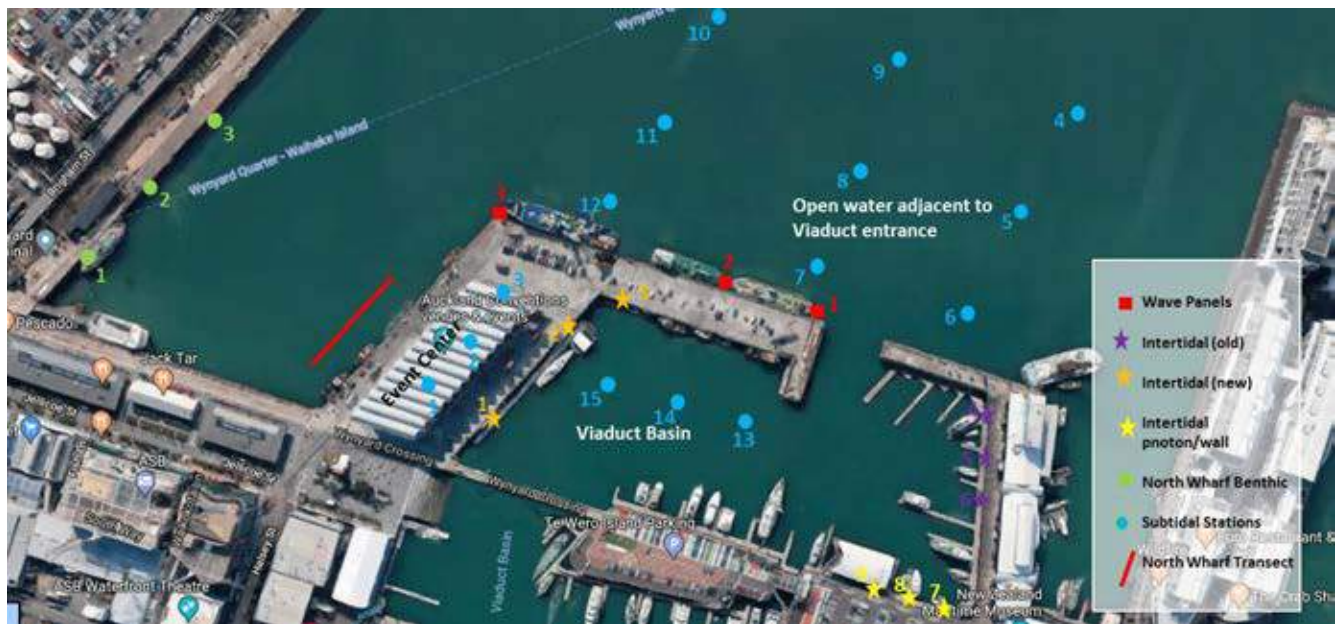
**Figure 2-1: Sample locations for intertidal (wharf piles, pontoons, walls and wave panels), and subtidal surveys (sediment cores and video).** Sediment stations were located under the Viaduct Event Centre on the Halsey Street Wharf Extension (Stations 1-3), in an area of open water in Freeman's Bay outside the entrance to the Viaduct Harbour (Stations 4-12), and in the Outer Viaduct Basin (Harbour) (Stations 13-15). An additional 30 m sediment transect was located in the corner of North Wharf and Wynyard Wharf. Intertidal Stations were located in the Outer Viaduct Basin (Harbour) on new wharf piles (Station 1-3), in the Viaduct Basin on old wharf piles (Stations 4-6), and in the Viaduct Basin on pontoons and walls (Stations 7-9). Wave panel sites were located on the external (open water side) of the Western Viaduct Wharf (Stations 1-3). Benthic habitat characterisation was located at the corner of North Wharf and Wynyard Wharf (Stations 1-3).

Further detail regarding sampling, methods and sampling locations (Figure 2-1) can be found in Appendix A.

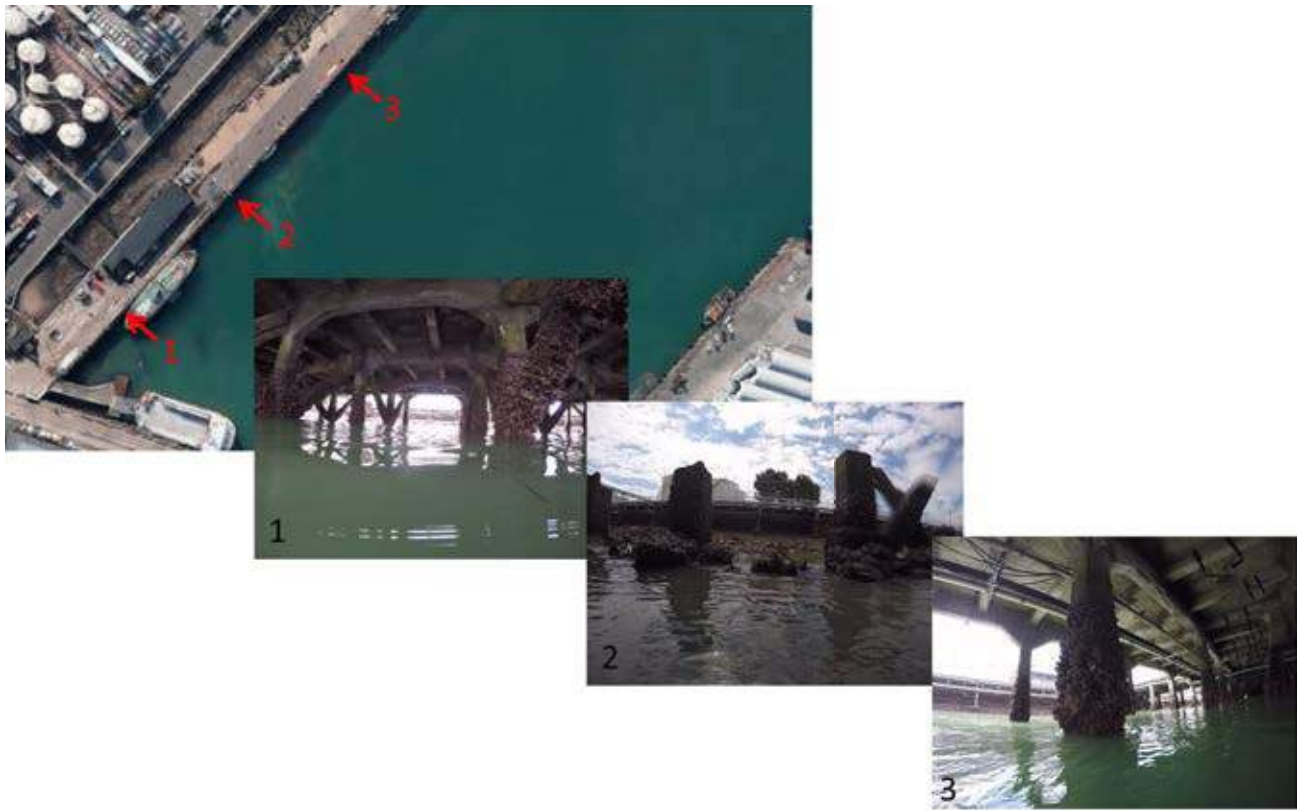
**Figure 2-2: North Wharf / Wynyard Wharf benthic characterisation sites (3 stations) located underneath the Wynyard Quarter Wharf.** Arrows indicate diver entry points. Photographs indicate the view from beneath the wharf looking shoreward.

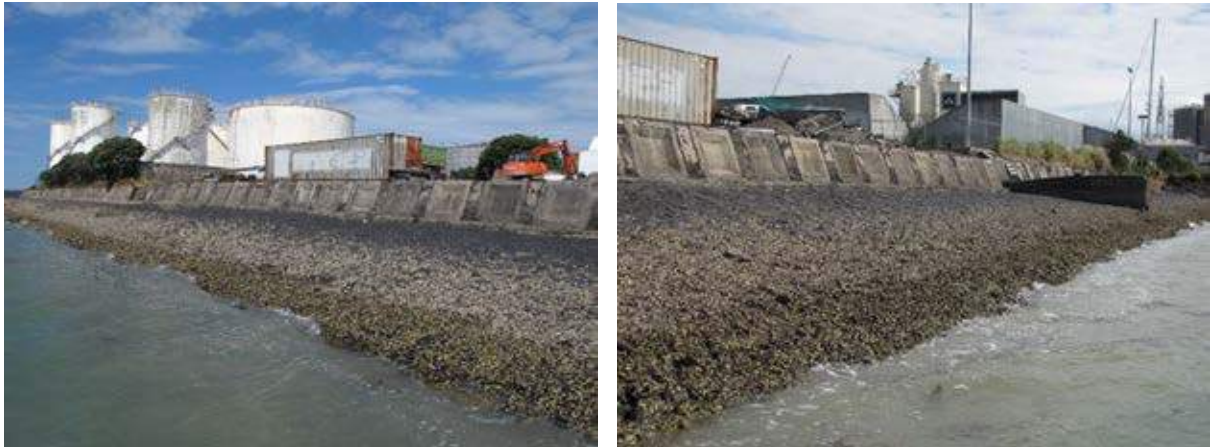
**Figure 3-17: The shoreline of the western Wynyard reclamation area facing north (toward the locations of Transects 1-3) and south toward the location of Transect 4.**

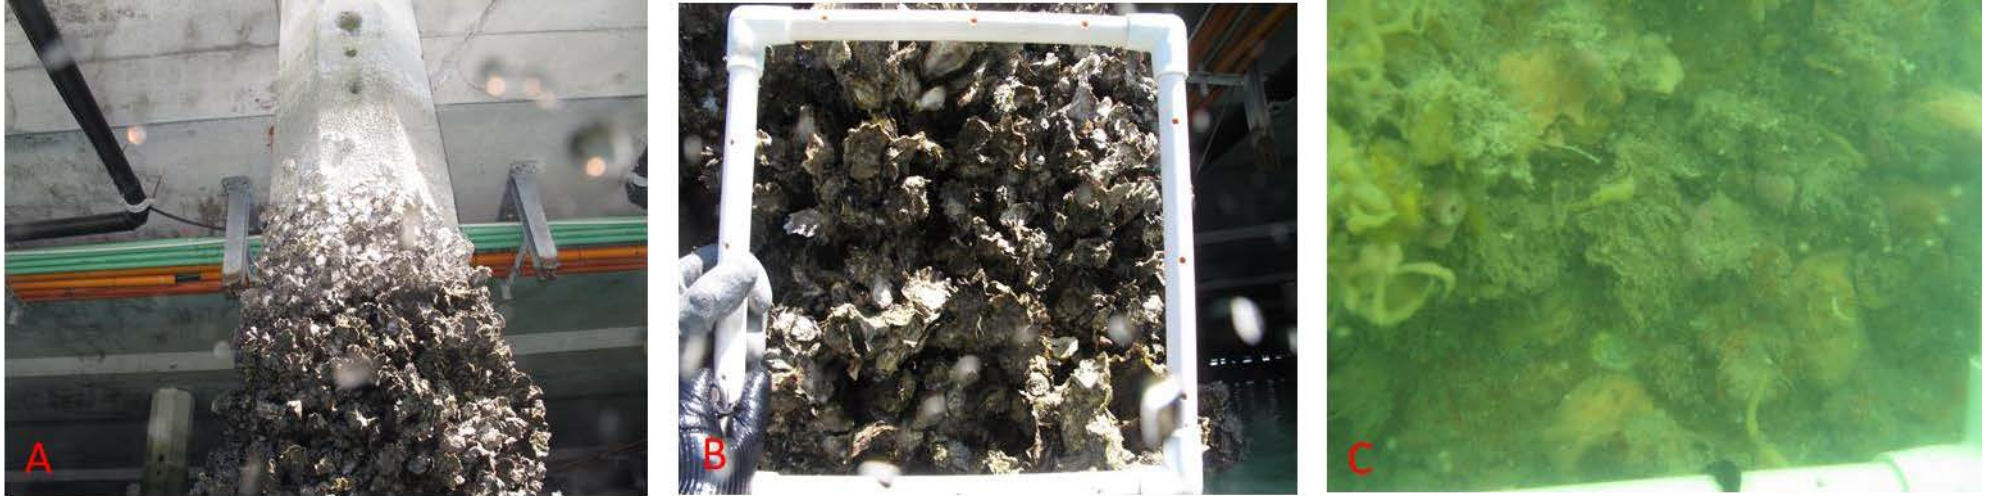
### 1. Wharf piles

Representative photos from wharf piles underneath the Event Center. A, quadrat a was at MHWS (as defined by the upper limit of barnacles on the pile). B, quadrat b was 2 m below MHWS and characterised as dominant oyster, *Magallana gigas*, cover. C, quadrat c was 5 m below MHWS.

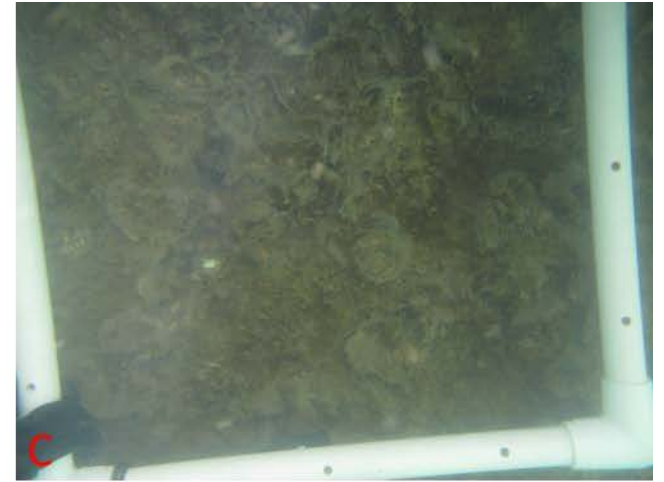
Representative photos from concrete walls in the Outer Viaduct Basin. A, quadrat a was at MHWS (as defined by the upper limit of oysters, *Magallana gigas*, on the pile). B, quadrat b was 2 m below MHWS. C, quadrat c was 5 m below MHWS.

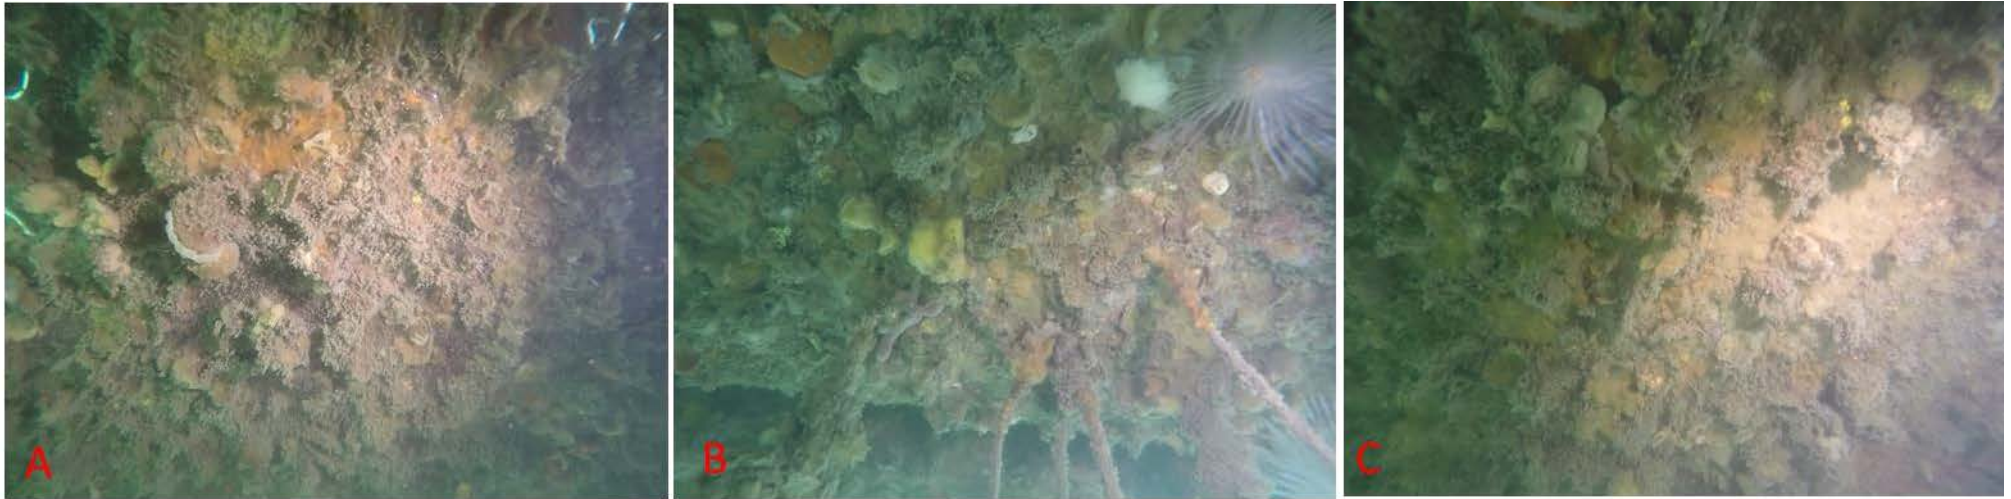
Representative photos from the underside of pontoons in the Outer Viadict Basin. A, quadrat a was at 0 m on a horizontal transect. B, quadrat b was 2 m and C, quadrat c was 5 m.

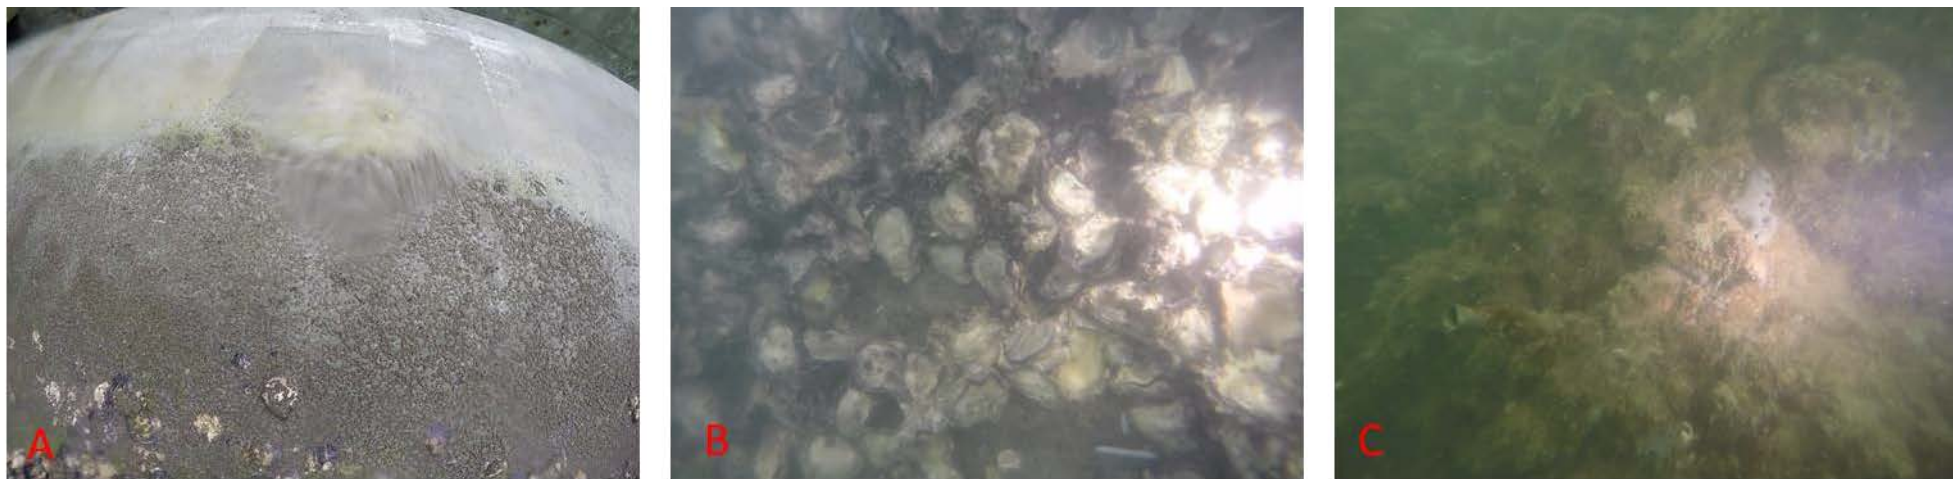
Representative photos from wave panels located on the Western Viaduct Wharf, seaward facing. A, quadrat a was at MHWS (as defined by the upper limit of barnacles on the pile). B, quadrat b was 2 m below MHWS and characterised as dominant oyster, *Magallana gigas*, cover. C, quadrat c was 5 m below MHWS.

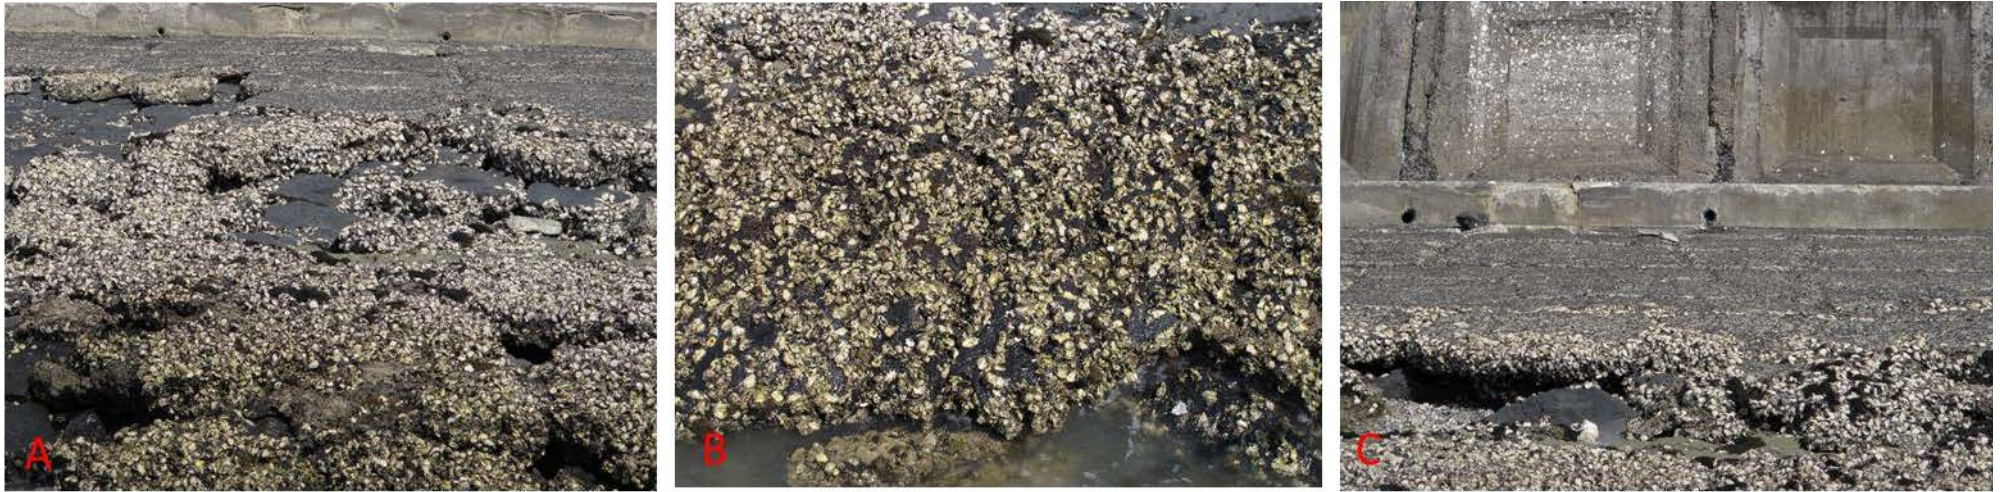
Representative photos from the reclamation wall located between Silo Marina and Wynyard Point. A, quadrat a was at MHWS (as defined by the upper littoral zone). B, quadrat b was approximately 5 m below MHWS and characterised as dominant oyster, *Magallana gigas*, cover. C, quadrat c was MLWS.

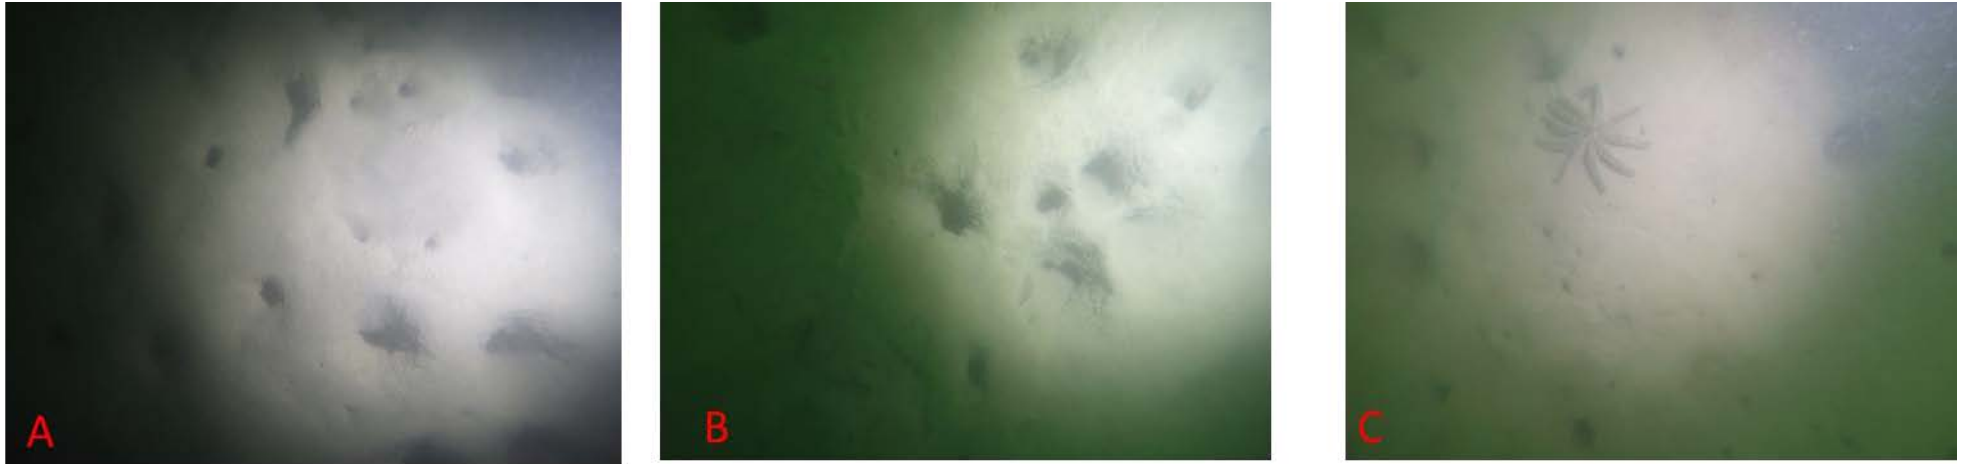
Representative photos from sediment stations showing invertebrate burrows. approximately 2 m below MLWS, on a horizontal transect along the seabed. C, quadrat c was approximately 4 m below MLWS. D, quadrat D was approximately 6 m below MLWS. E, quadrat e was approximately 8 m below MLWS.
