SOME IMPACTS OF ROADING AND FLOOD DAMAGE ON SOUNDS ROADS

Part only –(this is a second report) –

Period 1985-2010

May 2016

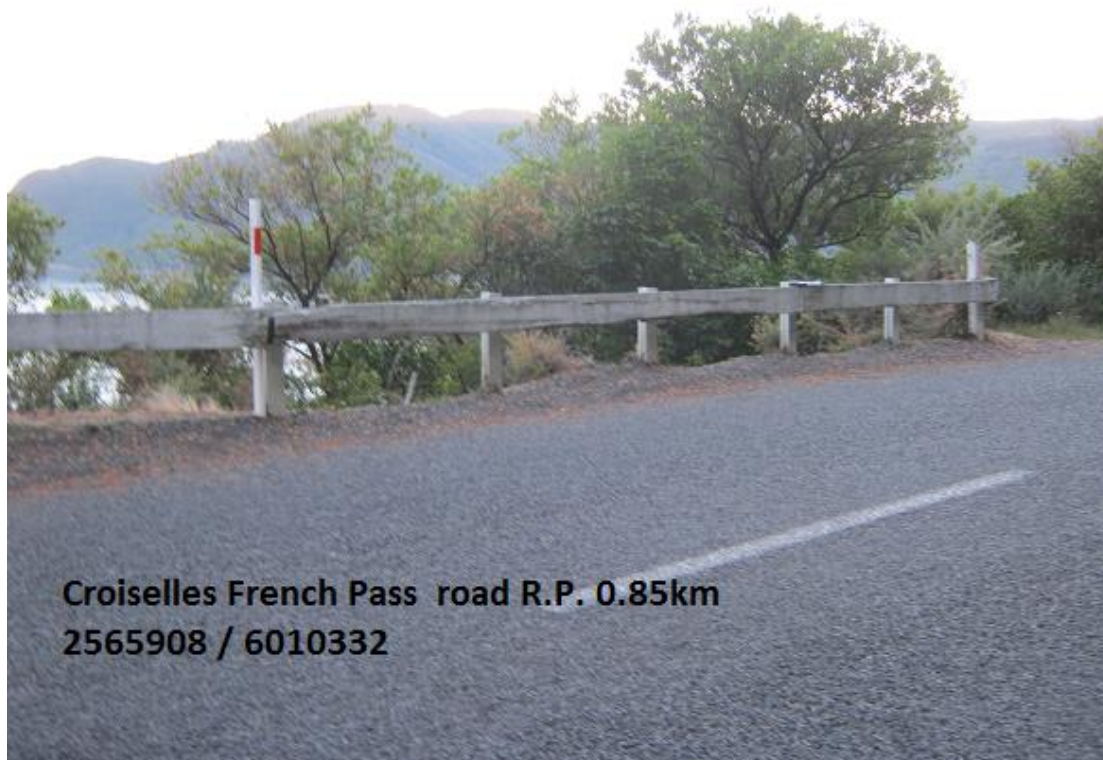
The damage has likely occurred as a result of early sidling fills which were not benched or compacted , although there is also some apparently unrelated but similar damage to the south of this site.

From the coast line looking up it is apparent there was an earlier event similar to this shorter section (this must have occurred prior to 1985 as I don't recall this damage) AND there is a later and significant event to the south which has occurred relatively recently (I think in about 2002 – THIS is NOT roading related)

The quantity involved was app. 800m3 and this event occurred app. 1990

I would estimate the earlier and later damage has probably deposited another 2000 m3 +- to the coast near this site .

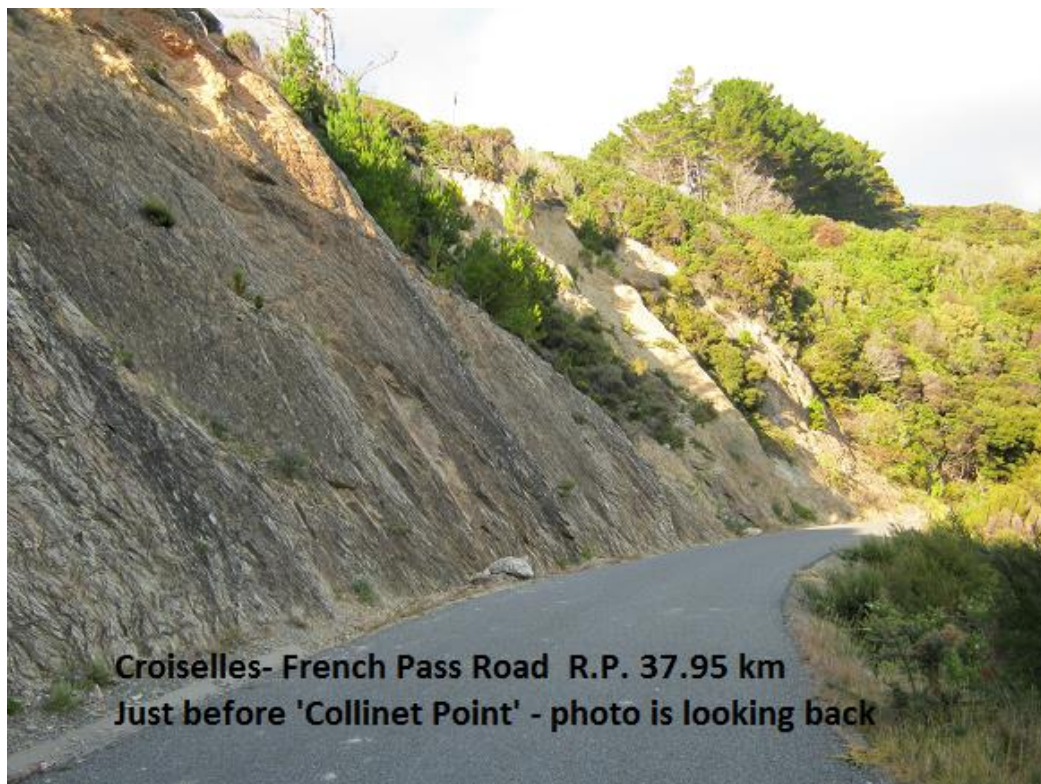
The main event at this site occurred in app. 1998 when near 1200 m³ collapsed to the sea and some of the uphill material also crossed the road at this site.

At about the same time a 'chunk' of schist dropped off the end of Collinet Point ; this is obvious from a boat (pretty small probably only a few m³)

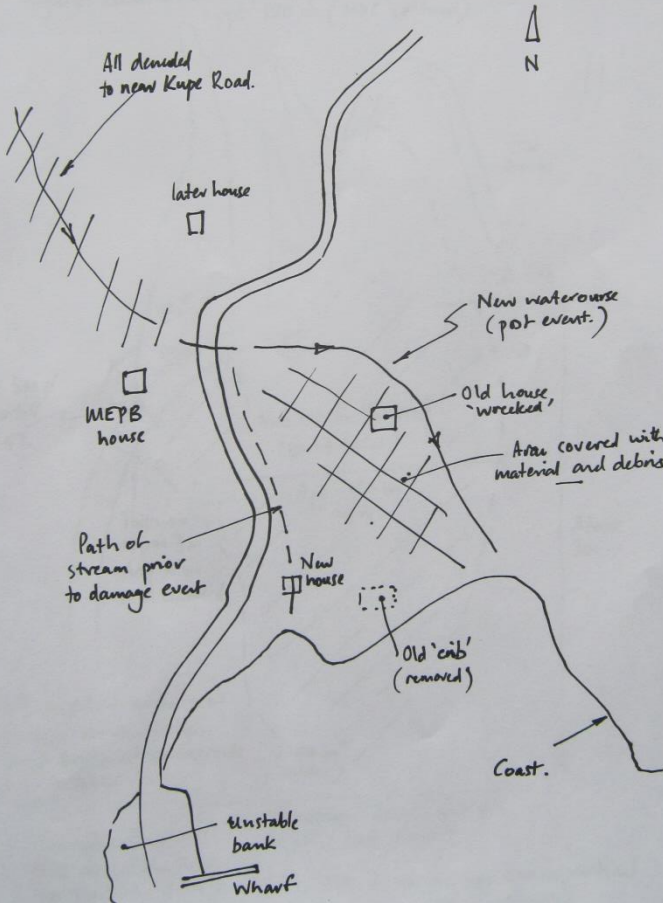
SKETCH D'URVILLE ISLAND
MAIN ROAD NEAR 'KAPOWAI' SITE 5 NTS

This was one of the sites where damage occurred as a result of the 'weather bomb' in Feb 1989 ; it is difficult to reconcile the benign environment now with the site immediately after the flood damage occurred.

The road at the site was 'sheared' right through about 4 metres deep and over a length of near 20 metres ; the existing 1.8m dia Reinforced concrete culvert was strewn down the stream completely smashed into small chunks about 100mm sq. , some held together with the remnants of the spiral reinforcing . I have seen damage to culvert pipes before but never anything as dramatic as this event – all 4 pipes were now just like pebbles in the creek bed and banks !!

The damage was completely unrelated to any of the roading activities , the culvert capacity was never going to be big enough for the intensity of rain (the culvert has been replaced with 2 / 2 m dia. RC Culverts effectively increasing the capacity by 2.5x – I suspect one will never know if this capacity would carry the discharge from a similar event)

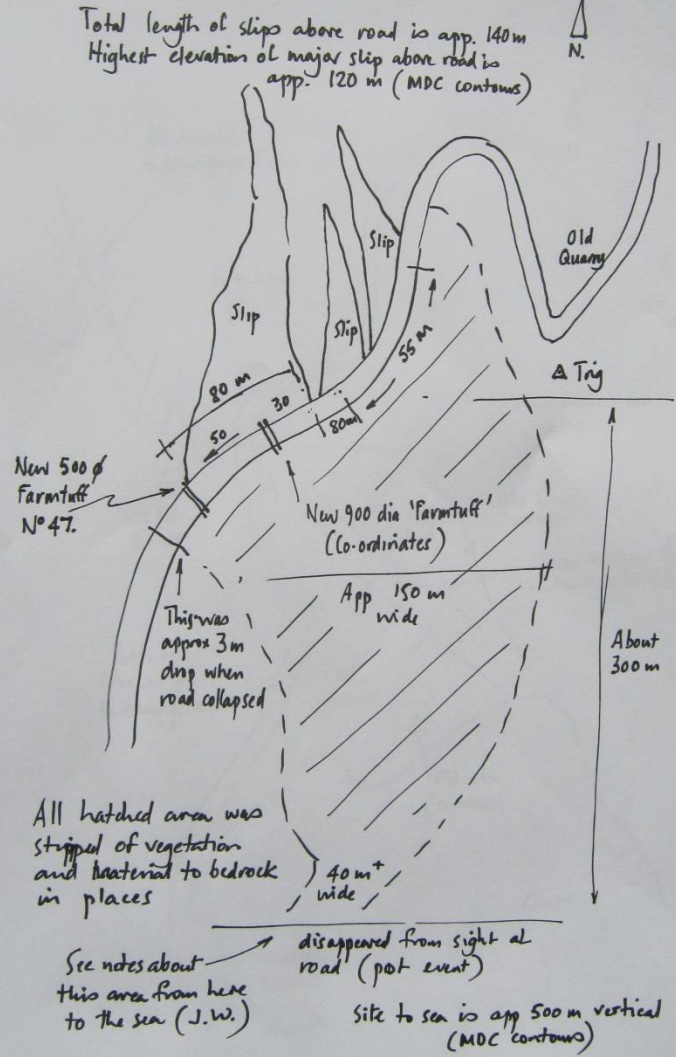
SKETCH
 MAIN ROAD D'URVILLE ISLAND
 THE 'BLUE' SLIP N.T.S.

Total length of slips above road is app. 140m
 Highest elevation of major slip above road is
 app. 120 m (MDC contours)

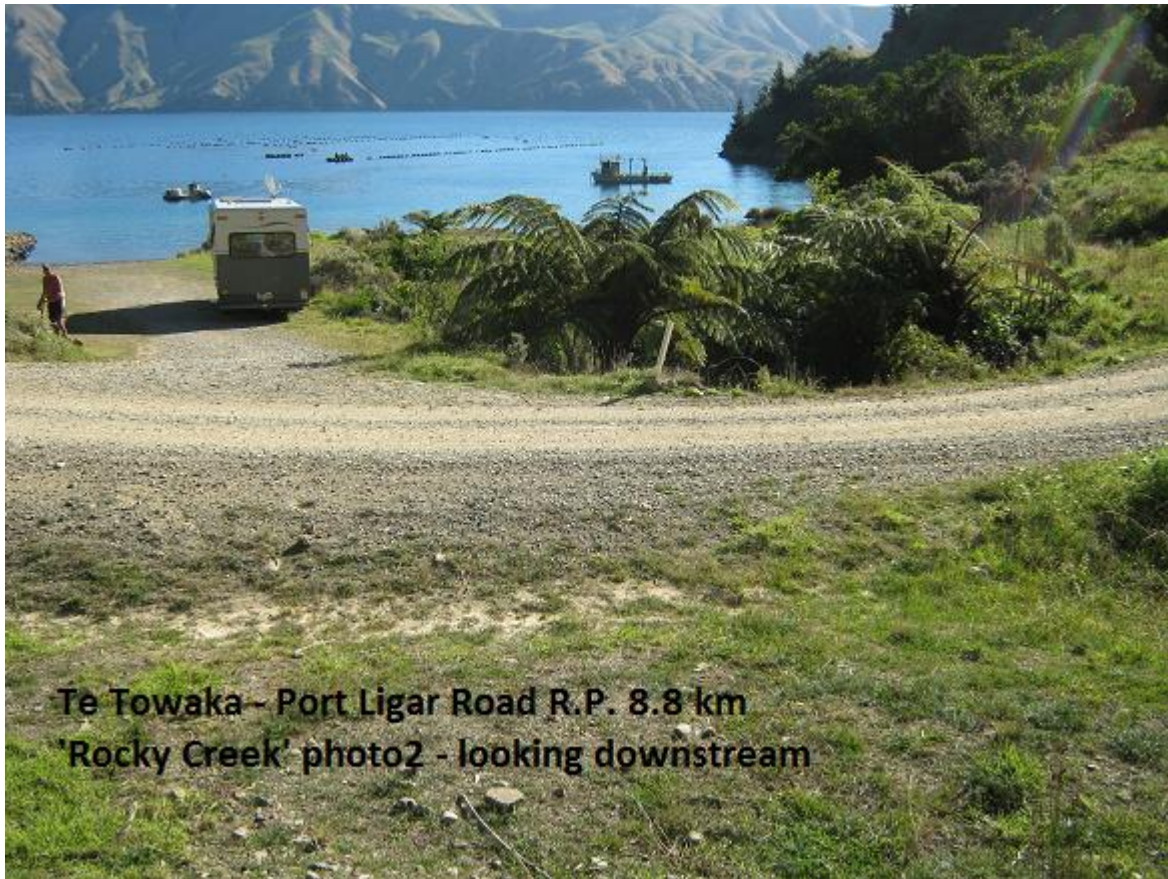
This photo is looking towards the sea . Gerald the old County roadman (before my time – ie pre 1985) is standing near his hut which has been on this site for > 60 years.

Gerald stated that the material over the site would have been at about his waist height in depth at the time of the event and I know it was over the road in the photo foreground.

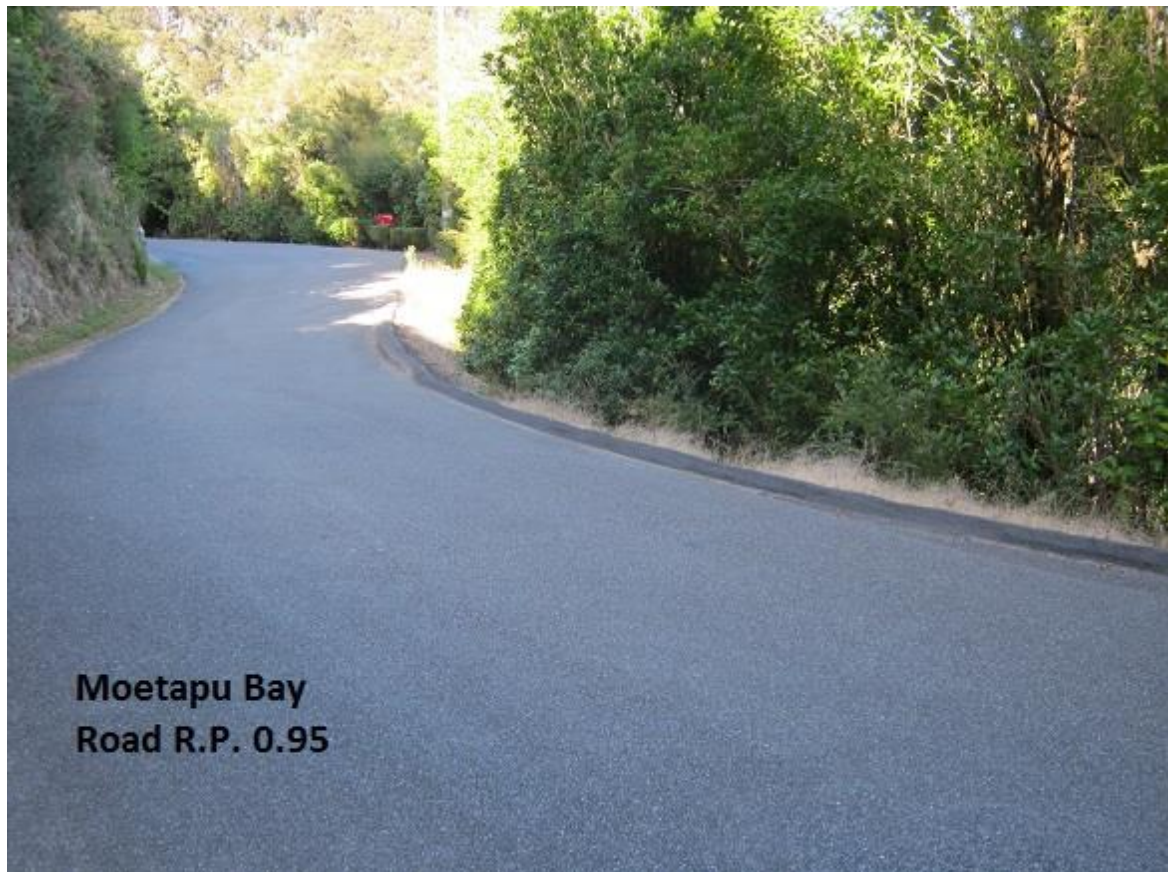
This event occurred in app. 1992 and involved near 600 m³ to the sea.

Note the plant mix nib constructed to prevent further water flows over the road edge at this site.

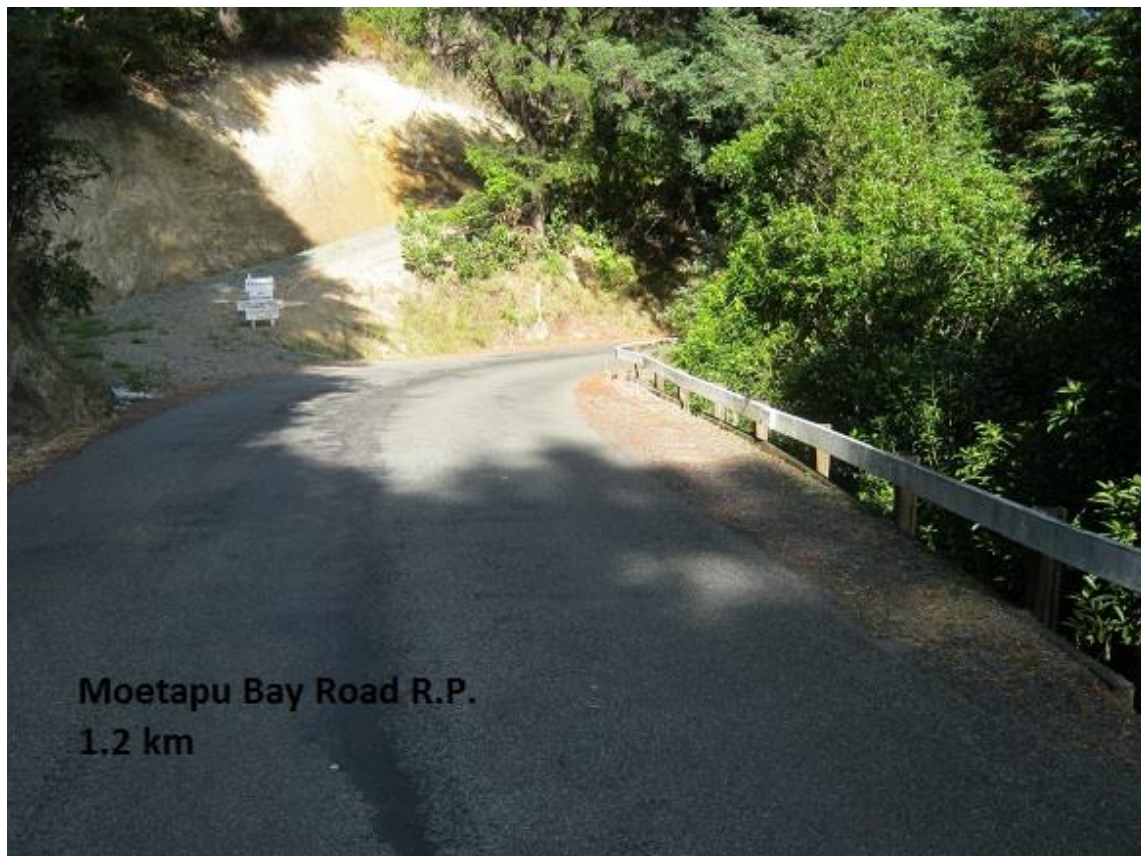
There is a retaining wall at the site 18 m long x 3 m high

The event occurred app. 1996

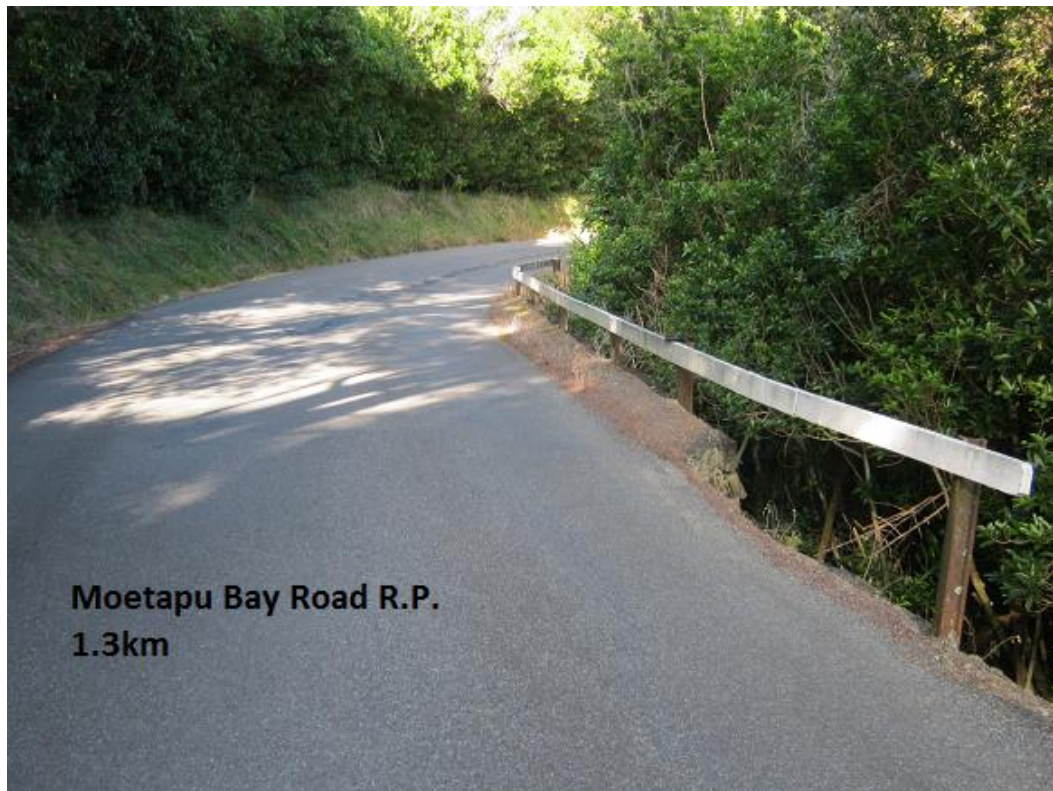
This is just below Culvert number 11

This was a significant event in this area.

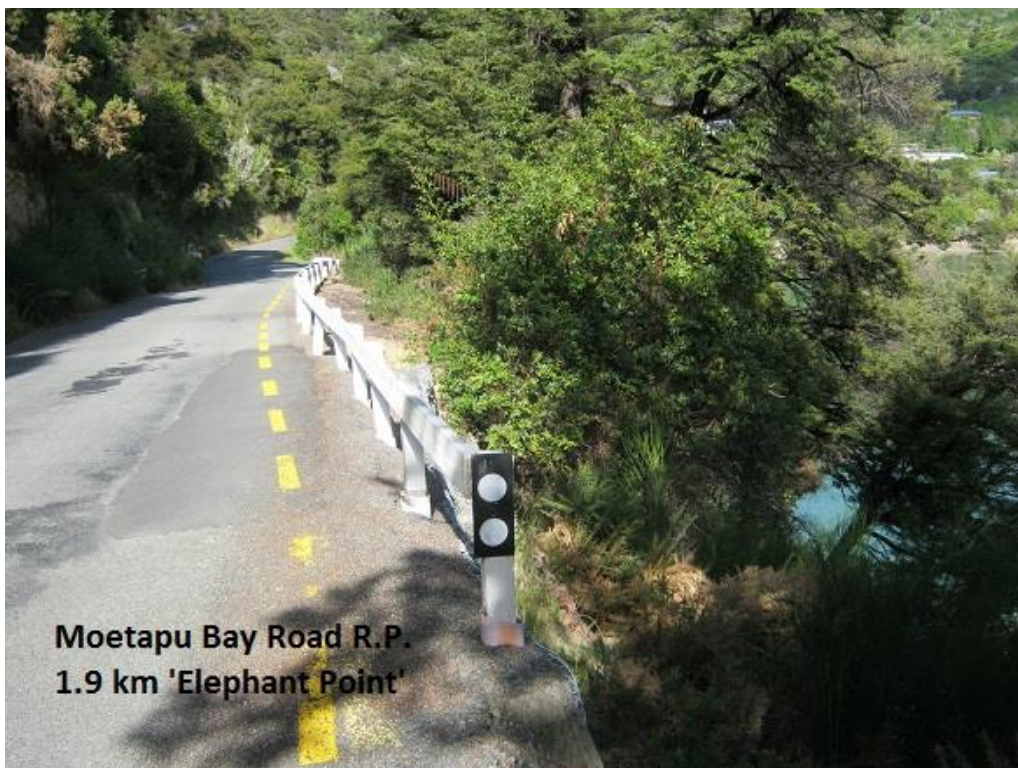
There have been several events at this site but the major event occurred in app. 1998 continuing until about 2004

There was > 1500 m³ of material to the coast , the event is most likely roading related.

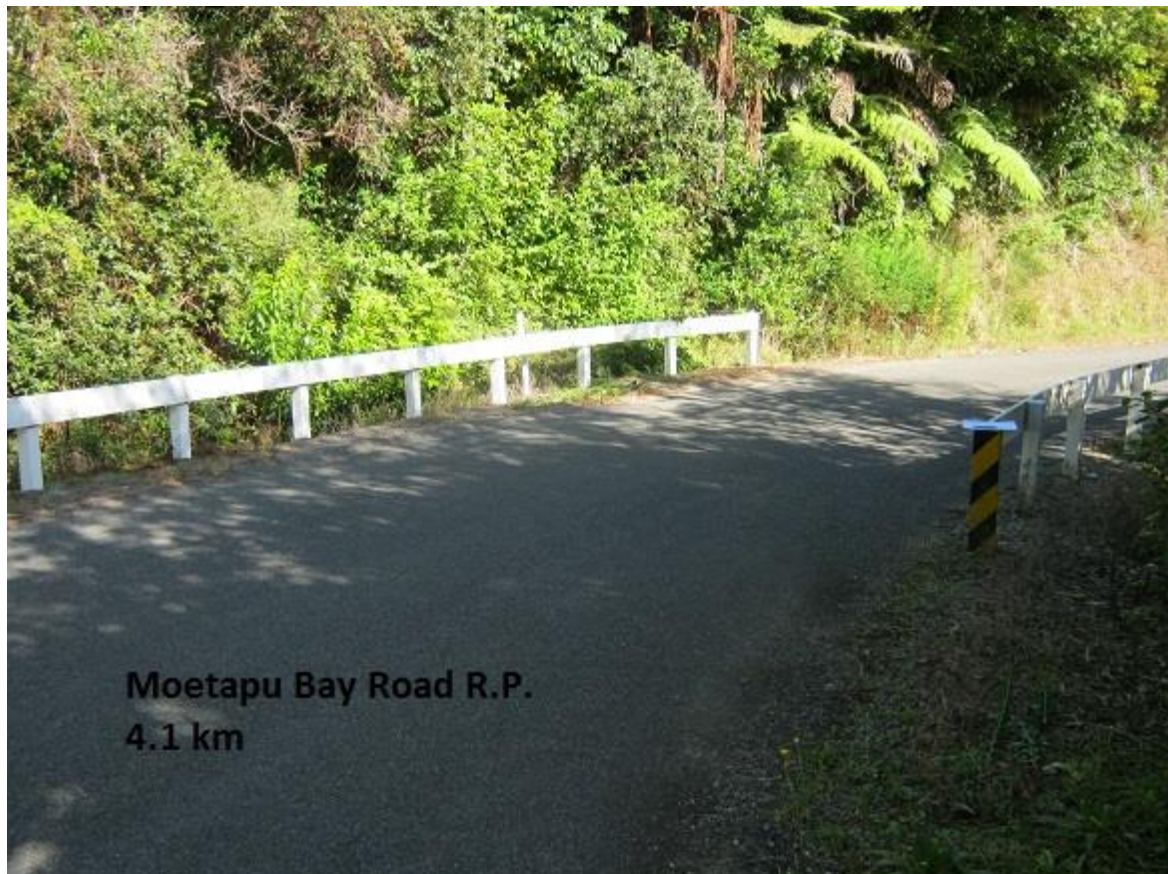
Material flowed down this watercourse to the sea

The quantity was app. 600m³ and the event occurred about 1998

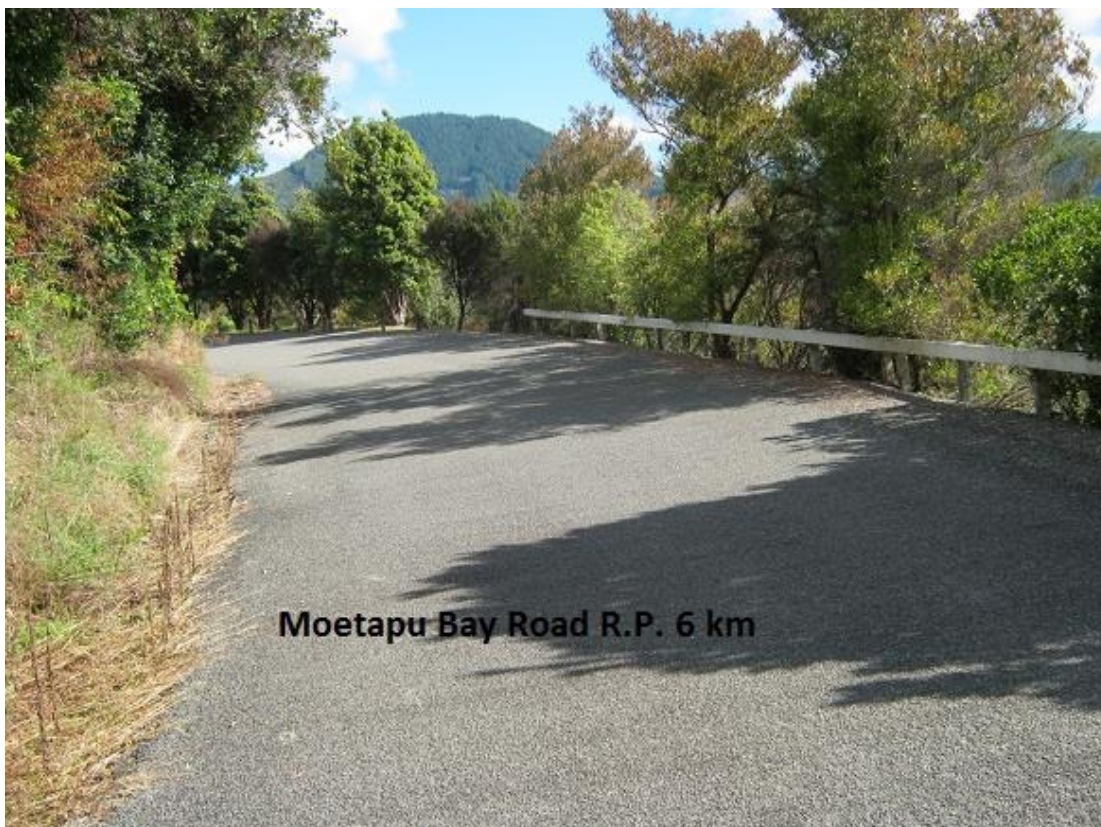
I consider natural erosion may have caused the initial slip as it came from well above the road.

Near 1500 m³ went to the sea and the date was app. 1990.

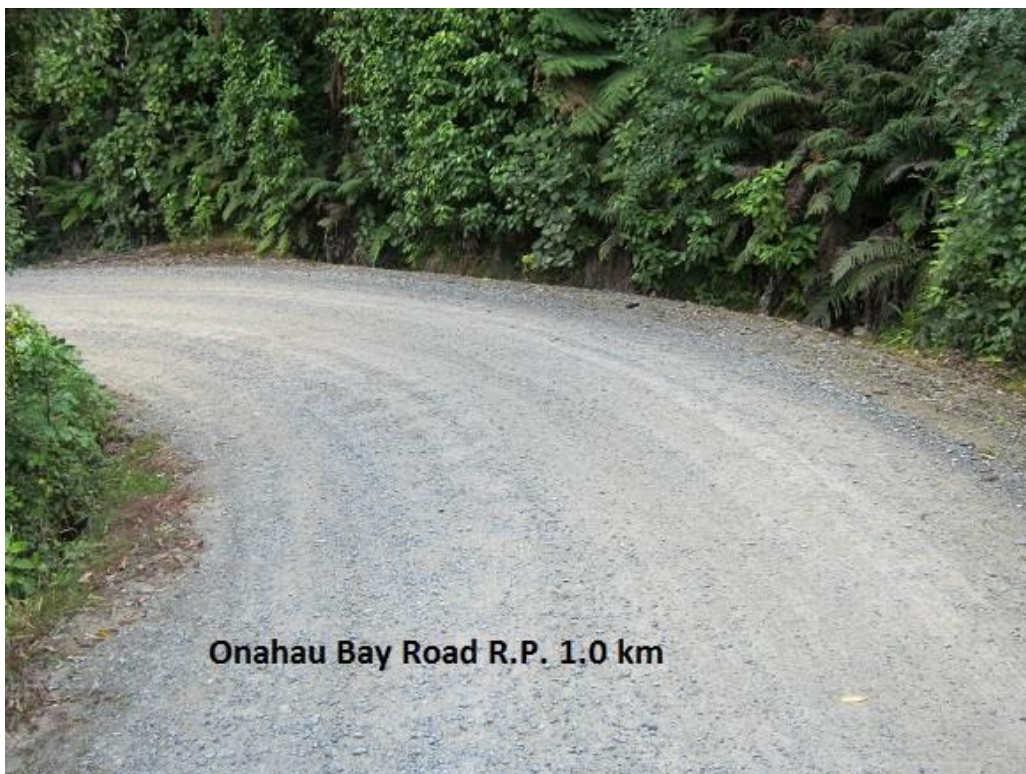
This event occurred in about 1990 and was most likely natural erosion as the material came from well above the road ; approx.. 400 m³ reached the coast although the total quantity involved was nearer 1000 m³.

There is a small gabion wall at the site

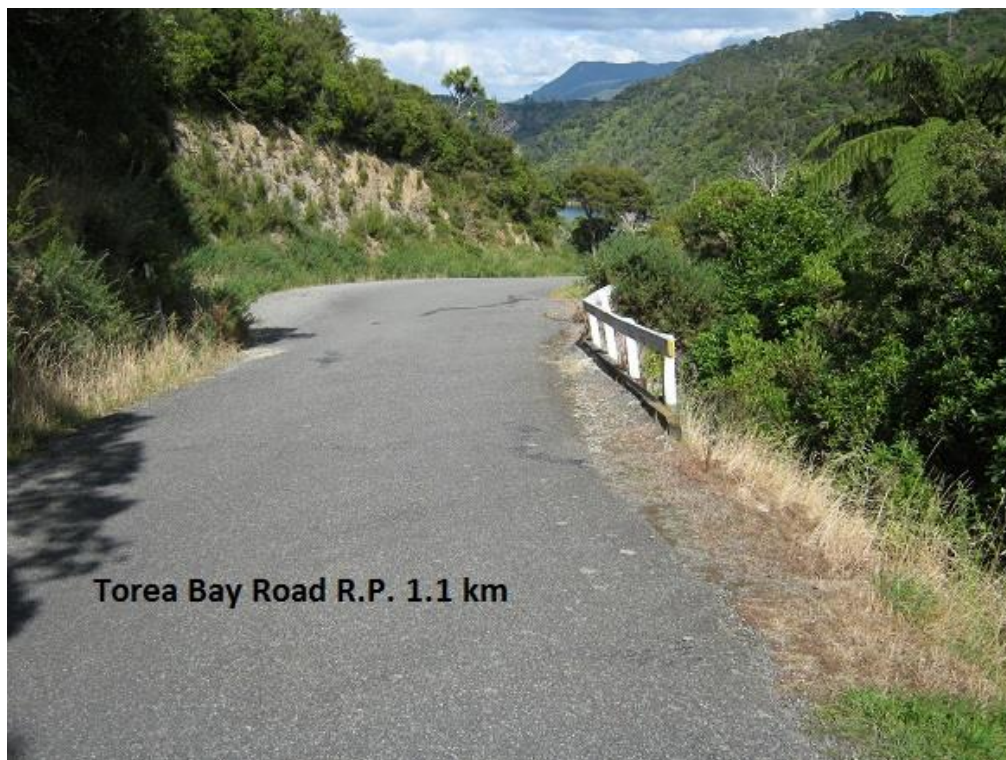
The complete section of road was retreated to the east over a length of app. 30 metres x 10m wide ; most material to the sea was from below the wall site.

There was approx. 1200 m³ flowed into the sea and the date was 1992.

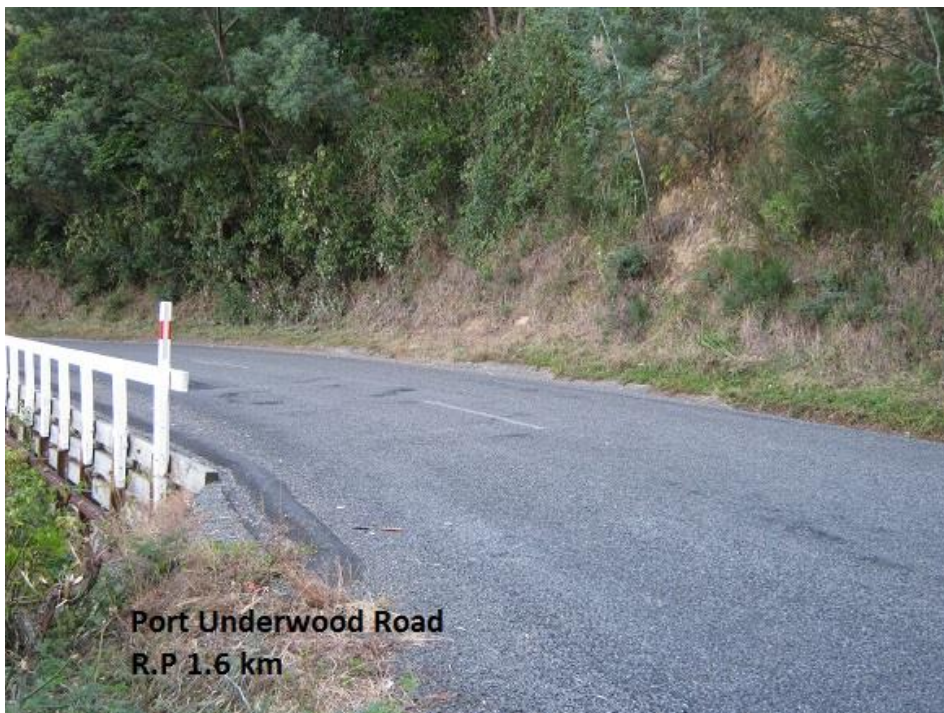
The event was in approx.. 1995.

NOTE stormwater bunds divert water flows away from the site .

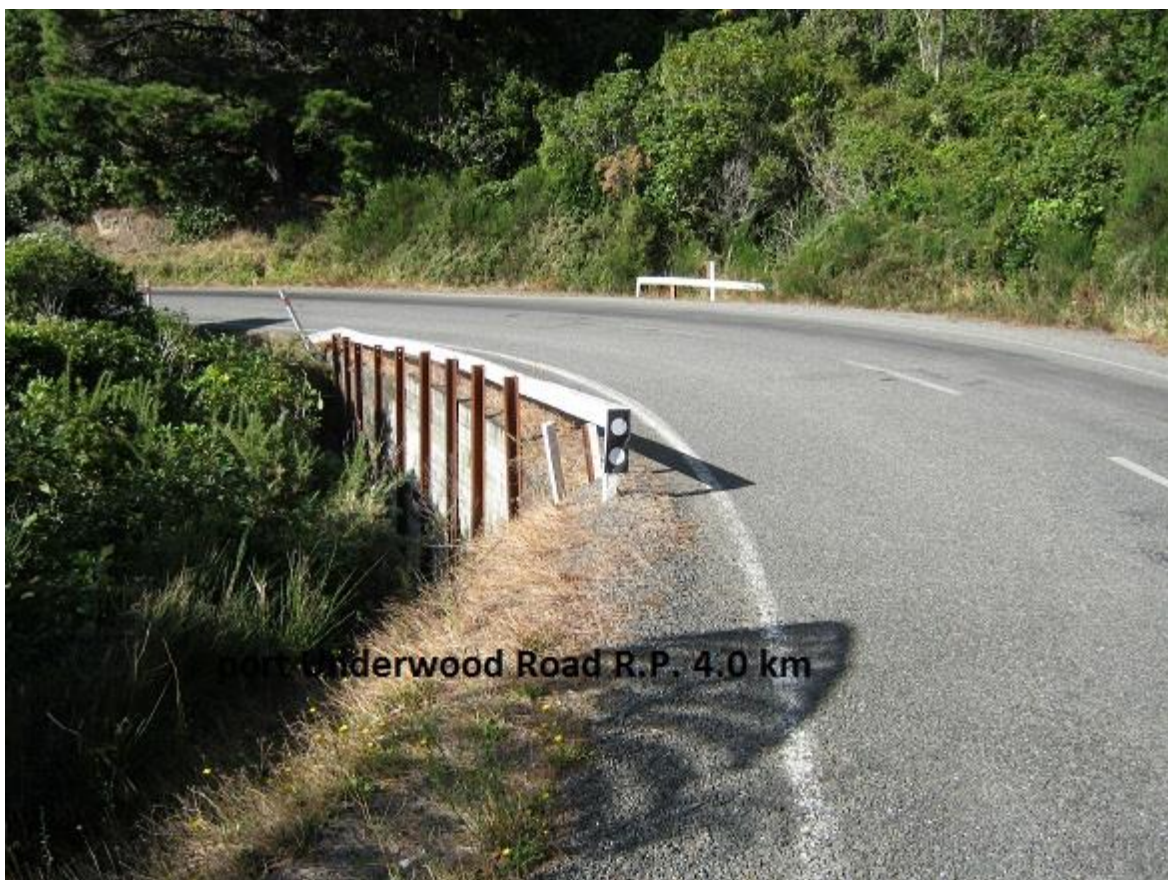
The road culvert collapsed and was replaced with a 450 Armco resited to the East side of the wall

This event can be attributed to the road I consider with uncompacted shoulders and possibly unstable 'cut' batters and involved near 600 m3 flowing to the sea . The event occurred app. 1996.

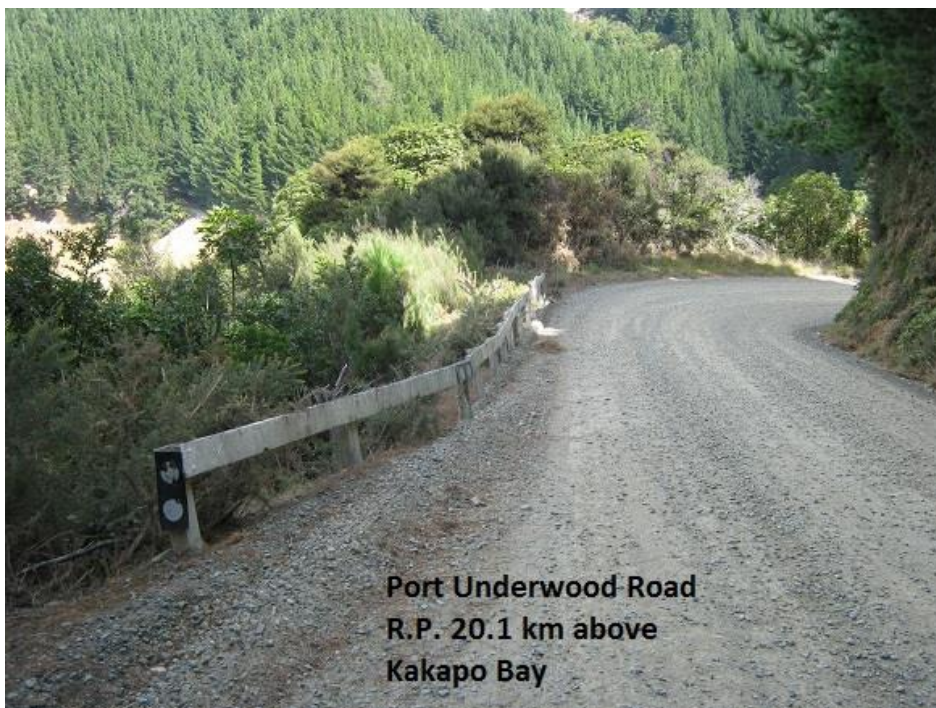
The quantity was app. 250m³ and the event occurred in app. 1990

The structure is not a retaining wall , just defining the road edge and reinforcing the shoulder.

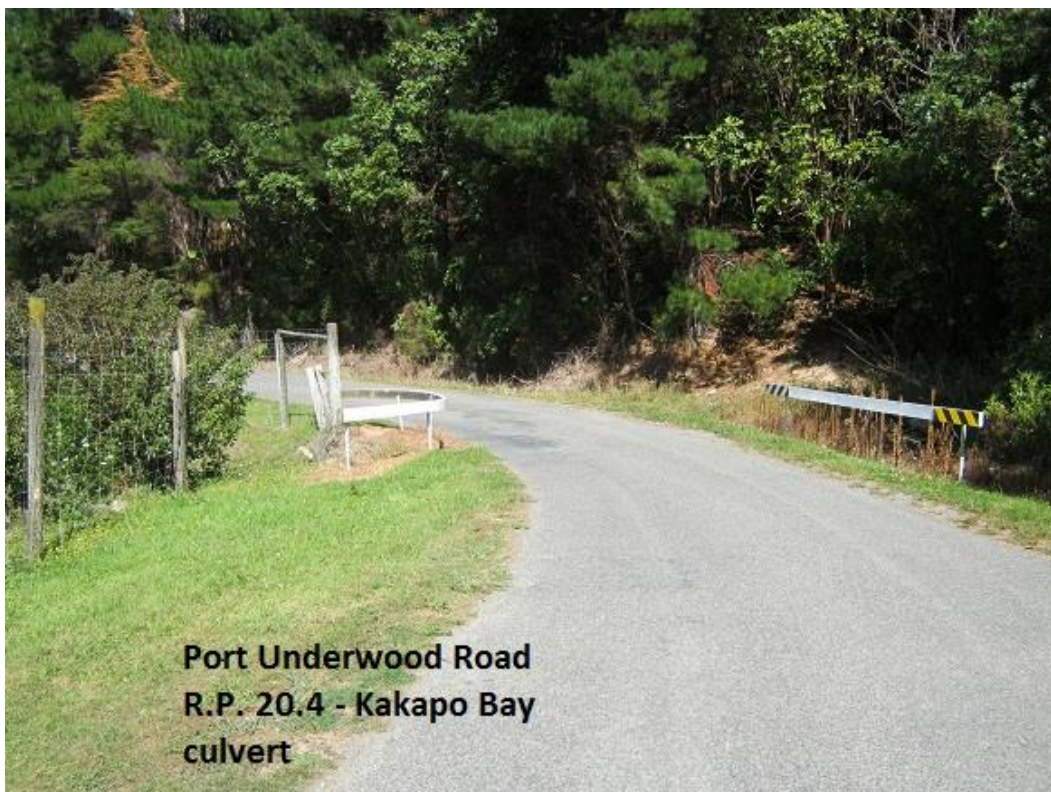
The culvert was replaced and there is a rail iron structure driven in the creek bed upstream of the culvert and road to collect any future debris.

I consider the event was a direct result of recent forestry extraction at the time. The date was approx.. 1990 and there would have been possibly 500 m³ + or – to the sea .

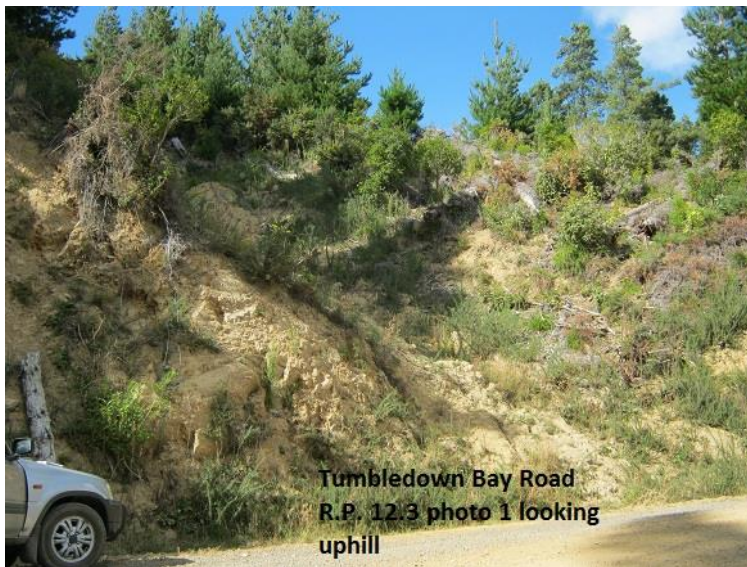
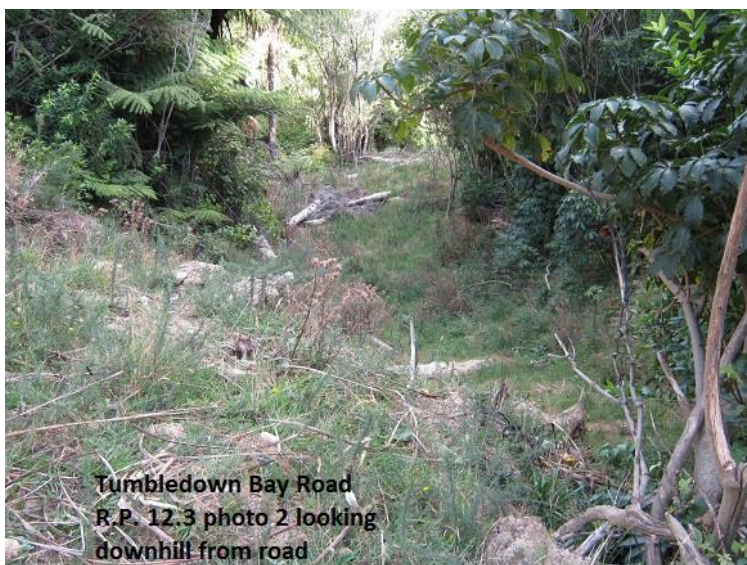
There was over 1500m³ in total of which perhaps 200 m³ reached the distant coast.

This event occurred in app. 2008

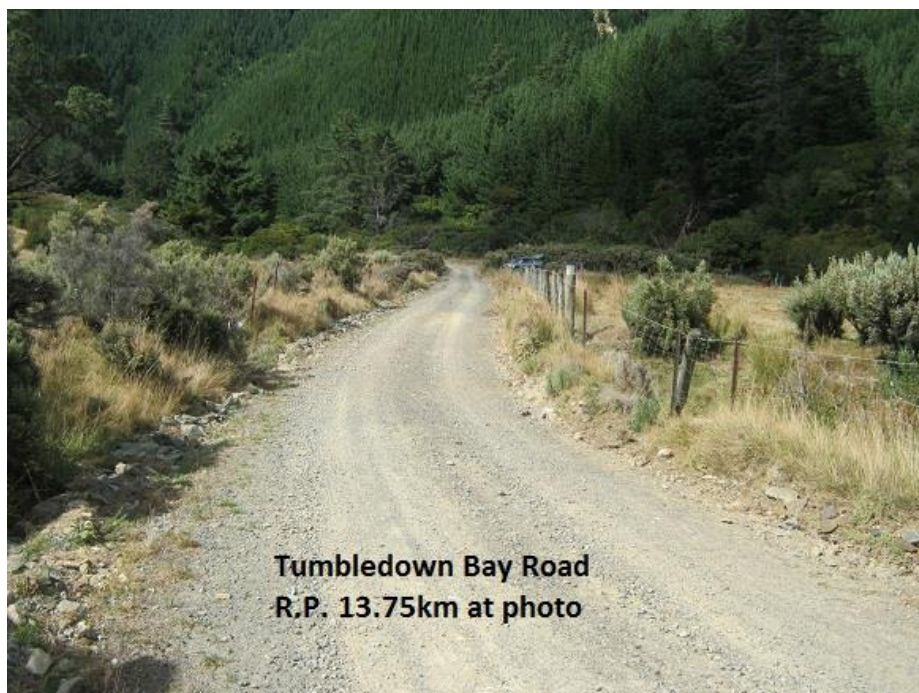
I would estimate at least 1500 m³ and possibly more would have flowed to the sea (there would be almost 900m³ alone from the road formation material)

The event occurred in approx.. 1996 and was close to forestry harvesting near the visible slip , however , I was unable to access Fighting Bay road at the time of the event so I do not know the actual cause.

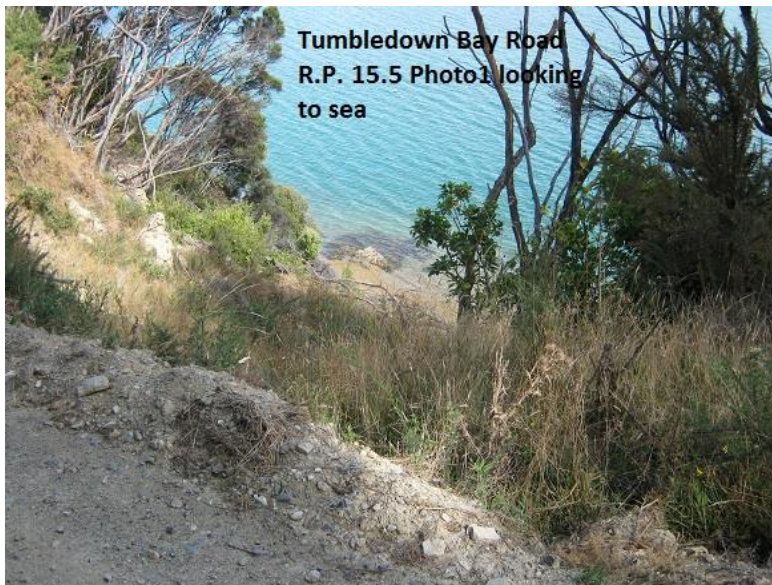
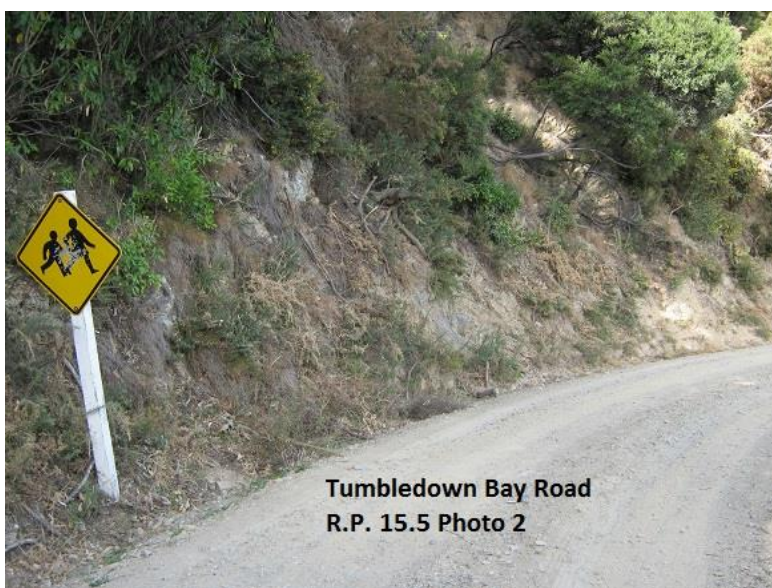
There was approx. 900 m³ at this site and the damage occurred in approx.. 1999

This site is just after a 'Children' sign.

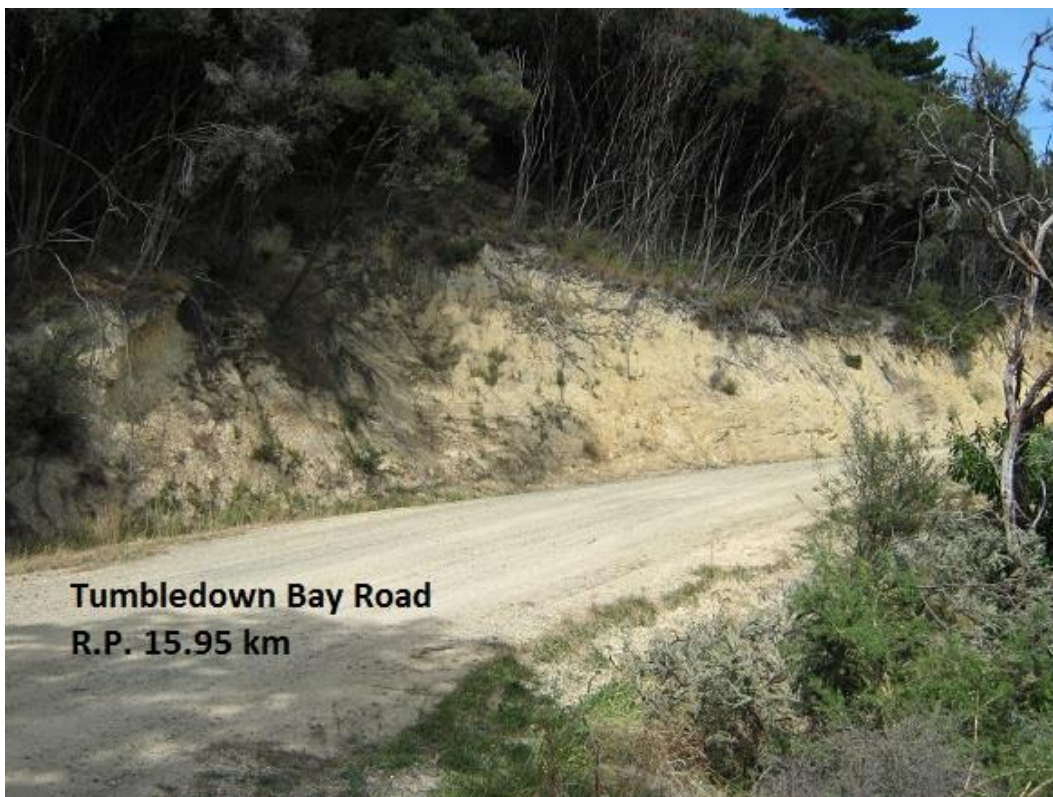
Roading related damage involving app. 400m³ of material to the sea.

This event occurred approx.. 2007.

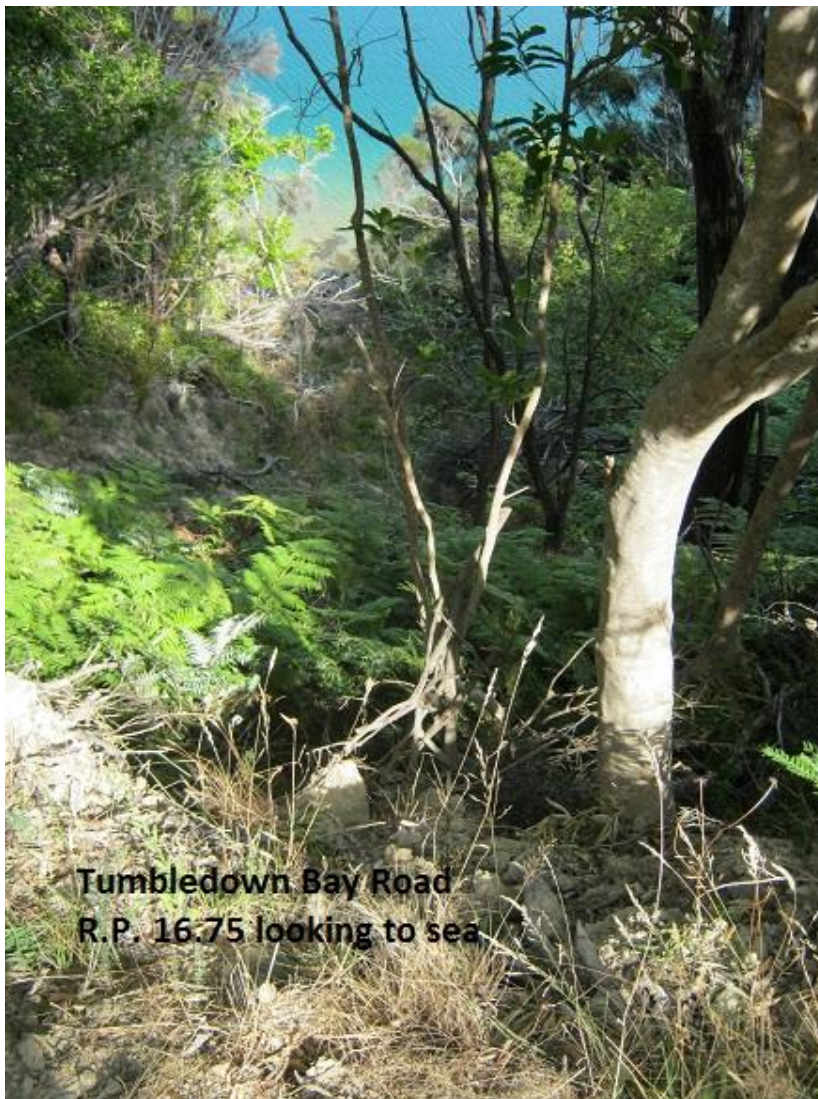
In total some 700m³ has flowed to the coast , the photo looks down to the sea.

This event occurred app. 2008

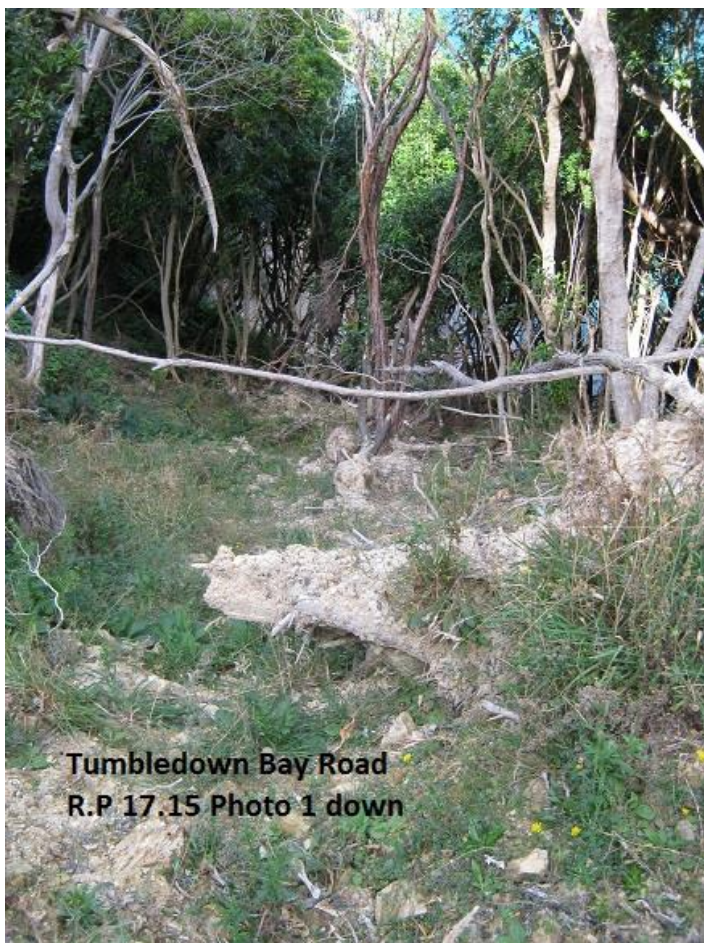
The event occurred in approx.. 1990

NOTE there is a slip site above the road at 16.9 km ; this material did NOT reach the sea.
