# Ford's Cut History and Bank Erosion Assessment

Report prepared for Environment Bay of Plenty by

Philip Wallace

January 2008

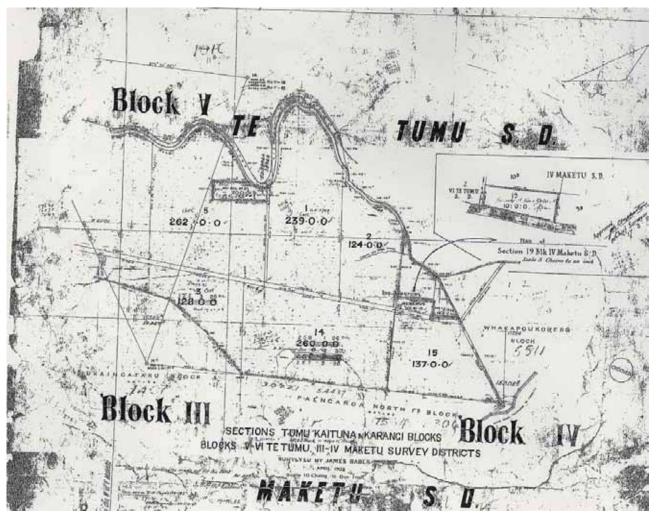
1902 survey, showing the old river loop (blocked off and bypassed in 1979) and the Papahikiwai Channel, prior to Ford's Cut

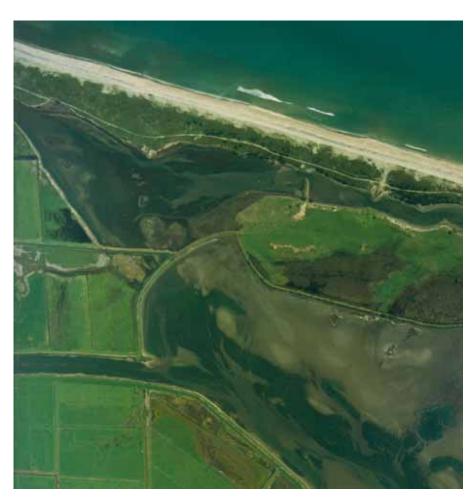
15 October 1994 (area to west not flown)
