PATEA BEACH SAND MANAGEMENT PROJECT

SUMMARY REPORT 2008 to 2015

A report prepared for the South Taranaki District Council

COASTAL SYSTEMS Ltd

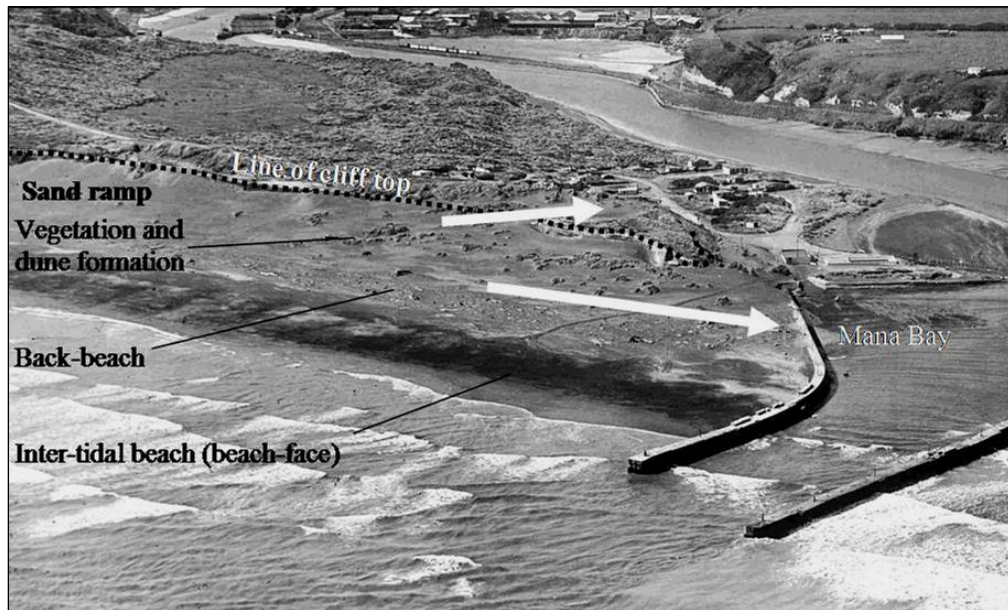
Figure 4 Some 26 years after completion of the moles, the North Beach has moved seaward some 60 m (Figure 3B) and a wide back-beach area defined by debris (driftwood) is evident in this 1947 oblique aerial photograph (Wrights Aviation collection). Vegetation (between the arrows) indicates the establishment of sand dunes, and a substantial sand ramp is evident against the cliff. The white arrows indicate wind-blown sand transport pathways, into Mana Bay (lower) and across the original headland and down onto the beach settlement (upper arrow).

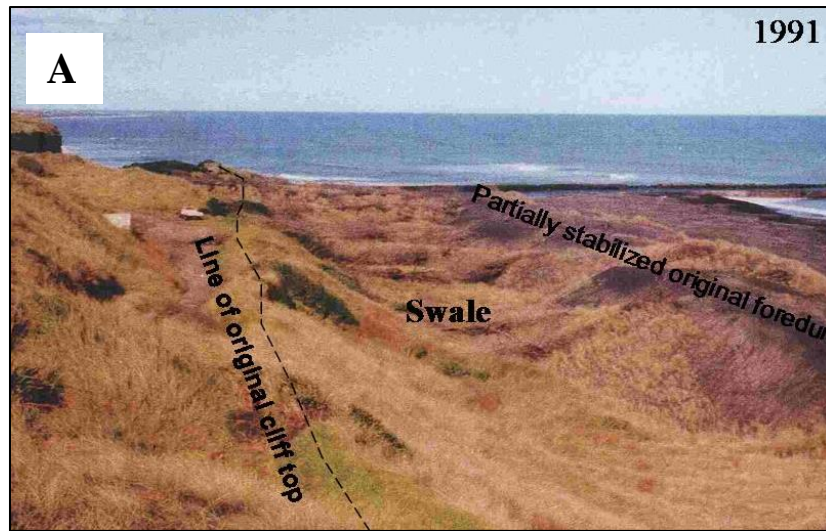
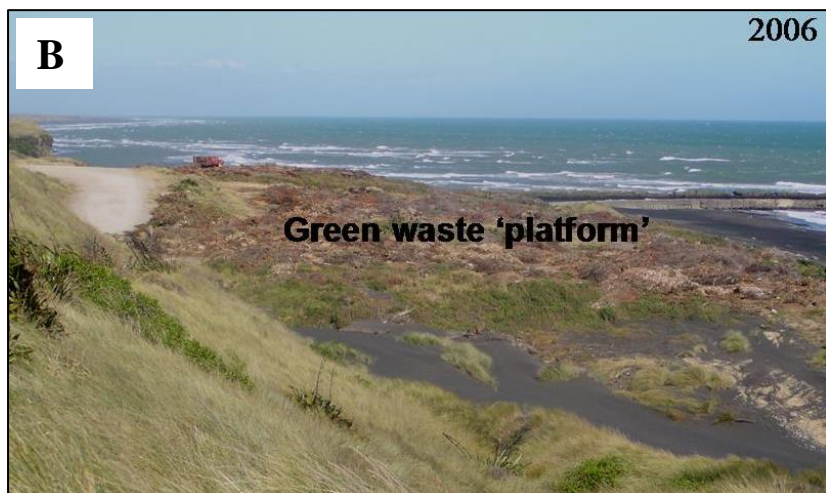
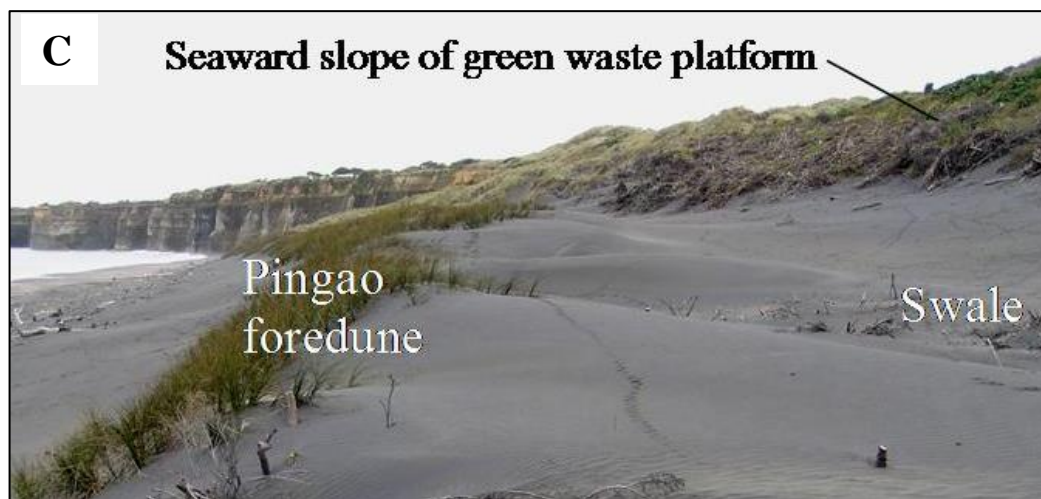
Figure 8 Relatively stable dune-scape in the early 1990s (Figure 8A), although some instability on the seaward side remains; this was stabilized by green waste which eventually produced a platform-like feature (Figure 8B) referred to as the “green waste platform”. The well established Pingao Foredune is shown in Figure 8C, backed by an infilling swale. Dried green waste mantles the green waste platform face at the rear of the lower photo.

develop into guts and sand then drift across the top of the GWP. The boundary of the northern and central sectors was particularly unstable and is discernable by the bare sand in the foreground of Figure 8B and this area is marked orange in Figure 10. Ongoing green waste placement was required to control erosion and sand drifts.

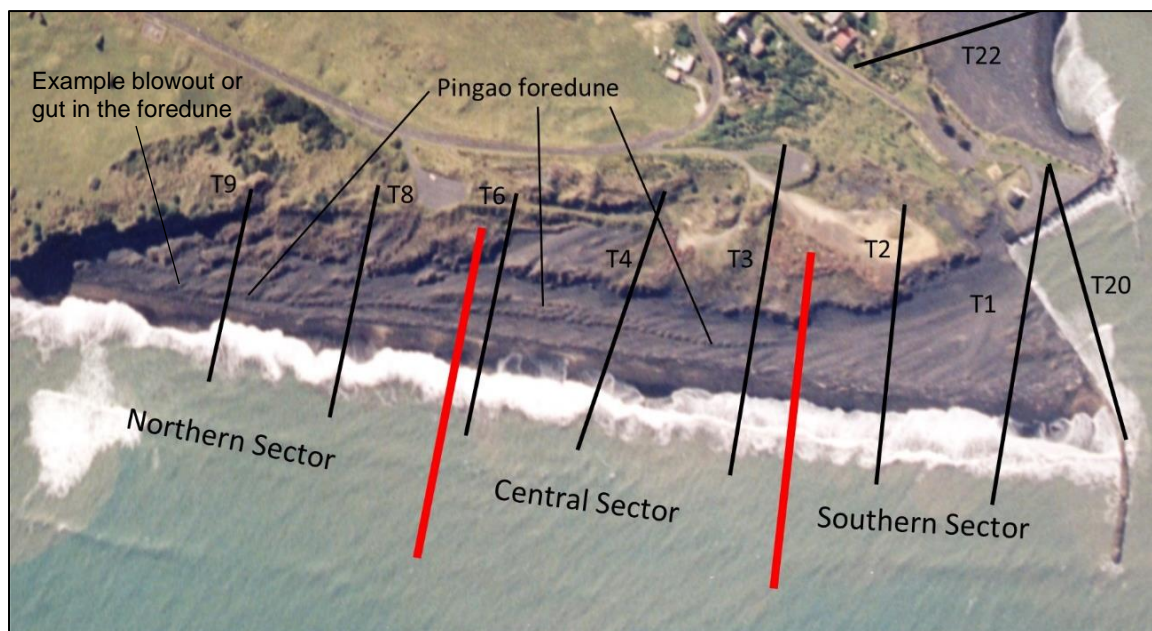
Figure 9 The three sectors of coast with contrasting physical characteristics and management requirements (described in text) have been marked on this 2002 aerial photo. Monitoring transects area also marked. The new Pingao Foredune stretches along the northern and central sectors. Note how this new feature is located increasingly closer to the shoreline along the northern sector and blowouts (guts) are evident by the distinct gaps in the foredune where sand blows through from the beach to the rear.

The Northern Sector dunes were characterized seaward by the Pingao Foredune (marked in the 2002 aerial photo in Figure 9). The foredune was severely “blown out” (guttled) in several locations and this is likely associated with storm-wave erosion creating a scarp (cliff) on the dune face; such scarps can actually be seen as black lines (shaded cliffs) in the subsequent 2005 aerial photo (Figure 10). Behind the foredune were discrete and hummocky marram dunes and erosion troughs broadly aligned with the prevailing wind. In some instances foredune blowouts have merged with erosion troughs to the rear which extend up the ramp to the cliff top and upper car park (between T6 and T8 in Figure 9).

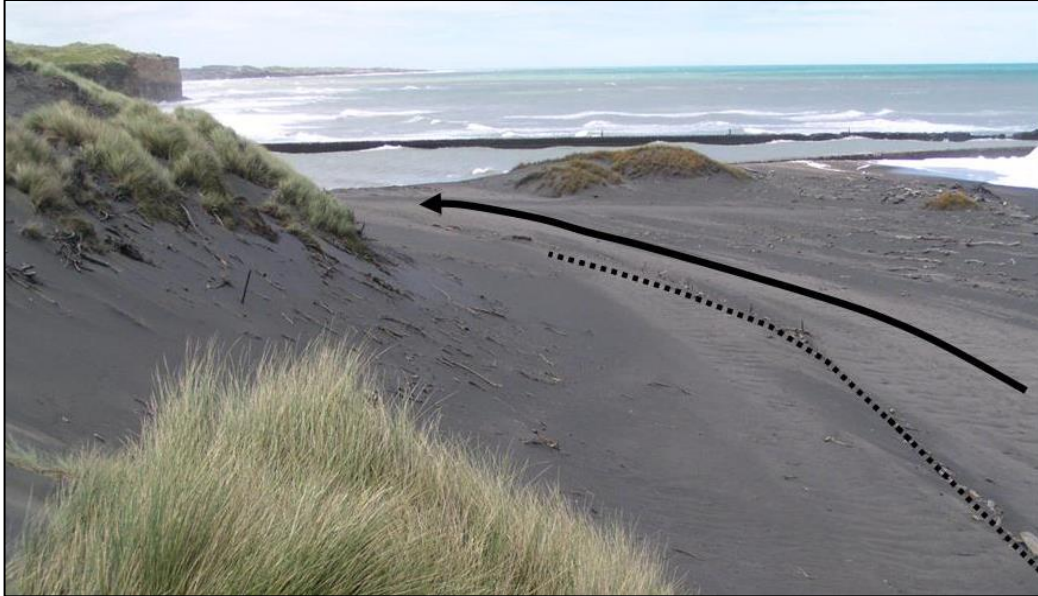
The Southern Sector lacked a continuous foredune, but rather comprised isolated dune hummocks of pingao located on the seaward side of the broad back-shore area (Figure 11). Behind the backshore lay the GWP face characterized by areas of marram grass, bare sand and decaying (dry) green waste, and included several large guts. The clay capping across the top of the platform would result in future drainage issues which affect the platform face (Section 4.5).

Figure 11 Southern Sector view in 2006. On right hand side, discrete pingao dunes are establishing along the seaward side of the wide backshore. To the left is the platform face with marram on upper slope and dry green waste spread down the face. The arrow depicts wind flow and the dotted line locates remnants of the early (1950s) mill slab wind-break fence which facilitated growth of the original marram foredune.

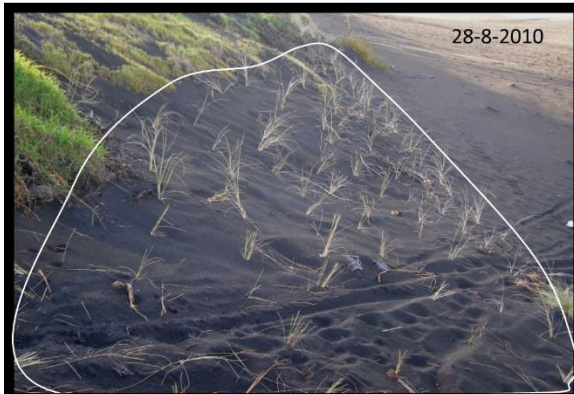
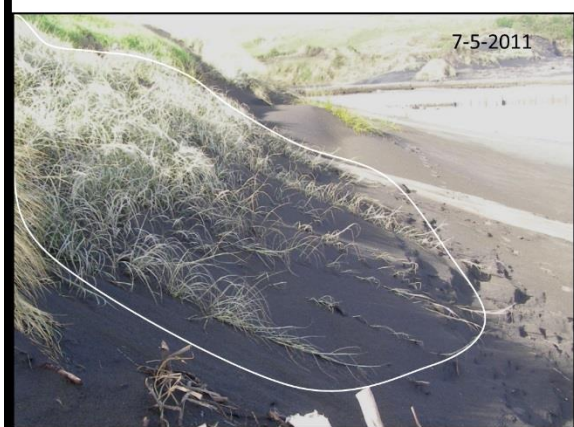
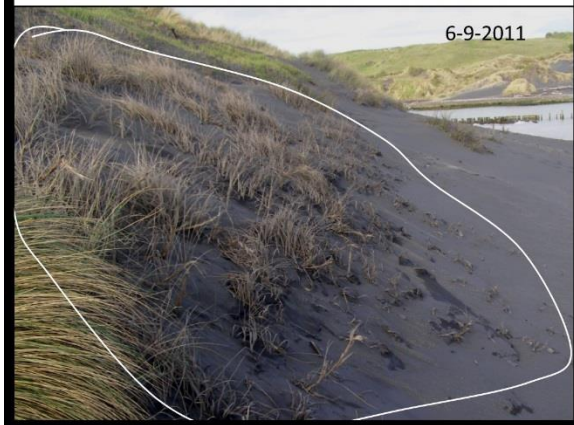
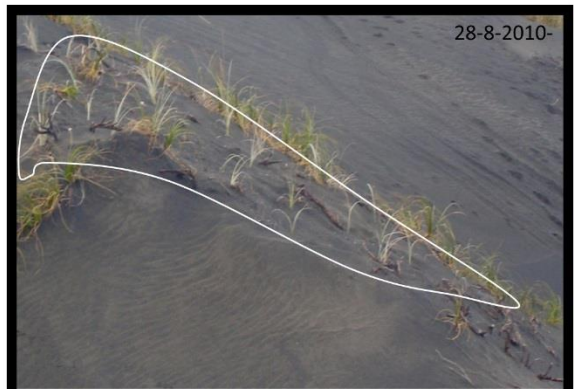
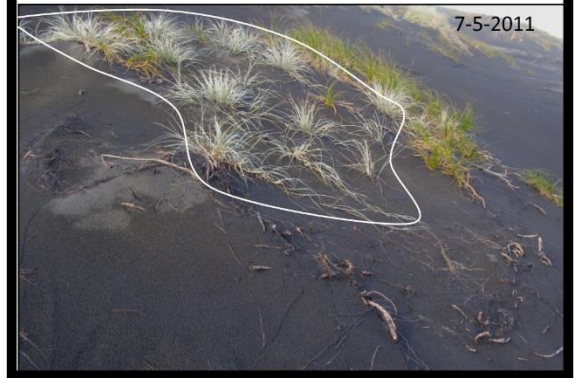
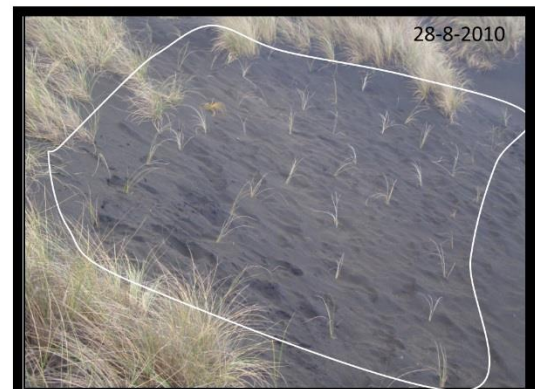
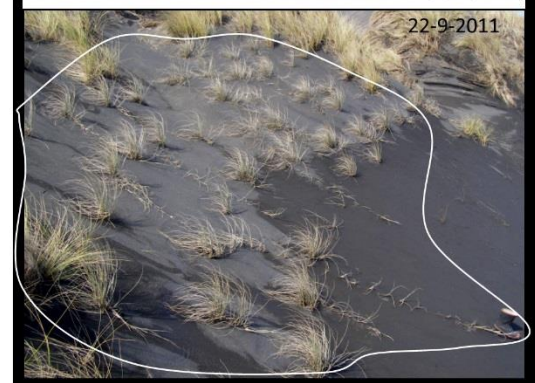
Figure 18 2010 spinifex trial examples from Sites C, F and G (for locations see Appendix B4). 2011 results also shown

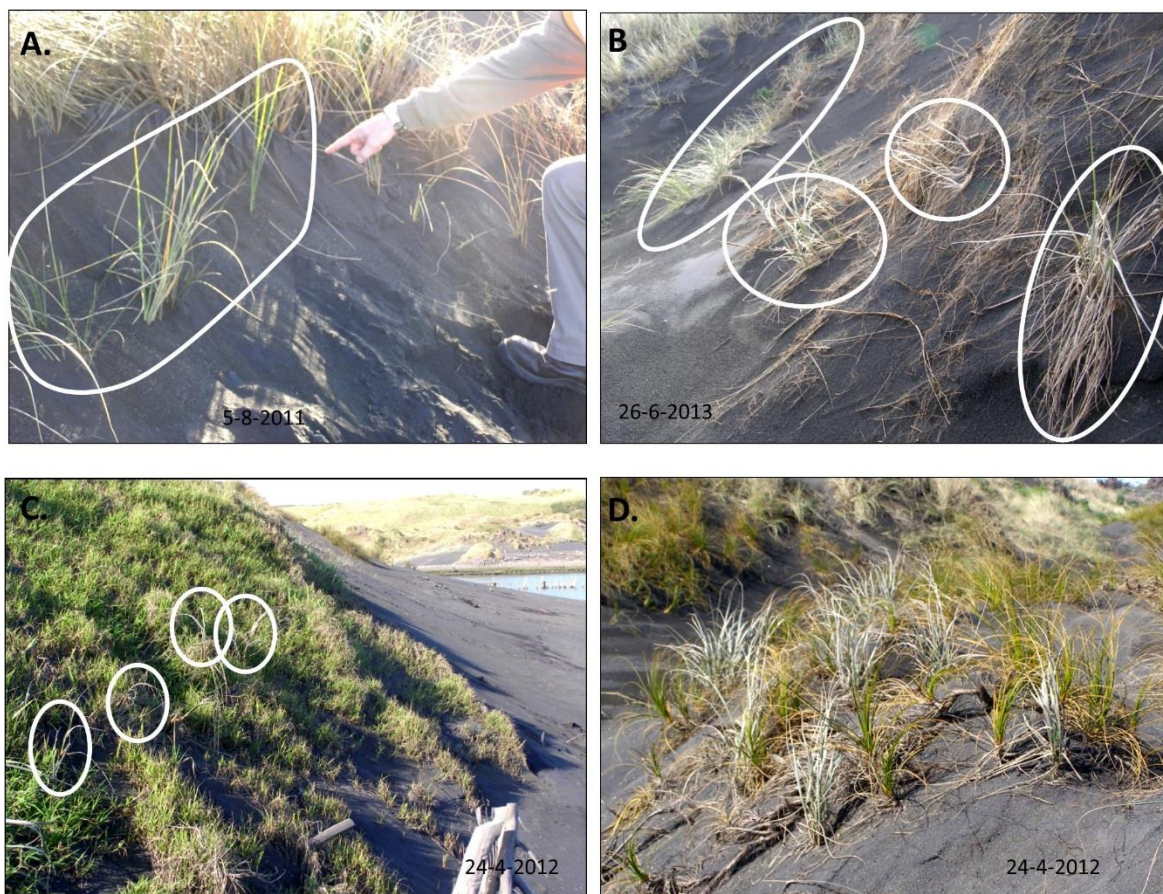
Where plants were located within existing kikuyu at the vegetation front they were suppressed (Figure 20C). When planted in bare sand below existing vegetation (Figure 20A) growth and runner development occurred on lesser sloped areas where sand deposition could occur (Figure 20B in background), but on steep (erosion prone) locations, runners became exposed and the plants struggled to even survive (Figure 20B in foreground). However, the spinifex grew well within existing pingao (Figure 20 D).

Figure 20 Spinifex trials from 2011 around seaward margins of existing vegetation (sites shown in Appendix B5). A shows new plants with B, C and D showing results for different types of described as described in the text.

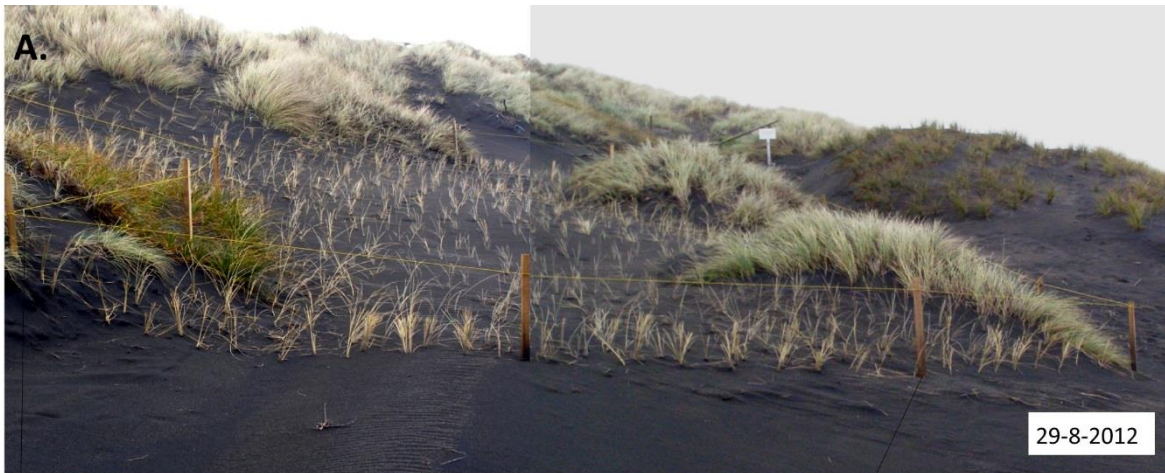
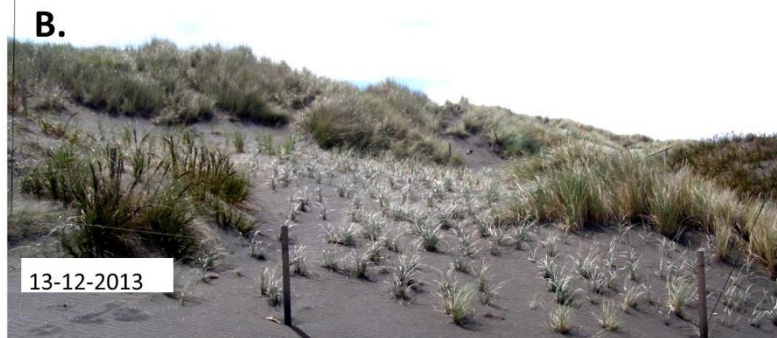
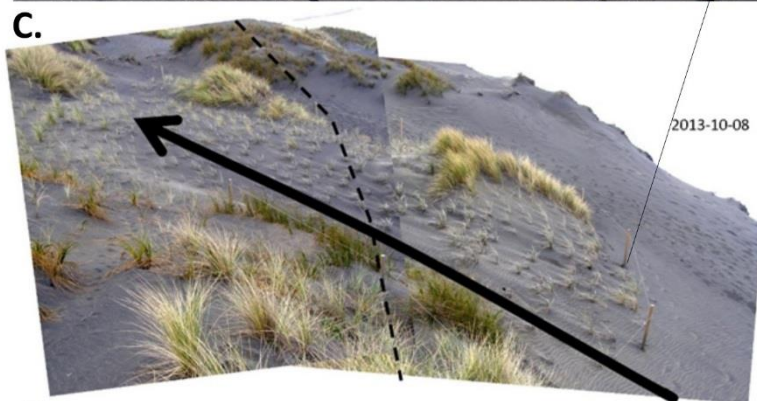
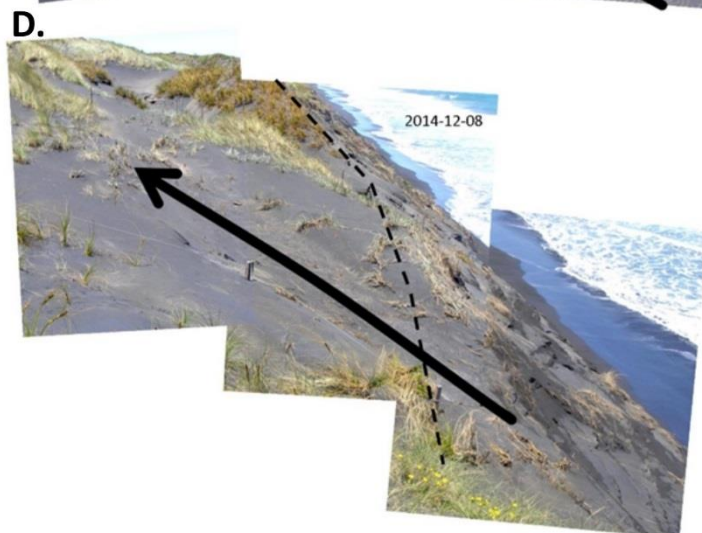
Figure 23

2012 block planting spinifex in the Lower Basin (A) and same view in late 2013 (B). Note fence battens allow referencing. Figure C was taken at approximately the same time as Figure B. Comparison between Figure C in late 2013 with Figure D in late 2014 illustrates the extent of foredune erosion with approximately 18 m of scarp retreat having occurred by that time. Dashed lines denote December 2014 scarp top with arrow defining wind flow concentration through the topographic low in the foreground. The planting site is significantly compromised with frontal vegetation having been scoured and vegetation to the rear becoming increasingly vulnerable to wind erosion, wind desiccation and burial.

The spinifex established well despite very windy conditions during early summer then the prolonged drought during late summer and autumn (Figure 22B and 23B). However, unlike the earlier spinifex trials virtually no runners grew. This behaviour was noted by plant ecologist Dr David Bergin to have also occurred in new plantings on other coasts and he speculated that it may be associated with the sustained high temperatures and moisture stress during the growing season. It appears there has been little additional runner occurrence by 2015. This was disappointing as runners were expected to spread onto adjacent unplanted areas. Nonetheless, runners from the 2011 planting in the Upper Basin are spreading into the central unplanted area, as illustrated in the 2015 photo (Figure 22C).

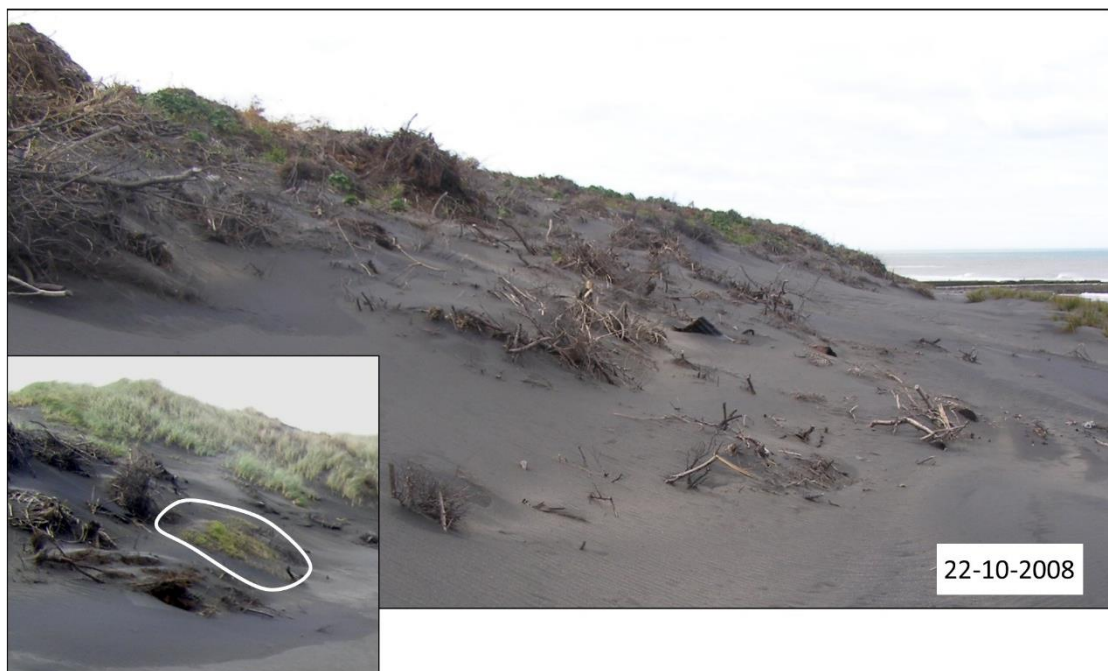
Figure 28 The Central Sector GWP in 2008 was characterised by green waste with vegetation along the crest (a range of garden weeds including kikuyu) and areas of kikuyu establishing on the face (see inset)

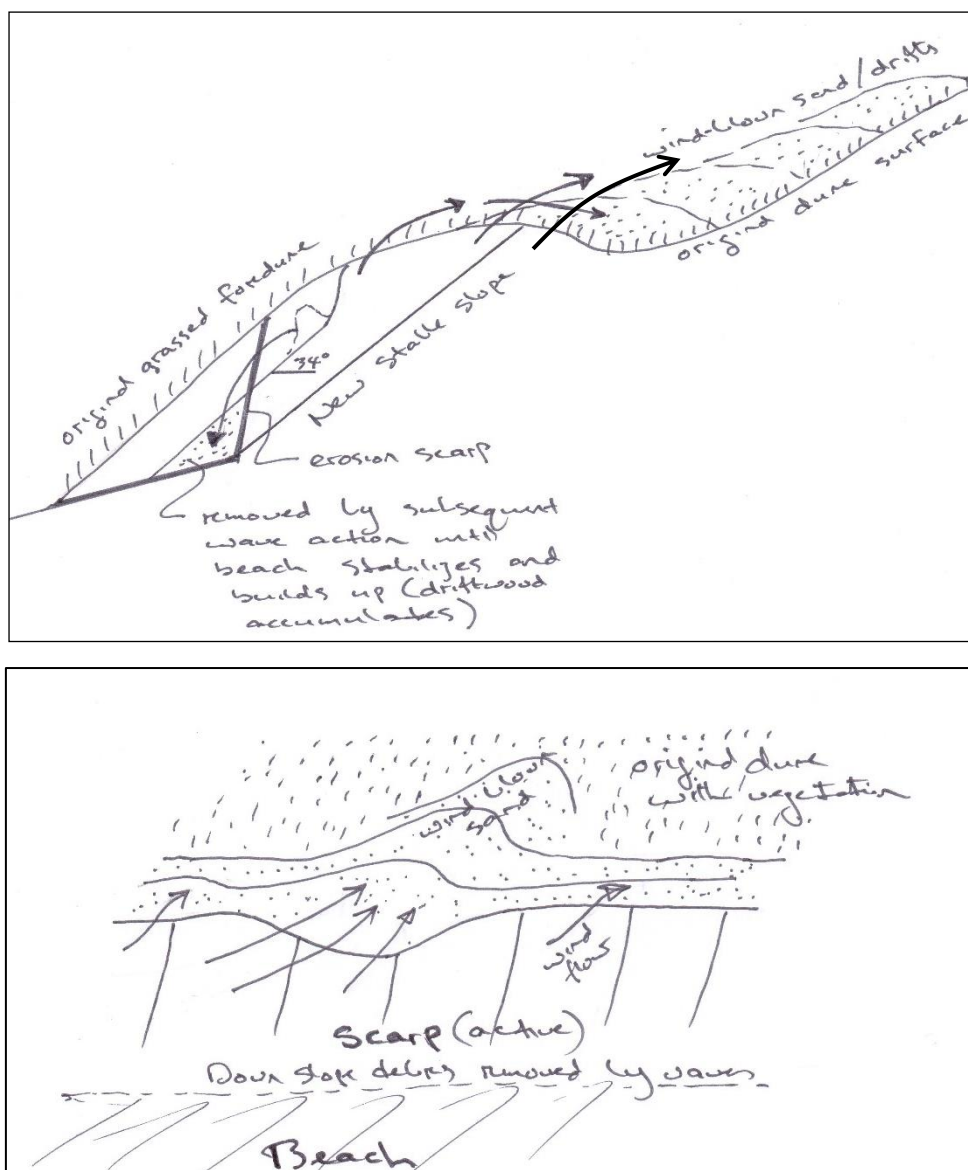
Figure 34 Upper figure shows profile (cross-section) view of slope adjustment processes following foredune erosion by storm wave action. The new stable slope is achieved by downslope movement of sediment under gravity (sliding, avalanching and block glides). Upslope processes are driven by wind erosion and inland loss of sediment which results in burial of vegetation and wind drifts migrating inland. Note upslope processes continue until the sand surface is protected by vegetation (or other material) regardless of slope angle. The lower figure shows an oblique view of wind processes removing sand from the scarp face and depositing it on the stable inland dune surface. Wind flow funnels through low points along the scarp crest line, and gullies develop with additional capacity for localized erosion and landward deposition.

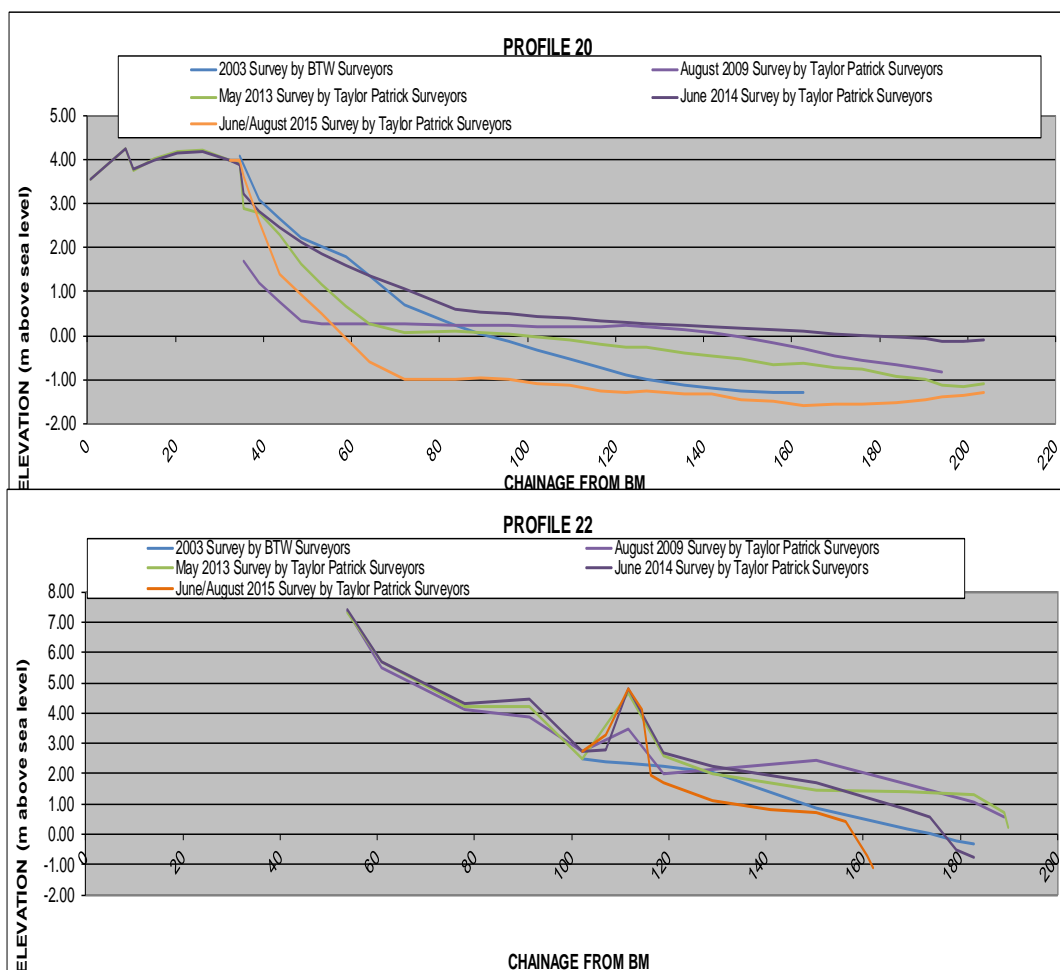
Inlet data are depicted in Figure 35 with an inner bay graph (Transect 22 at the upriver end of this bay) and an outer (Manu) bay graph (Transect 20). Manu bay appears to have been systematically infilling with sediment, possibly with sediment lost from the northern beach/dune system. However, the June 2015 flood dramatically lowered the profile some 1.5 to 2 m. The inner bay profiles show the landward side reducing in size by about 20 m upon the formation of a foredune coinciding with a very large accumulation of sediment across the bay in 2009. Sediment was systematically lost thereafter (in contrast to the outer bay), and again there was a dramatic loss of sediment during the June 2015 flood when outer edge retreated some 20 m and the profile lowered by about 1 m. A reverse relationship is indicated between the two bays and a tide-driven mechanism is plausible given the modified flow regime caused by the Patea Dam. However, the graph for the inner bay also shows the channel (right side of graph) moving landward (eroding) and this may also be related to river control works (raising the southern training wall) on the opposite side of the river.

Figure 34 Superimposed profiles for Transects 20 (seaward bay) and 22 (landward bay) see Figure 9 for locations. Changes are described in the text.

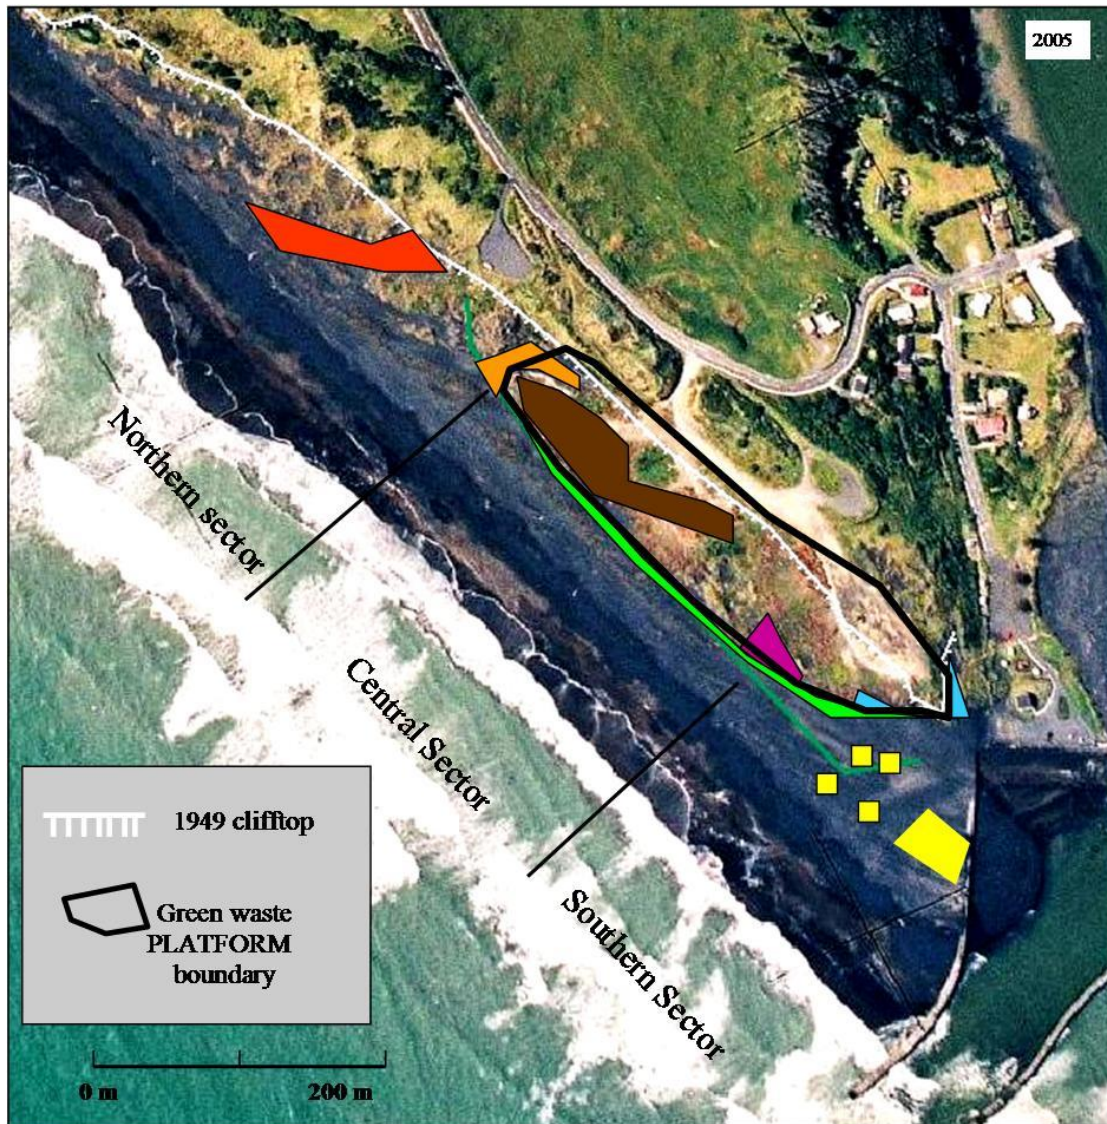
Figure 1 Area of green waste dumping as at 5 June 2008 (brown), areas requiring sand stabilization now (orange) or in near future (red, purple, aqua), area for mid-face planting (green) and areas of isolated dunes to be removed and vegetation relocated (yellow). See text for discussion.

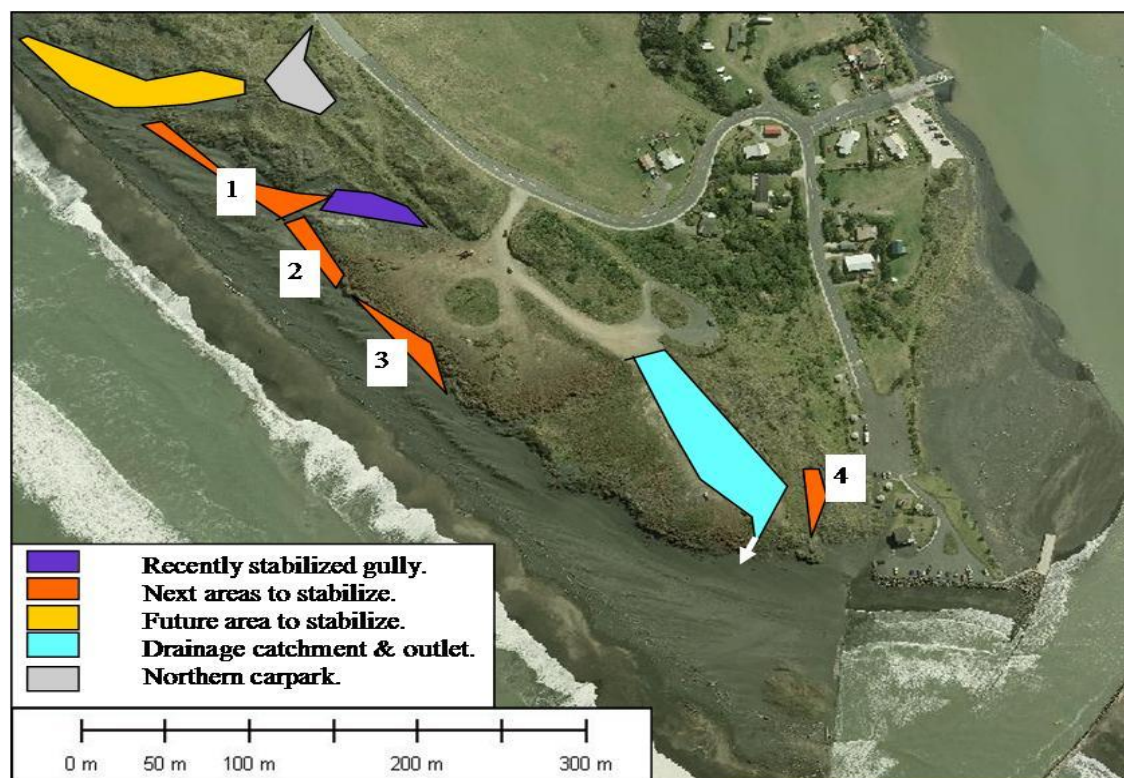
Figure 1 Features and locations referred to in this report. Numbered erosion sites referred to in text.

While about 75% of the gully at the northern margin of the green waste platform has now been satisfactorily stabilized, the landward area “feeding” sand into the gut still requires stabilizing (depicted as [1] on Fig 1 below. In addition, areas [2] and [3] fronting the central platform, along with a smaller area at the southern end of the platform [4] require treatment. Stabilizing some of these areas will take several years as sand must deposit within and about the stabilization materials.

In the future, a large area fronting the northern car park (see Fig 1) will required treatment. However, treatment area [1] first needs to be stabilized as it will provide the access route.

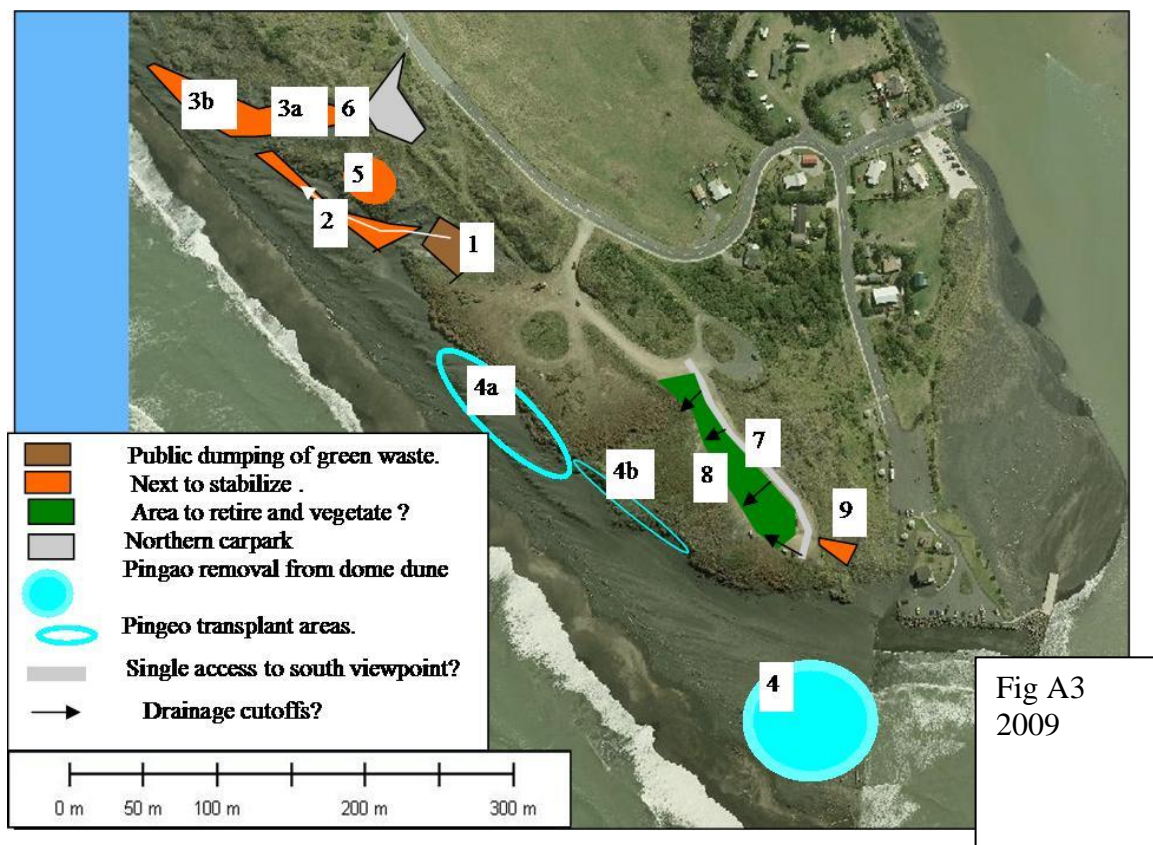
1. On 7th September, 2009 I inspected the site in conjunction with supervising a contour survey carried out in the vicinity of recently removed vegetation from the “dome” dune (#4 in diagram below). Note that the numbers in this diagram are same as those used in previous inspection reports. The survey was carried out to monitor environmental response as the dune-sand blows into the river over coming months. The contour plan is included with this report. The survey was carried out by Taylor Patrick and used the same survey control as earlier 2003 and 2007 surveys to enable temporal comparison with previous/subsequent surveys. Analysis will be carried out after the forthcoming 2 yearly monitoring (profile) surveys.

2. On 26 August local contractor Noel McCole relocated the pingao cover from all but the north end of the dome dune (#4), the remnant being left to help regulate the subsequent sand dispersal into the river. Smaller nearby self seeded dune hummocks of pingao were also removed; this area needs to remain vegetation-free as dune growth will compromise long-term stability in this area.
