2017-01 LRep  
Status: Open  
20 January, 2017

Prepared for:  
Tonkin and Taylor Ltd

## Background information: Whanganui Port Basin management assessment

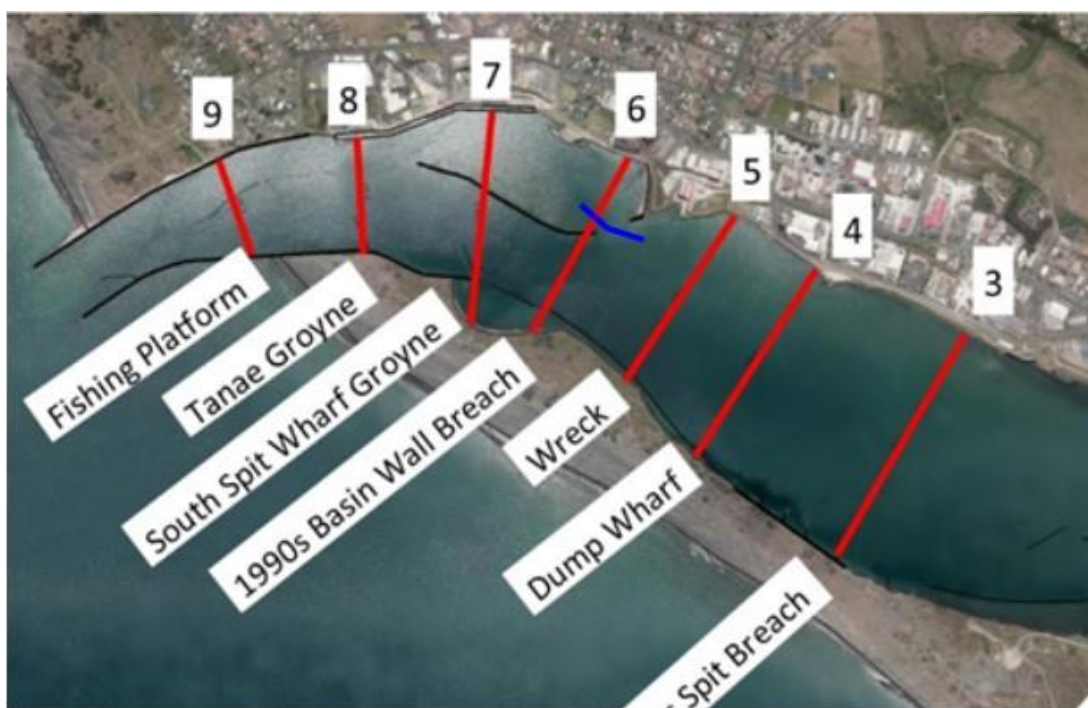
**Figure 3** Section locations (red lines), numbers and names. Black lines locate river control structures. (source Figure 15, Baseline Study 2016). Blue line is transect sampled in Figure 5 to compare breach bed levels.

The 2016 Baseline Study (Section 2. Analysis and Discussion) addressed morphological change in the vicinity of the breach based on (a) superimposed profiles (see Figure 3 below for section locations) which were derived from bathymetric data, as well as (b) aerial photography. However, the Baseline Study primarily addressed effects on the river side of the Basin Wall breach. Superimposed profiles for 1993, 2006 and 2015 at transects 5 (250 m upstream of the breach, transect 6 (just inside the breach), and transect 7 (within the Basin midway along number 3 wharf) are depicted below in Figure 4. In
