Middleton Bay Long-term Management Strategy

A report prepared for the South Taranaki District Council

Reference	2020-3b CRep
Version	1.2 (FINAL)
Status	For council use
Date	7 August, 2020

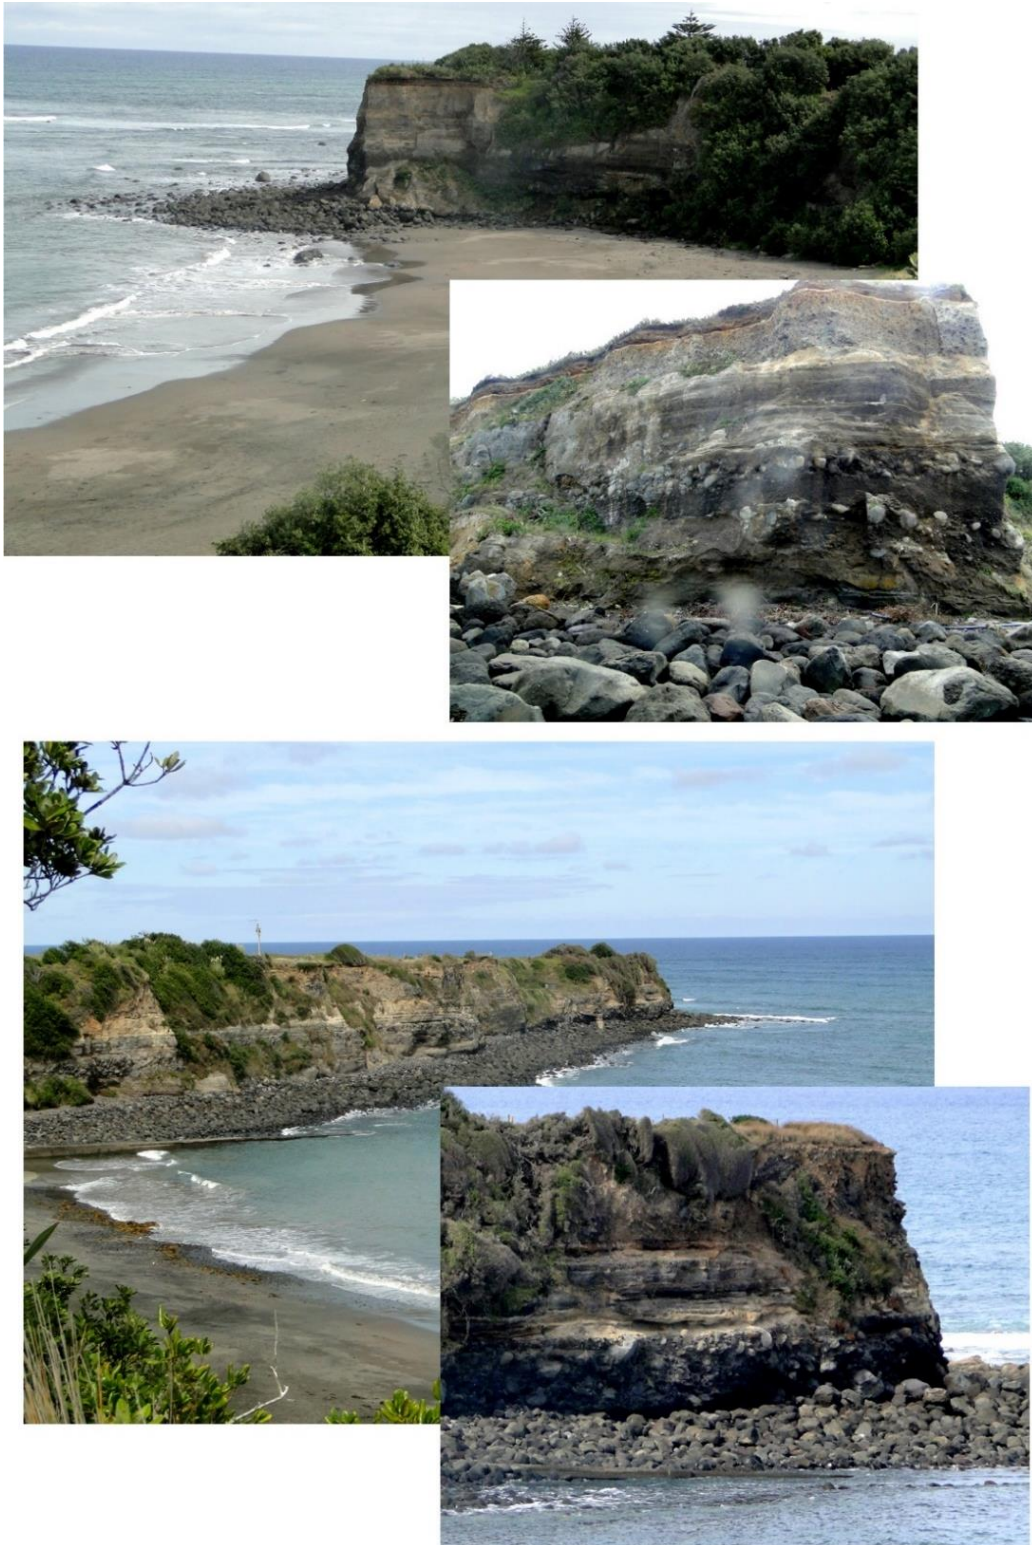
The Ōpunakē Formation (30,000 to 38,000 years old) contains the controlling geology at Middleton. It outcrops in the mid to lower cliffs and comprises layers of volcanic sandstone, conglomerate and andesite boulders from numerous lahars which occurred during a constructional phase of the volcano's history. As the cliffs erode these boulders drop out and form the protective apron along and around the headlands which later (as cliff erosion proceeds) become the offshore reefs which extend seaward for several hundred metres off the headlands (Figure 5). The reef and bay topography result from spatial variation in boulder concentration with less boulders providing less shoreline protection and faster cliff retreat and visa versa. This variation also explains the shorter northwestern headland and a longer southeastern headland as the northwestern promontory contains considerably less boulders than the southeastern promontory (Figure 6).

Figure 6 Middleton Bay headlands. The northwestern headland in the upper photos is considerably shorter and contains less boulders than the southern headland. Photos taken on 16-3-2020.

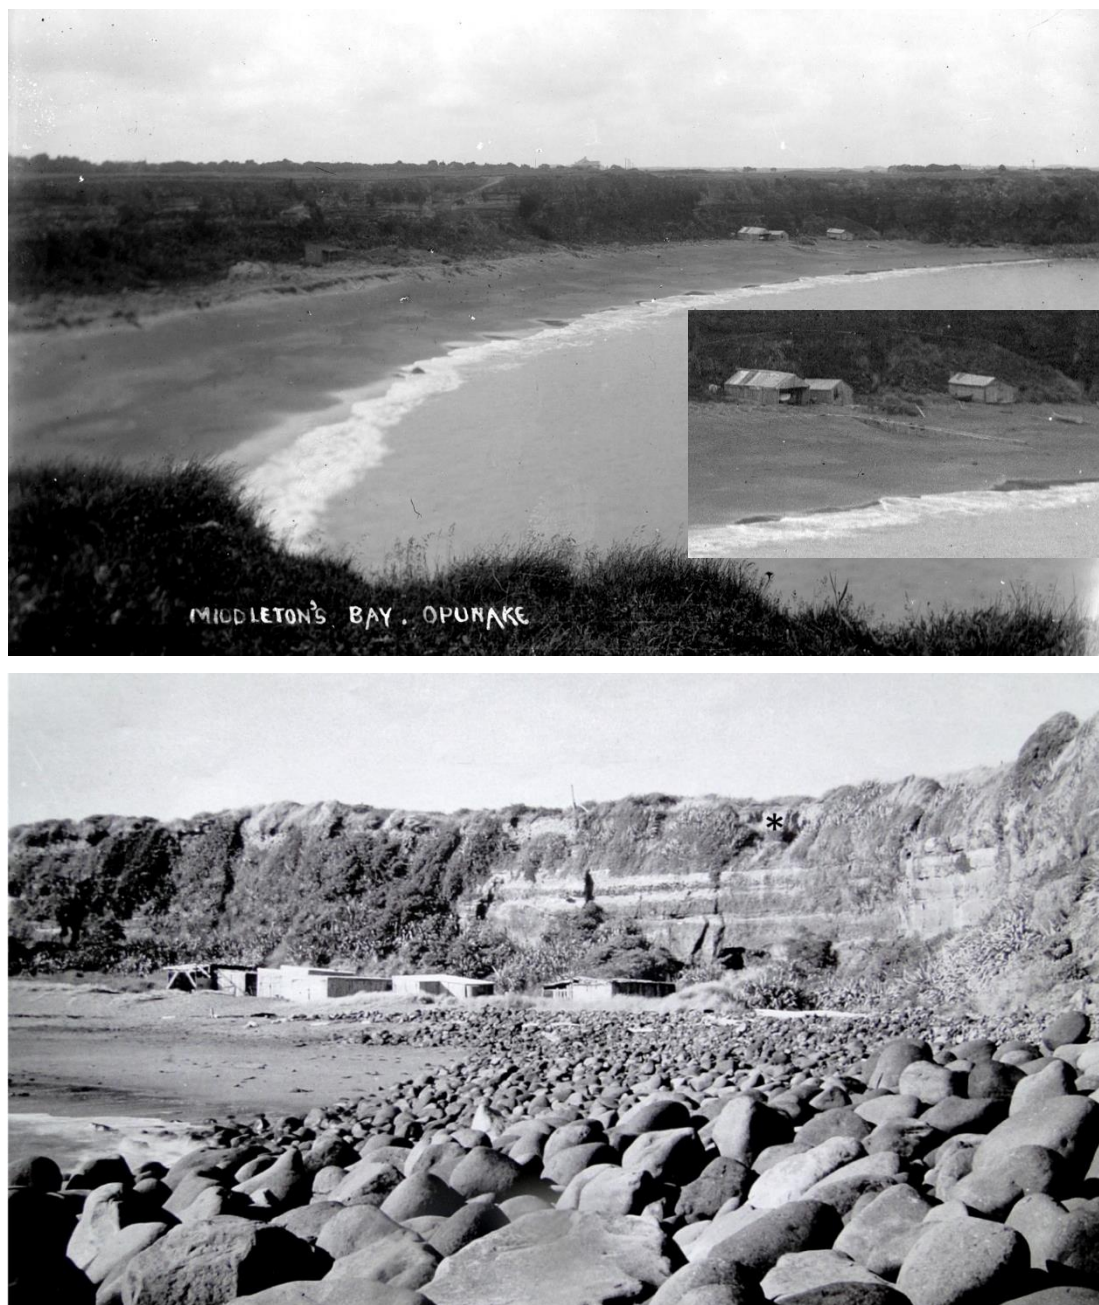
Over the past 100 years the southeastern half of Middleton Bay has been subjected to increasing human activity and associated effects on the coastal environment. The earliest evidence of human activity thus far located is the 1924 Feaver photograph (Figure 7 upper) which shows three buildings at the far (SE end). Gibb (1998) notes that these historical buildings were "...for clinker built surfboats used for recreational fishing. The sheds were constructed close to the seaward face of the foredune. Fishermen would haul the heavy boats down the foredune face and launch them through the surf. On return the boats were winched up the foredune and into the sheds". A 1940s photo (see Figure 7, lower) shows additional boatsheds fronted by young sand dunes.

Quarrying of the cliff above the Boat and Underwater Club room occurred during the 1950s when the council hoped to obtain gravel for local projects. This location appears to correspond to a natural drainage channel, see * in Figure 7. The overburden was stripped and volcanic stone excavated then trucked up the new access road. However, the material proved to be unsuitable and the project appears to have been abandoned by the early 1960s. The exposed material was used thereafter to build out the fronting shoreline – with the reclamation becoming the present car park.

Figure 7 The earliest photo (upper) of Middleton Bay taken in February 1924, shows a scarp in the foreground (NW sector), a single dwelling? behind the foredune in the foreground, and 3 boatsheds at the far (SE) end. The lower photo is estimated to have been taken in the early 1940s and shows additional boat sheds and sand dunes developing to seaward. The asterisk marks stormwater channelling incised into the clifftop. Photo supplied by Mr Gerald Bourke.

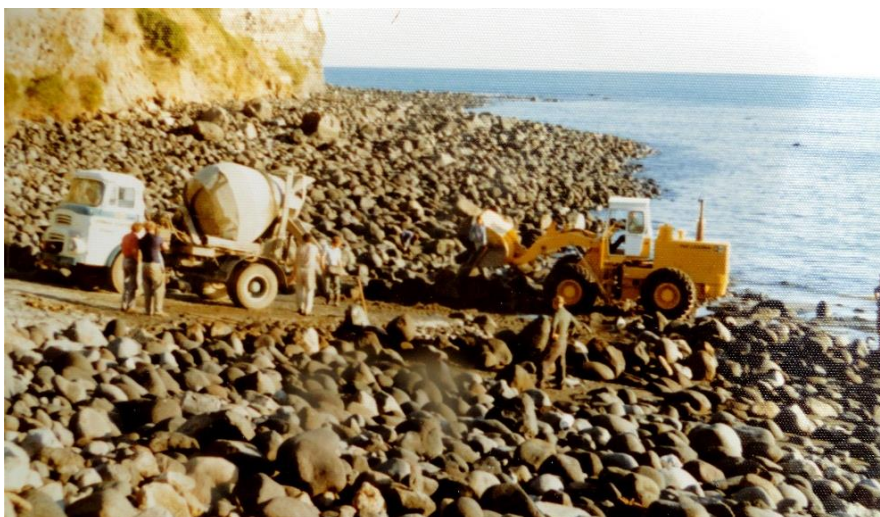
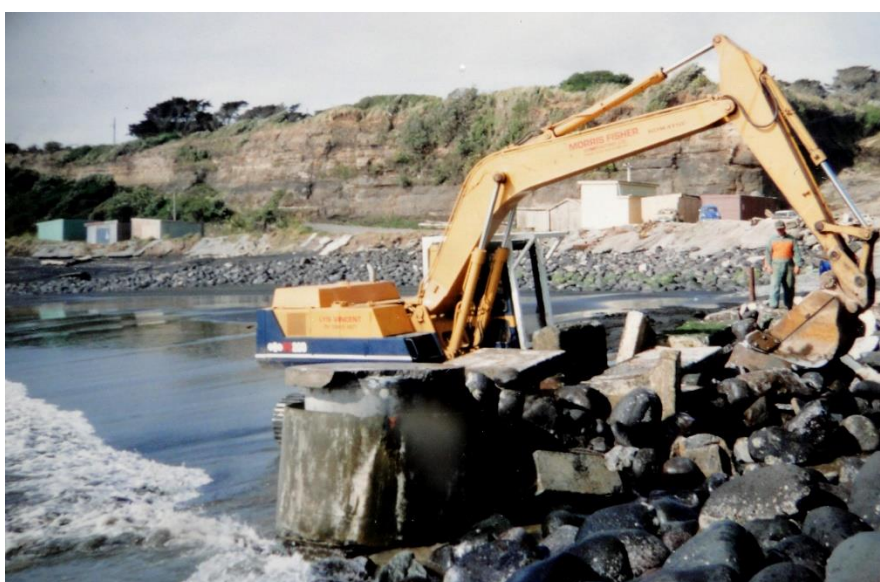
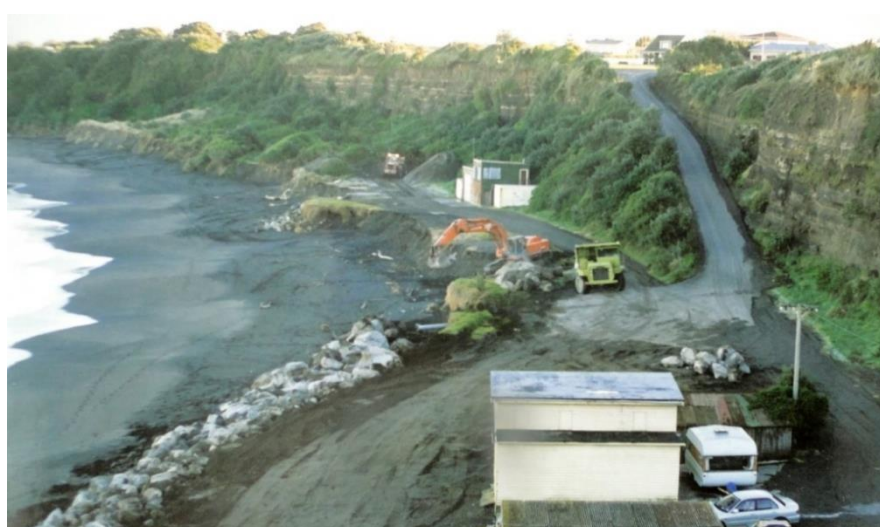
In July 1999, the present seawall (boulder revetment) was constructed along the length of southeastern sector (Fig 9 lower). This structure replaced a previous structure that had developed piecemeal over time and was fronted by boulders, rubble and waste concrete capping as illustrated in the background of Figure 9 (center photo) and in Gibb's 1998 photos in Appendix A. The new structure was consented (coastal permit 5504).

Gibb (1998, p12) noted that when a replacement seawall structure was established it should have a curved alignment which he diagrammatically depicted. But this advice was not followed and the new structure had a straight alignment. Consequently, the seawall face is misaligned to the wave crests during high-tide, storm-wave conditions and this increases wave reflection toward the northwest. This process has potential to exacerbate shoreline erosion in the Central Sector, in addition to potential erosion caused by waves interacting with the end of the seawall (end-effect erosion).

Figure 9 Upper photo: pouring concrete for the boat ramp, May, 1977 (Mr Brian Vincent photo). Central photo: constructing the (present) ramp wall using concrete blocks, c. 1986 (Mr Brian Vincent photo). Lower photo: constructing the current rock revetment in July 1999 (Mr Gerald Bourke photo).

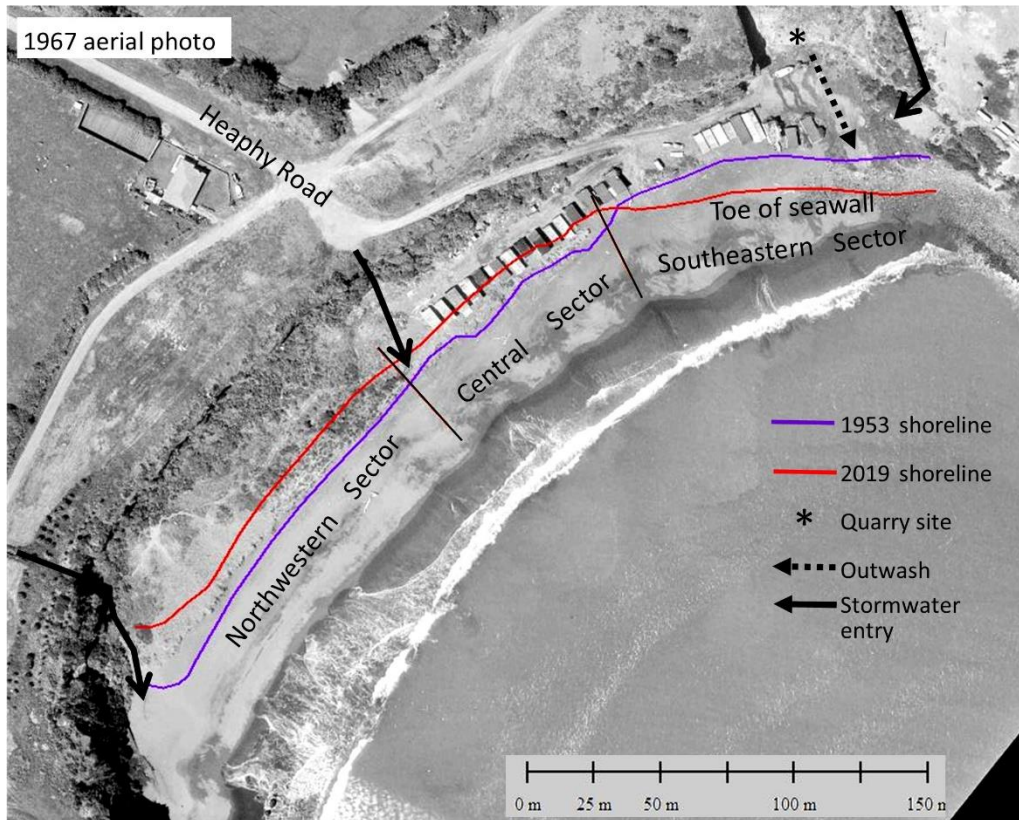
Figure 10 1953 and 2019 shorelines overlaid on the 1967 aerial photo. The 3 sectors are marked along with the quarry site (*) which appears to correspond with the early natural cliff drainage channels marked by the * in Figure 7. Quarry outwash (arrowed) contributed to local buildout (accretion) of the shoreline.

Figure 10 shows these shorelines for 1953 and 2019 superimposed upon the 1967 aerial photo. These bracketing shorelines show the following overall behaviour during the 66 year time span:

- The (natural) NW sector's shoreline had eroded on average 14 m (0.21 m/yr). It is noted that this shoreline may have been unstable well before 1953 with the early 1924 photo (Figure 7) showing a scarped foredune indicative of erosion.
- The central sector, which has been subject to isolated protection works during that 66 year time period, had eroded on average some 9 m (0.14 m/yr), and
- The SE sector shoreline (which had undergone reclamation and had a continuous seawall since 1999, has moved seaward on average some 12 m. Note that surface features in Figure 10 indicate fine sediment washing out of the quarry site and down (arrowed) past the buildings to help buildout the shoreline.

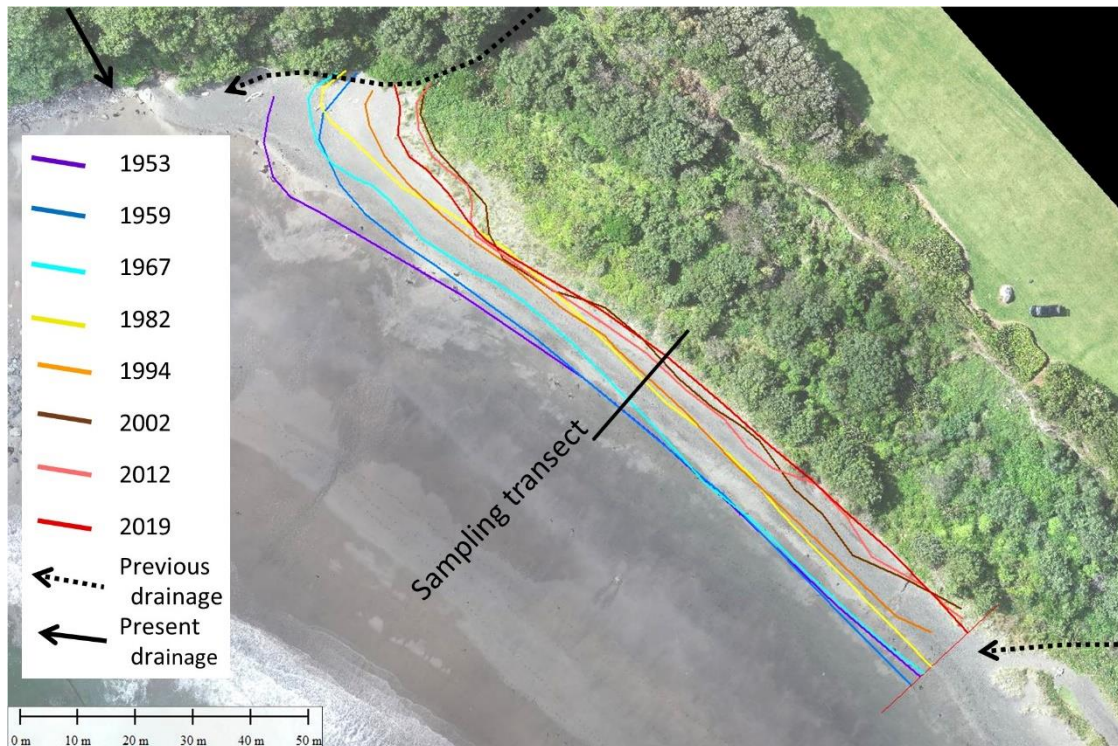
Figure 11 Shorelines in the (natural) Northwestern Sector from 1953 to 2019. Location data from the marked “sampling transect” are graphed in Figure 12A.

Further analysis was then undertaken for the NW Sector using 6 intermediate samples (1959, 1967, 1982, 1994, 2002, 2012) and this expanded set of shorelines is displayed in Figure 11. These shorelines show a steady landward migration which is enhanced at the NW end. However, here the shoreline moves somewhat seaward after 2002 which likely resulted from relocating the stormwater outlet further seaward from 2004.

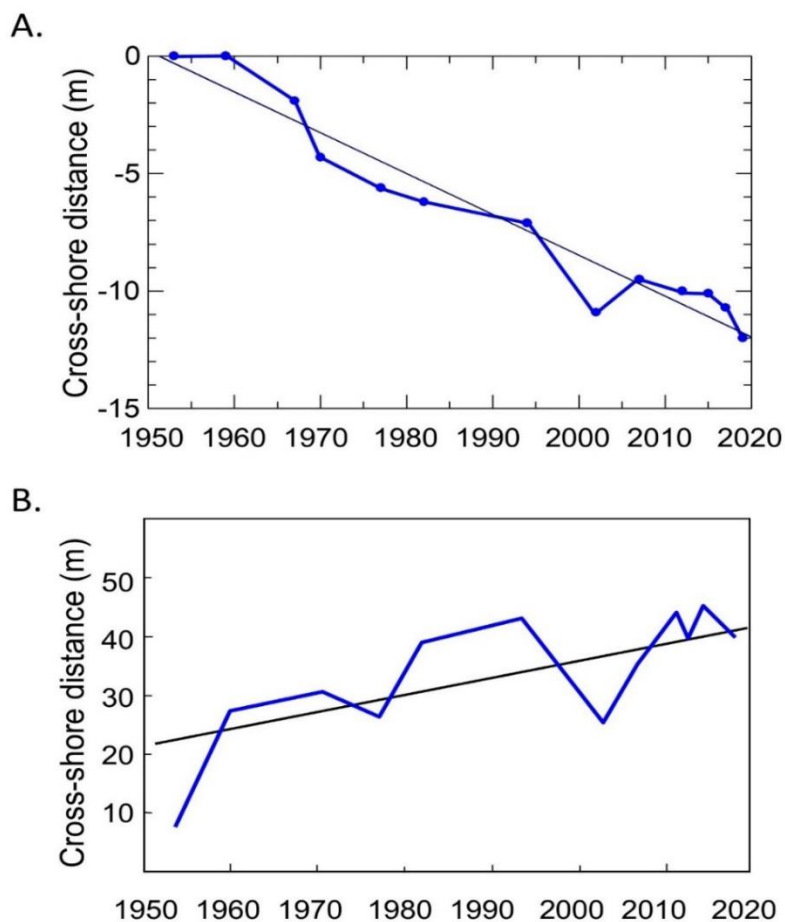
Figure 12 Shoreline time-series graph for Middleton (A) at the Northern Sector transect (Figure 11). For comparison, the Ōpunakē Bay shoreline is shown in (B) for the northwestern half of the beach (adapted from CSL, 2019, Figure 9). Linear regression models have been fitted and define (contrasting) longer-term trends and qualitatively similar shorter-term shoreline fluctuations.

While derivation of all component values is beyond the scope of the present report, the shoreline analysis carried out for the natural NW Sector in Section 3.2.2 provide a 100 year value for LT of 18 m. The ST value is derived by calculating 3 times the “standard error of estimate or SEE (see Glossary)” about the regression line, which comes to 3 m in this case.

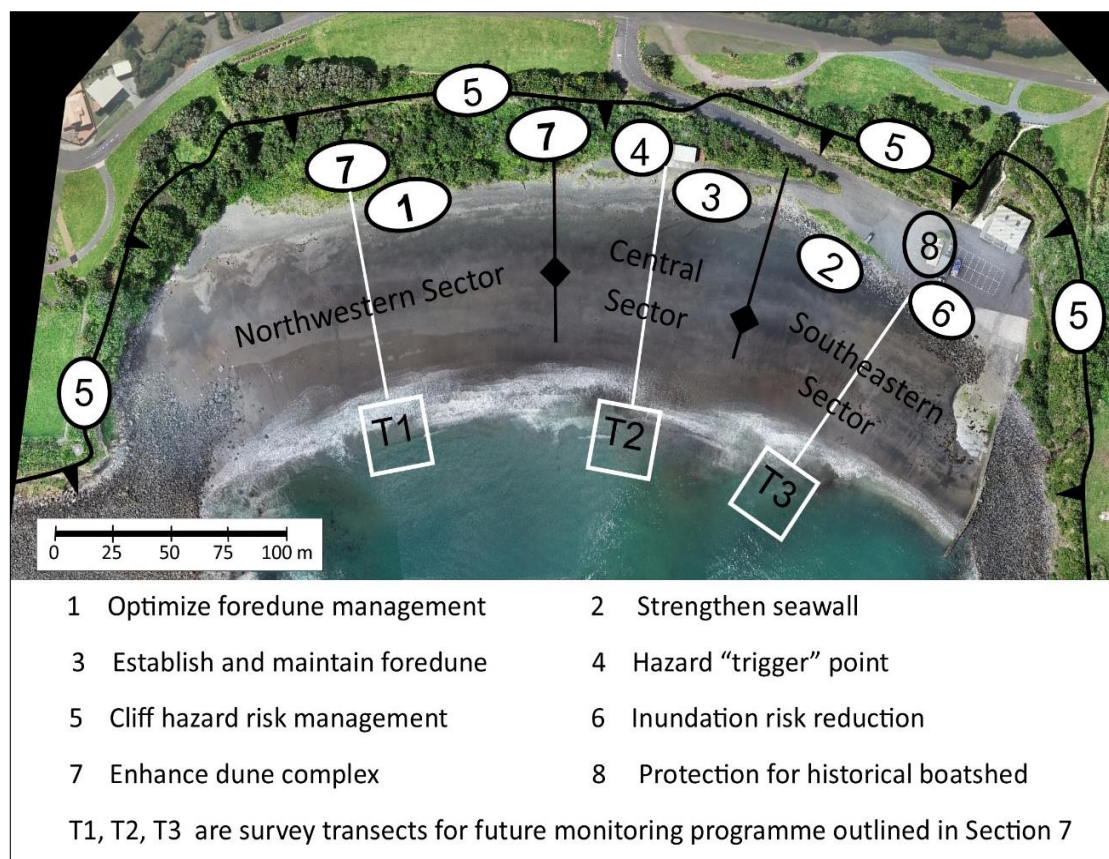
The Central Sector has a net erosional status although the rate is unclear as the shoreline has been artificially added to over time to protect the boat sheds. This, the narrowest sector, is sandwiched between the systematically eroding shoreline to the NW and the hard structure to the SE, the latter of which will become increasingly prominent and wave-reflective in the future. This sector is likely to have the shortest survival time and will require management interventions. There are 3 possible options:

Figure 19 Location of management options and monitoring transects described in the text using corresponding numbering/referencing.

- i. *Continuous hard protection will stabilize shoreline; however, it is unlikely consents would be granted given the negative impacts such structures have on the fronting and adjacent beaches.*

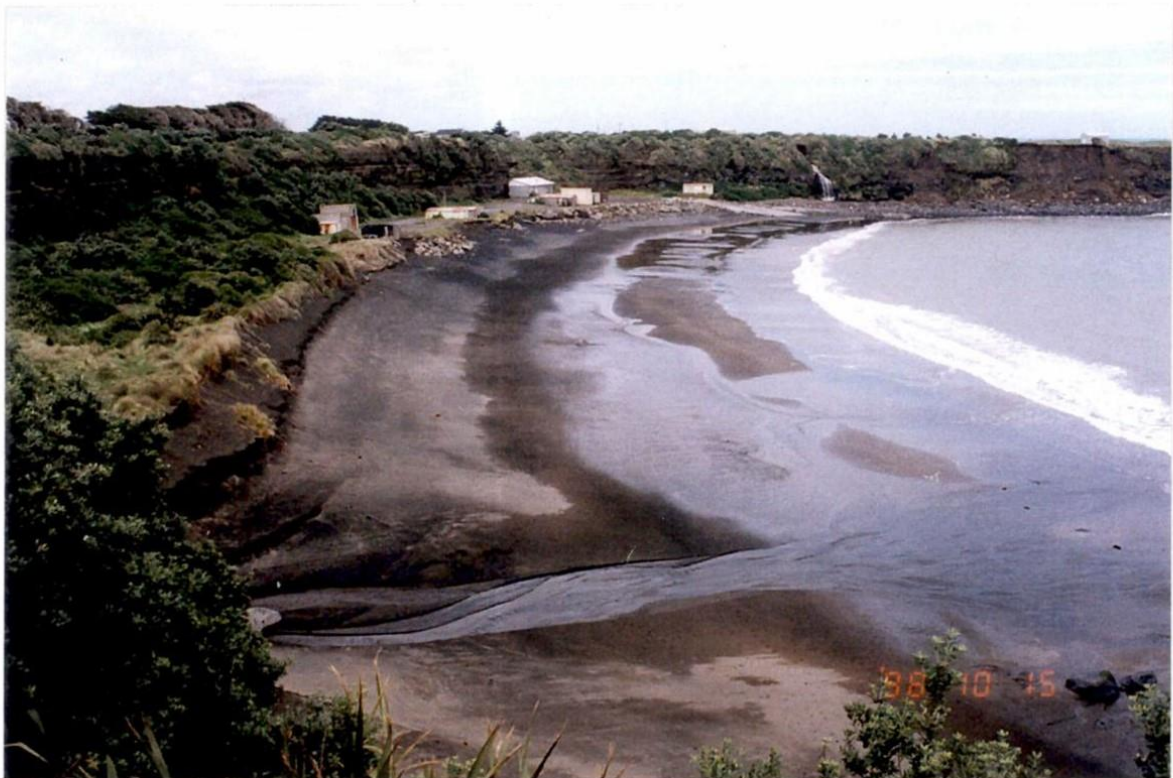
Figure 3: Middleton Bay looking SE at low tide showing volcanic-derived sand beach and well vegetated foredune (Photo: 15 October 1998).

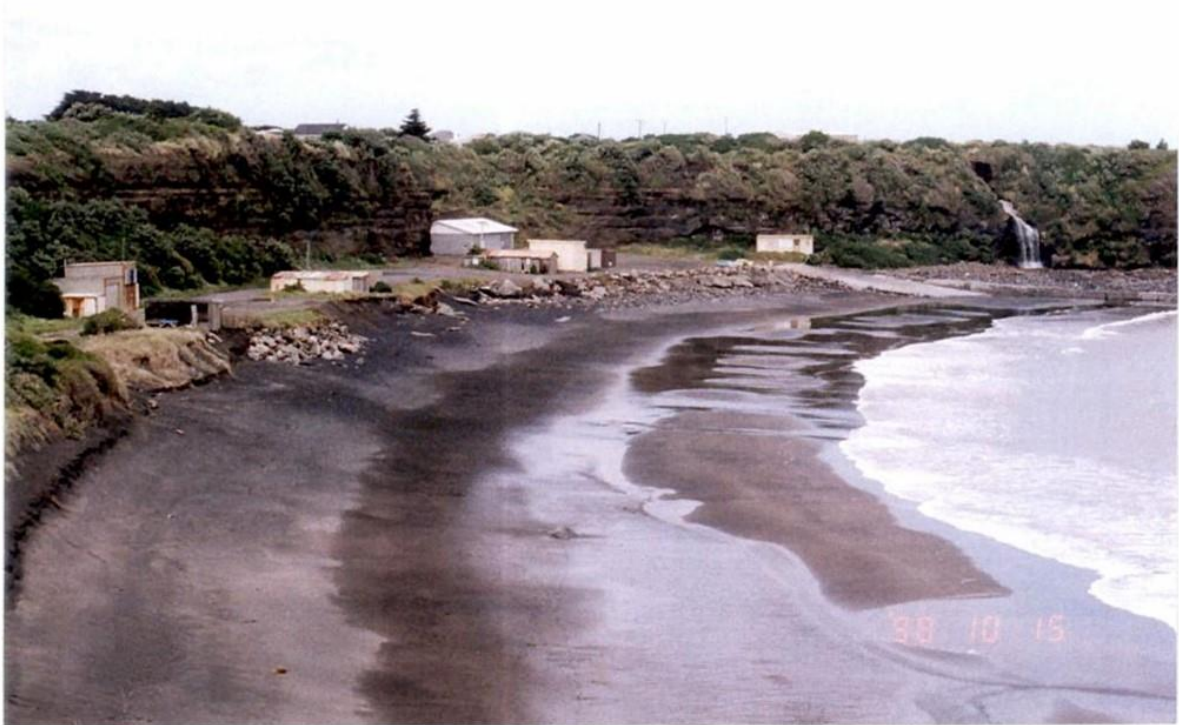
Figure 4: View SE of the developed SE half of Middleton Bay showing old and recent buildings and foreshore structures (Photo: 15 October 1998).
