Coastal Geomorphological Change at Opunake Bay, Middleton Bay and in the Vicinity of the Patea Rivermouth

Based on a report to the South Taranaki District Council

By Dr Roger D Shand

Reference	2022-9 CRep
Reviews	TDS (CSL), SB (STDC)
Version	1.0
Status	Final
Date	23 August, 2022

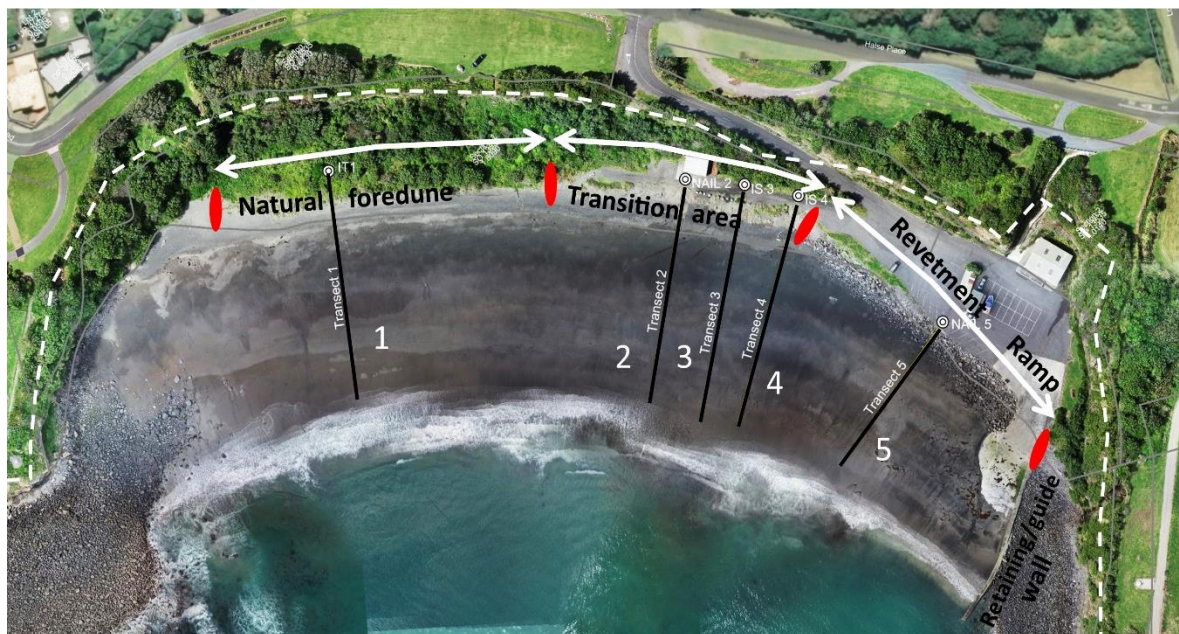
The beach is composed of fine to medium grade sand overlying boulders. The shoreline in the NW sector has eroded at an average rate of 0.21 m/yr since 1953, the central sector has an average erosion rate of 0.14 m /yr and the SE sector has accreted at 0.18 m/yr. This environment is described in detail in the report entitled “Middleton Bay Long-term Management Strategy” (CSL, 2020).

Figure 2.1 TPL profiling transects numbered 1 to 5 from northwest (left side) to southeast (right side). Red ellipses mark boundaries between marked geomorphological units; on left the natural sand dune, on right the seawall and ramp, and the transition zone in between. The cliff top is defined by the dashed white line
Base photo TPL, November 2019

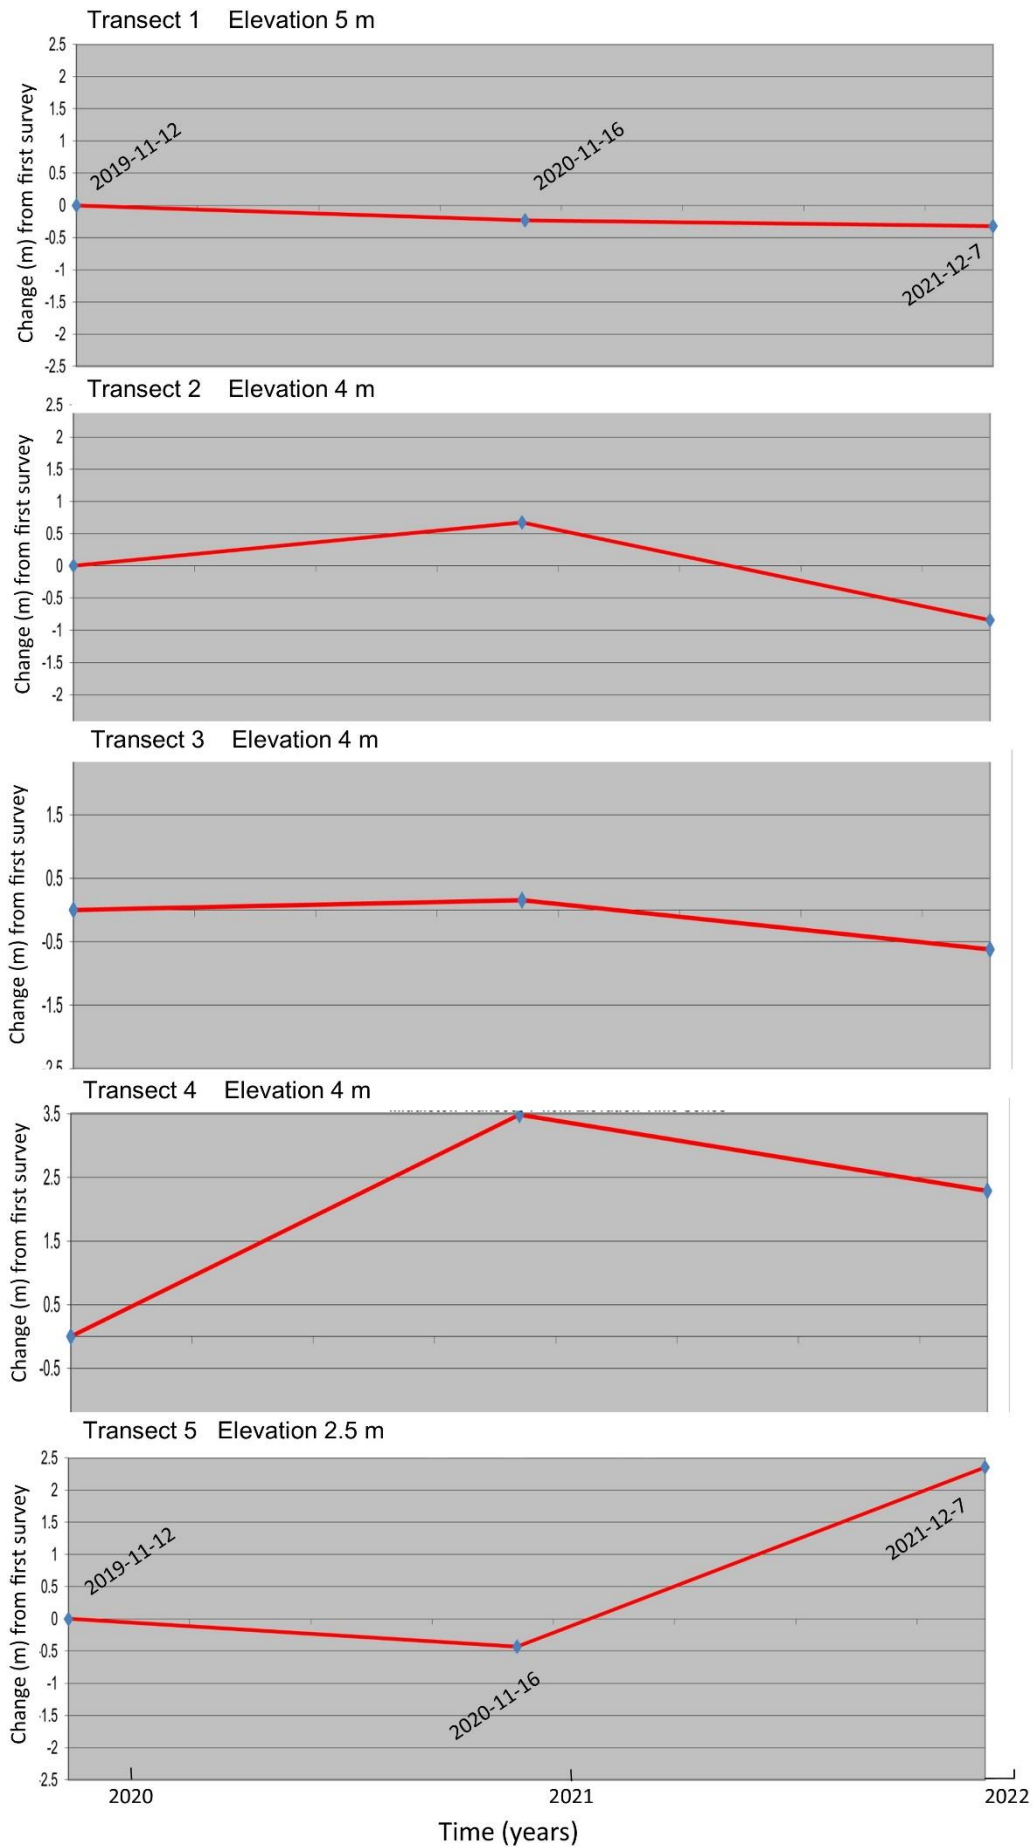
Figure 2.3 Time-series for Middleton Bay Transects 1 to 5 at stipulated elevations for 2019, 2020 and 2021 surveys.

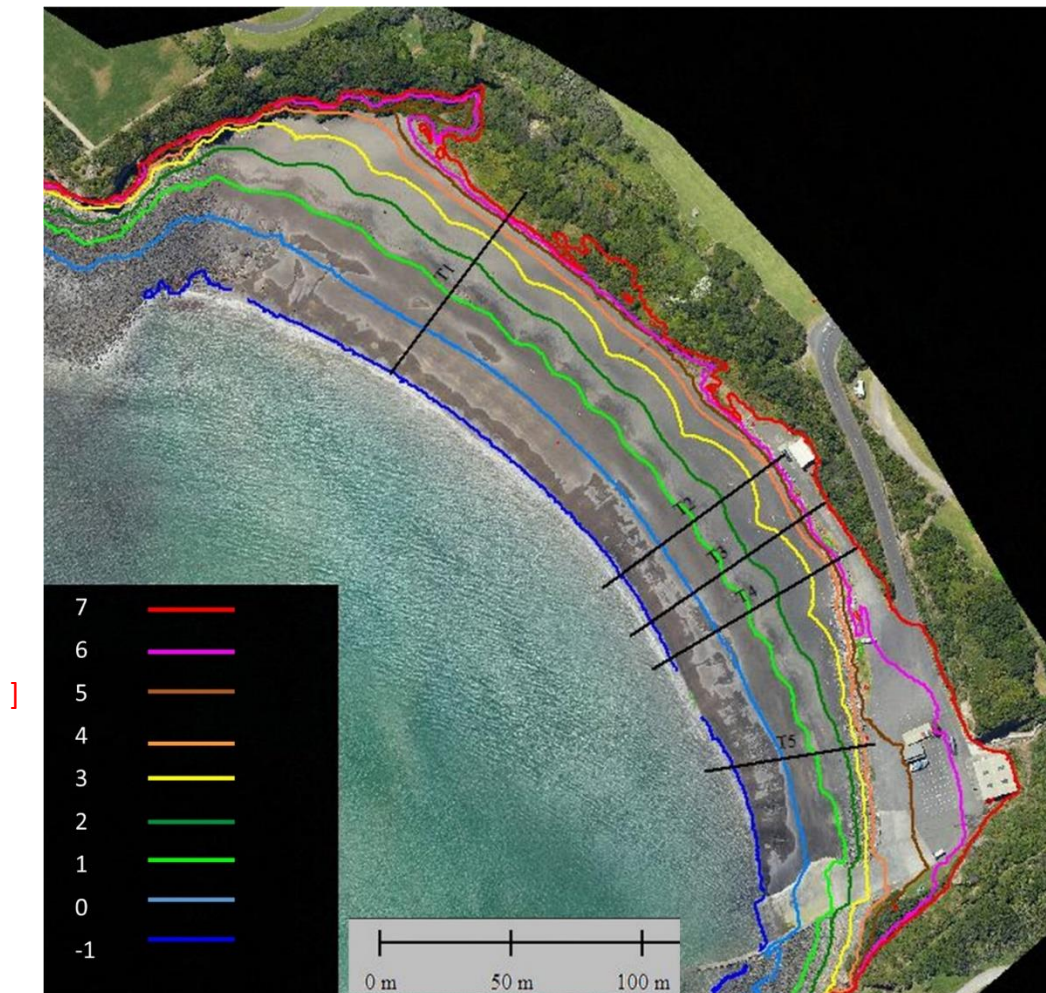
Figure 2.4 The Landpro aerial orthographic vertical photo with 1 m contours across the beach, foredune and revetment/carpark.

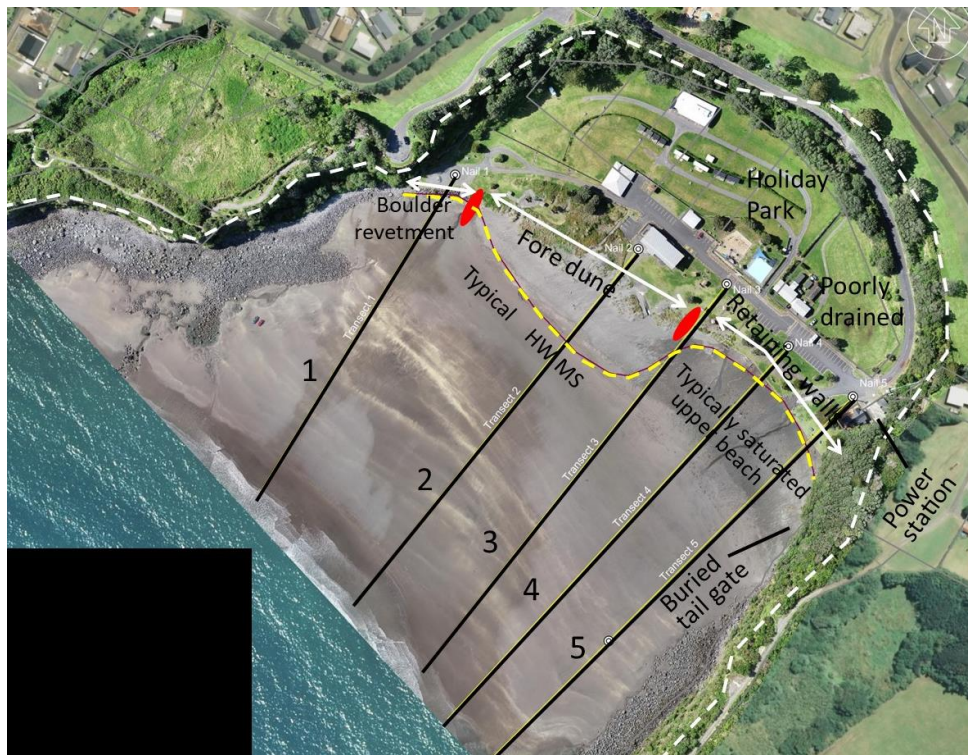
The retaining walls separate easily saturated Holiday Park grounds from a typically damp upper foreshore. The nonlinear plan form of the upper beach, illustrated by the typical spring HWM (dashed yellow line in Figure 3.1) appears to result from drainage outlets at both ends of the beach which facilitate localized beach-surface erosion

Figure 3.1 Red ellipses mark boundaries between marked geomorphological units; on left boulder revetment, on right the retaining walls with poor drainage to both landward and seaward. In the centre a foredune protrudes seaward. The cliff top is defined by the dashed white line and the typical HWMs by the dashed yellow line. Also marked are the 5 TPL profiling transects. Base photo was taken by TPL in November 2019.

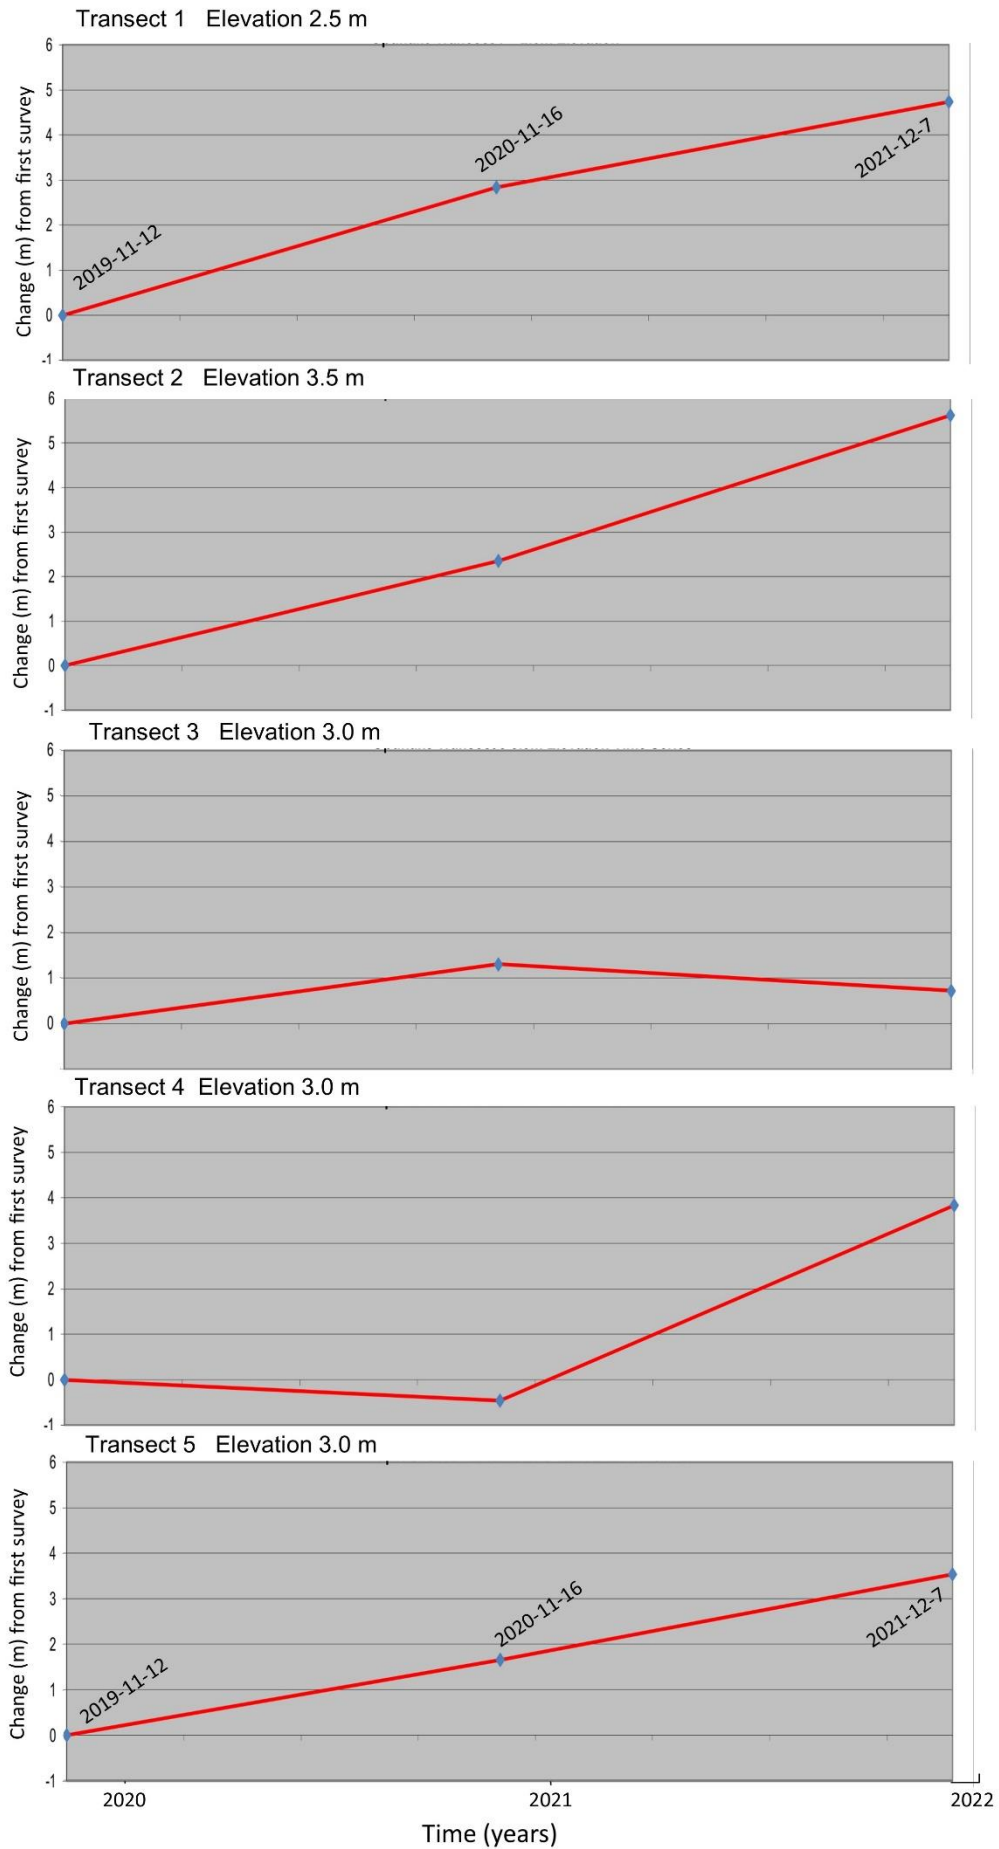
As described earlier in Section 1.3, to interpret profile change, time-series graphs of cross-shore distance from the first survey for a key (representative) elevation were constructed. For Transect 1 fronting the boulder revetment, the chosen elevation is 2.5 m above MSL, which is located on the beach fronting the structure. For Transect 2, the representative elevation is the dune toe which is 3.5 m above MSL. For T3, T4 and T5 the elevation is 3.0 m which is on the beach immediately seaward of the retaining wall. The resulting time-series are plotted in Figure 3.3 and show the December 2021 northwest and centre shorelines (T1 and T2) continuing to advance seaward (beach accretion) at 2 to 4 m per year. Such change indicates a steady sediment input from seaward along the north western side of the Bay – the dominant sediment transport route.

Figure 3.3 Time-series for Ōpunakē Bay Transects 1 to 5 at stipulated elevations for 2019, 2020 and 2021.

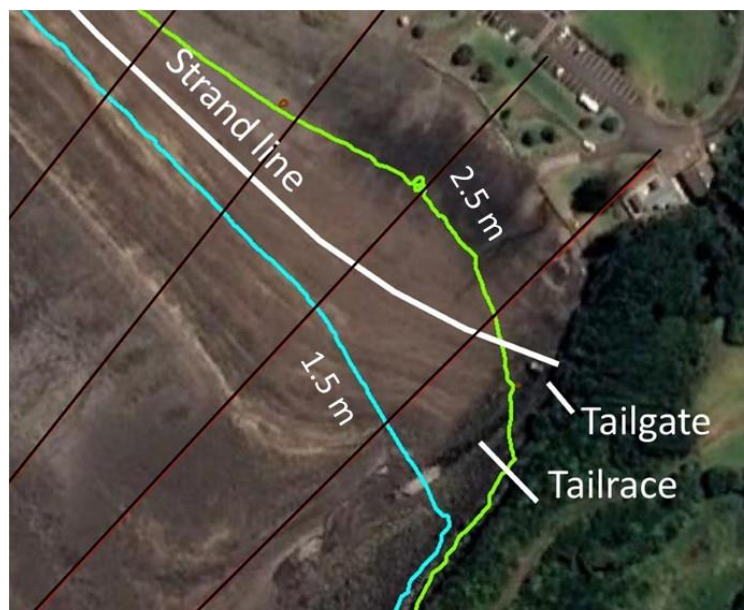
The contour lines show the selected transects adequately represent beach topography. The 5m contour defines the central sand dunes and the 3 m contour illustrates drainage outlets onto the beach. Of particular note is the seaward curvature in contour shape on the right (south eastern) side of the 2022 image. This contrasts with the 2016 aerial in Figure 3.5 where the strandlines¹ curve landward. This illustrates the southeastern sand buildup detected in TPL's T5 profile survey. The tailgate and tail race are evident and marked in the 2016 and the outflow appears to have previously been able to flush sand reaching this area. Ongoing sand accumulation will have environmental consequences including worsening drainage affecting the Holiday Park area.

Figure 3.5 2016 Google Earth image with a strandline marked and 2022 contours superimposed for shape comparison. The power station tail gate and tail race are also evident.

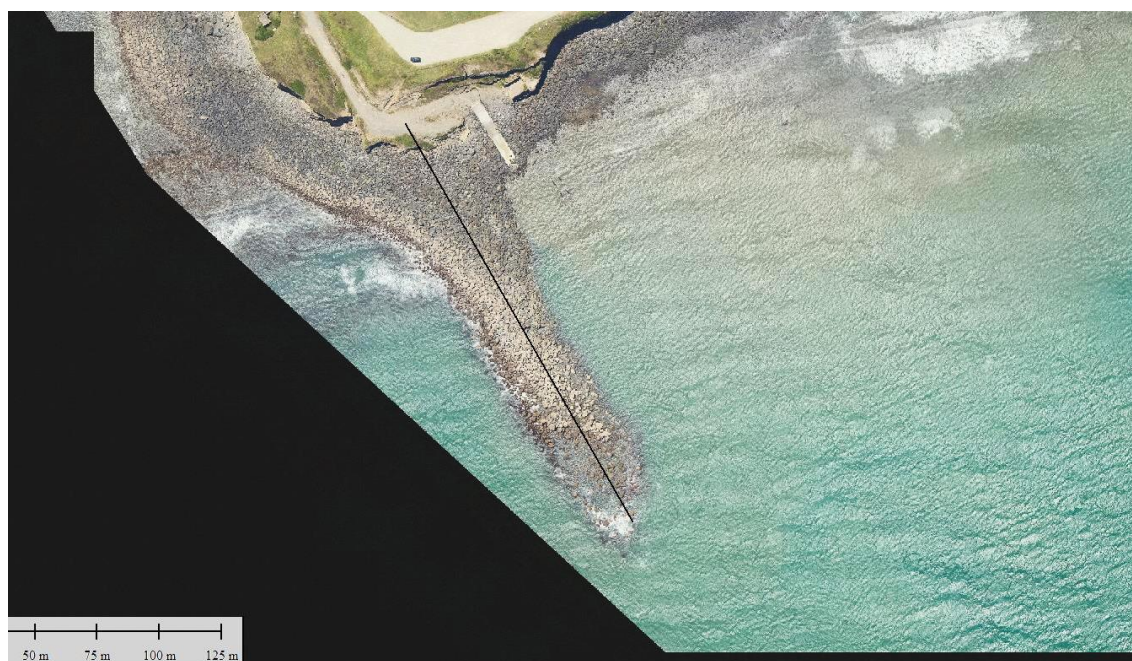
Some maintenance to the breakwater and boat ramp appear to have been carried out in the early 2000s in preparation for constructing an artificial surf reef. TPL and Landpro aerial surveys in 2019 and 2022 respectively, found the breakwater's present crest elevation reduces from about 1.5 m above MSL at the landward end to about 1.0 m below MSL at the seaward end (Figure 3.7).

Figure 3.6 The 2022 Landpro ortho photo of the Ōpunakē breakwater with the axis used for profile data capture (Figure 3.7) marked.

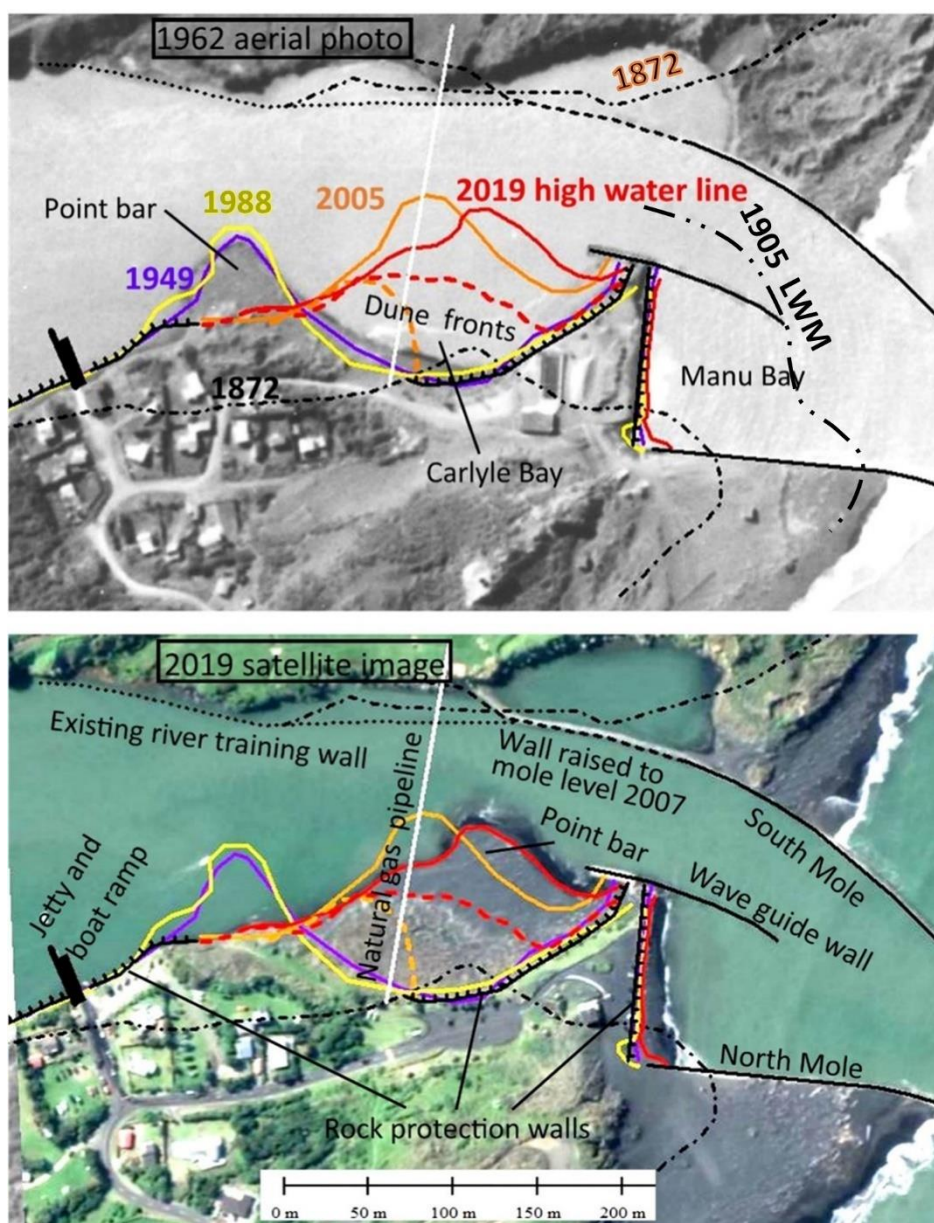
The geomorphology and development history of the Patea Rivermouth area are described in some detail in CSL reports 2006, 2015 and 2021a and summarized in Figure 4.1. The moles were constructed in the late 19th /early 20th century with the North Mole extending some 325 m from the northern cliff and the South Mole reaching 450 m from the then southern riverbank. The South mole diverted the river mouth from its former southerly orientation into the sea (see the 1872 shoreline) to the present shore-normal alignment.

Figure 4.1 Patea Rivermouth historical shorelines marked on a 1962 aerial photograph (upper image) based on vegetation and textural change, and structures and shoreline response marked on a 2020 satellite (lower). Source: CSL (2021a)

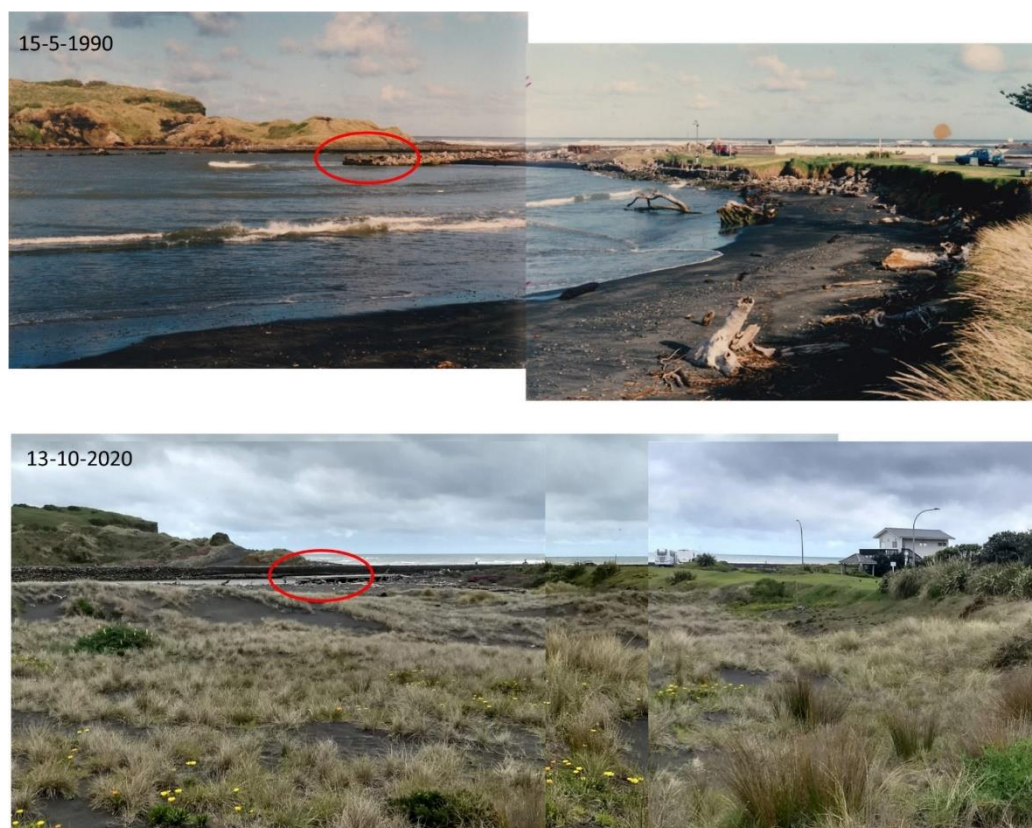
Figure 4.2 Carlyle Bay in 1990 (upper photo) with water, waves, a sandy beach and backed by an erosion scarp which was subsequently infilled with boulders. By 2020 (lower photo) the bay had filled with maturing sand dunes and vegetation. Red ellipses mark the upstream end of the wave guide wall. Photos CSL

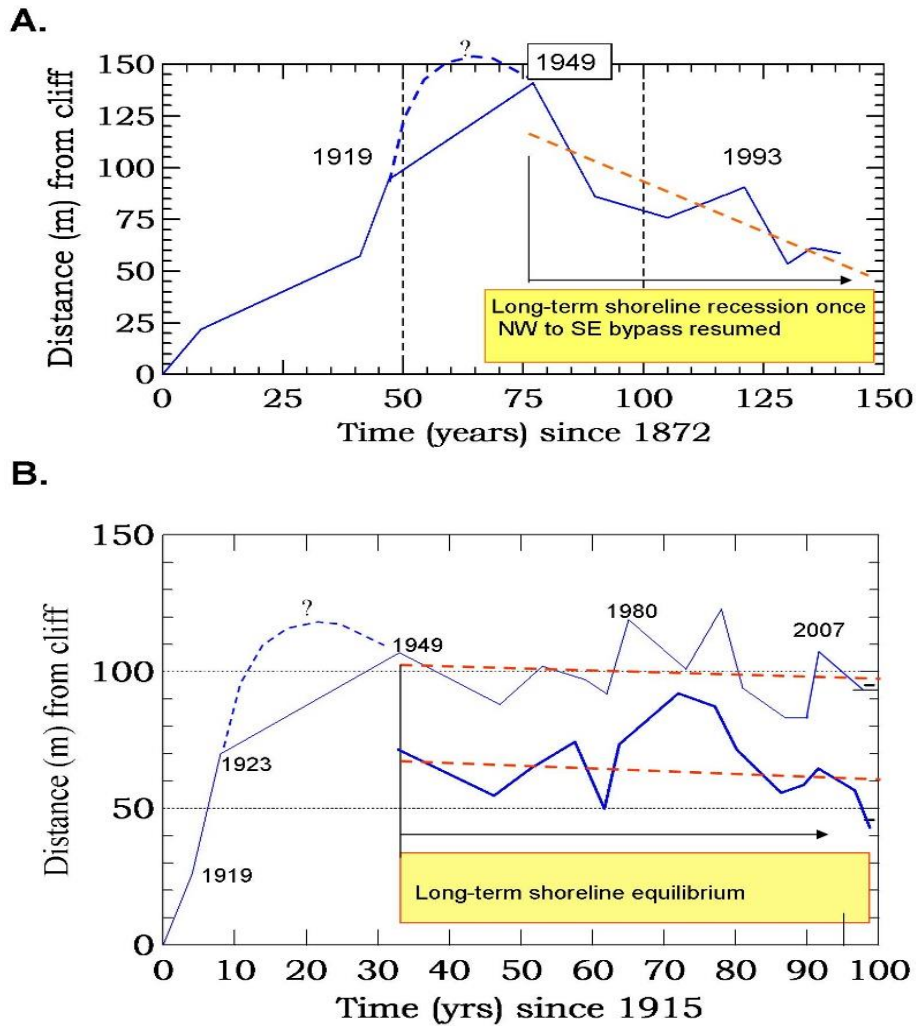
The historical structures have dramatically modified the open coast shorelines as illustrated in Figure 4.3. Both shorelines moved at least 100 m seaward closer to the moles, with the southern shoreline then undergoing systematic erosion while the northern shoreline remained relatively stable, although since 2010/11 a significant episode of erosion has occurred and the shoreline effects are defined by the ground and aerial monitoring data in the following sections (4.2 and 4.3).

Figure 4.3 Shoreline responses to the rivermouth moles. The upper graph depicts the South Beach transect 100 m SE of the South Mole (approximating Transect 30 in Figure 4.4). The lower graph shows North Beach transects 250 m northwest of the North Mole (thin line) which is mid Transect 2 and 3, and 700 m to the northwest (bold line) which is mid Transect 8 and 9. From CSL (2015)

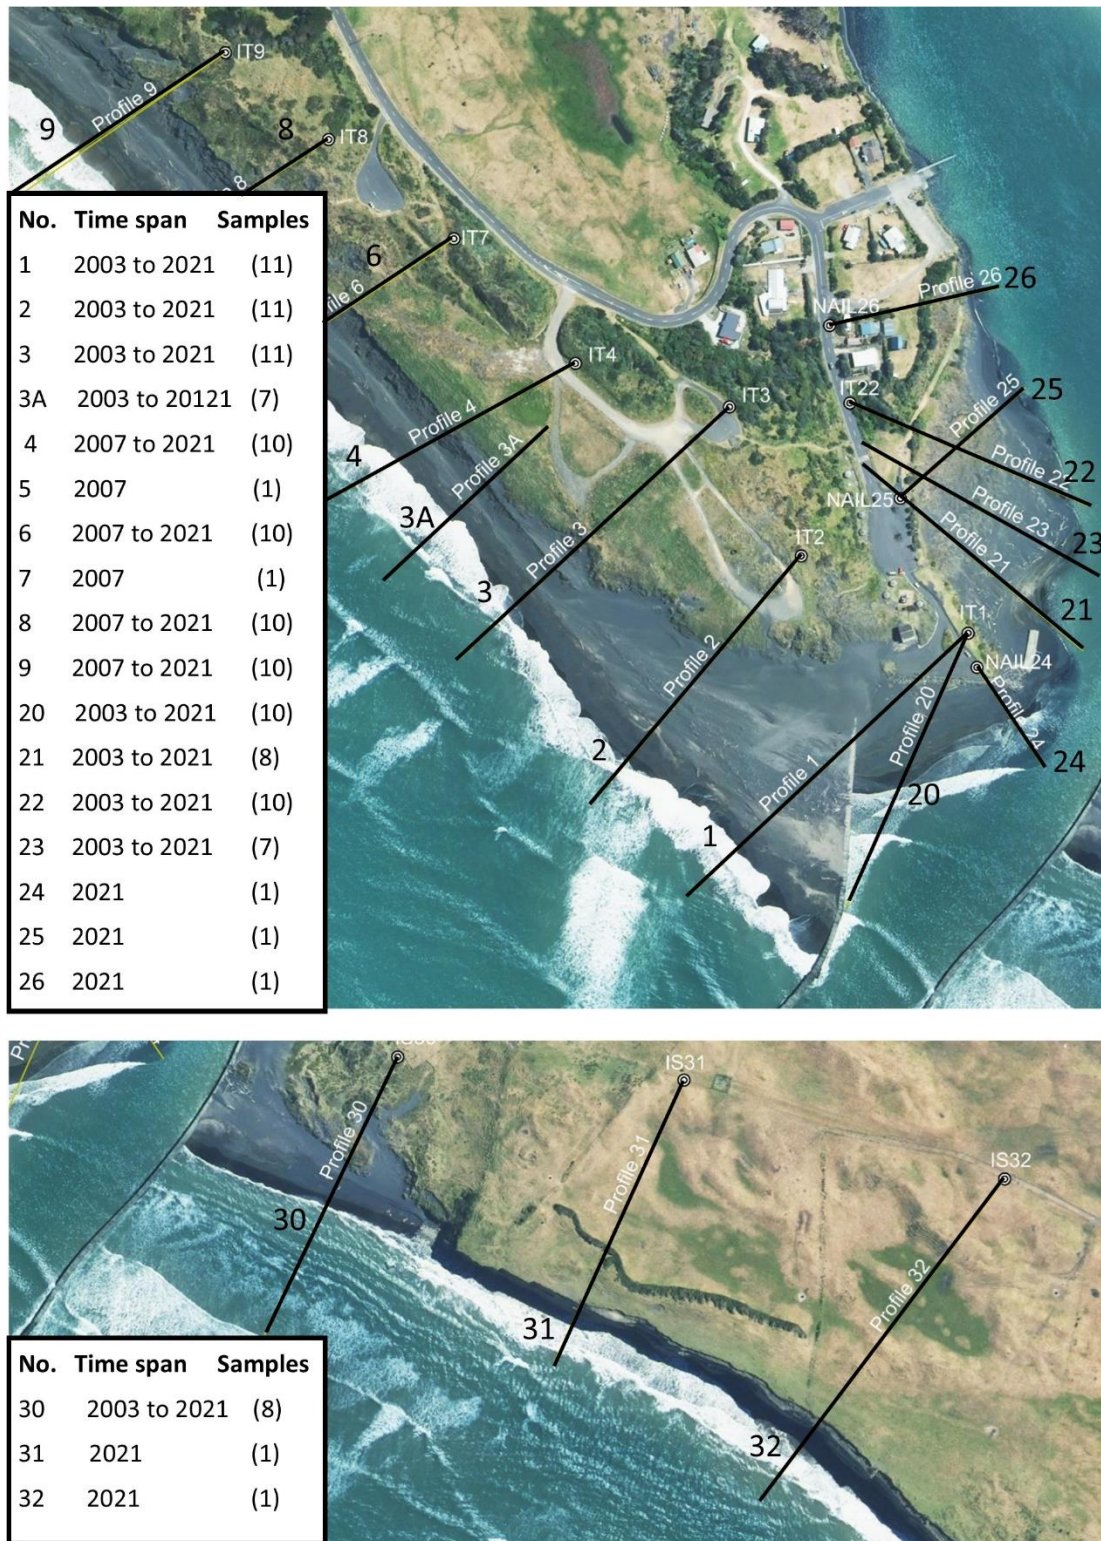
Figure 4.4 Transect locations for TPL profile surveys. Sampling histories also provided

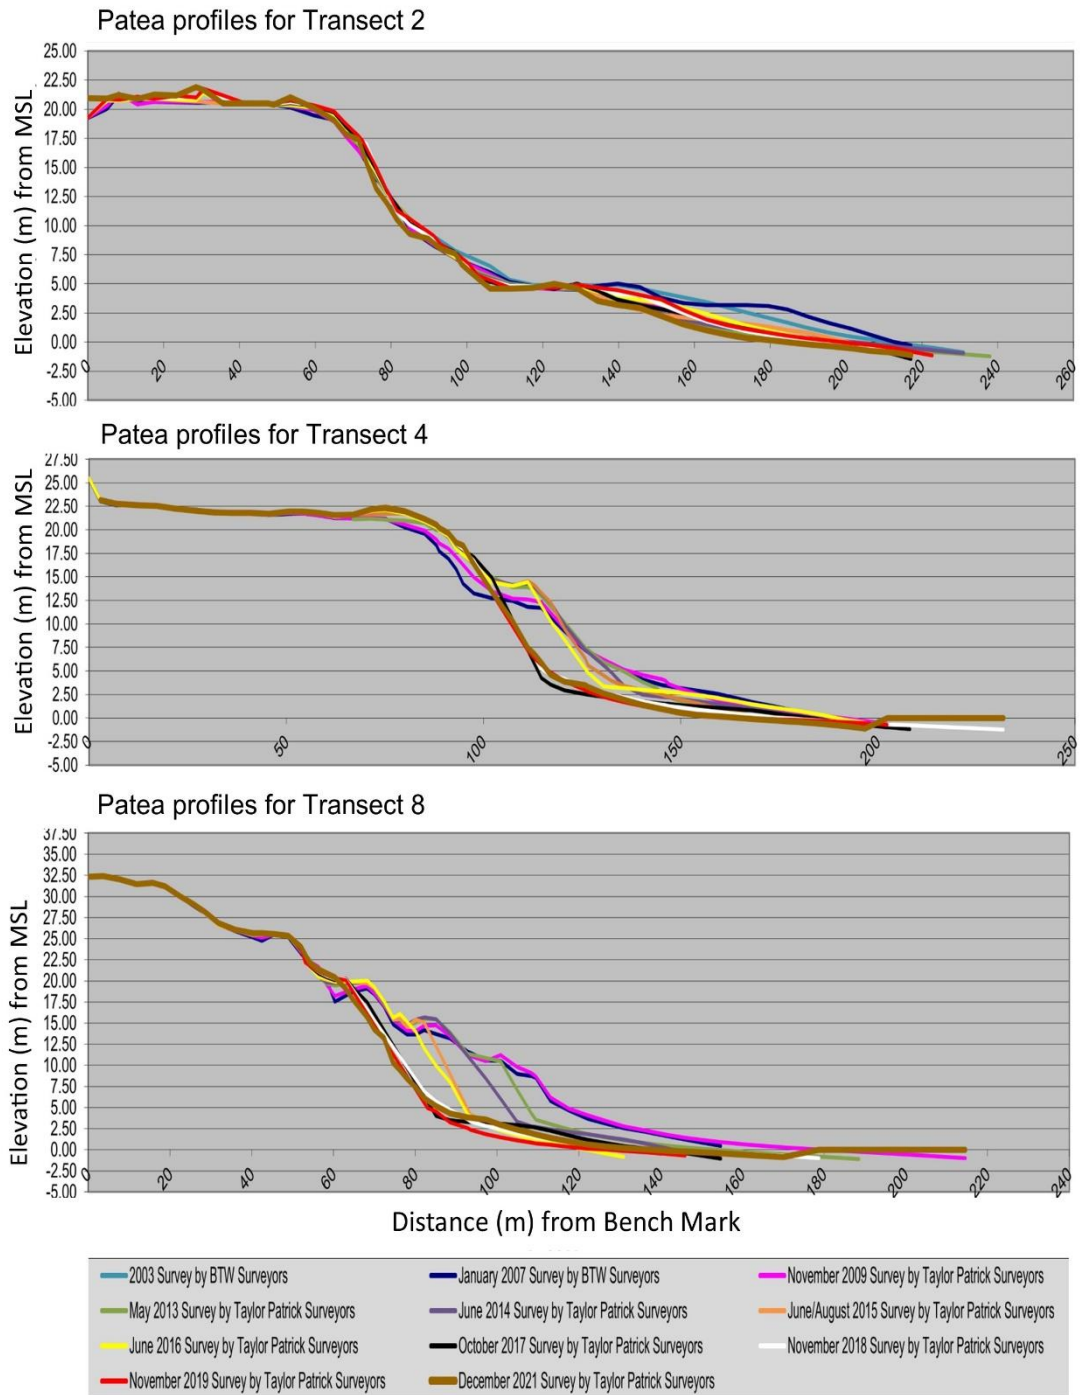
Time-series line graphs for the dune toe (MSL +4 m) and mid dune face (MSL +10 m) clearly define the erosion episode at T4 and T8, but it is not apparent closer to the mouth. However, it could be that the shoreline impact here was masked by the arrival substantial quantities of eroded sediment from further updrift (T4 and T8), a possibility supported by the more recent deposition which is evident in the T2 time-series graph.

Figure 4.5 Superimposed profiles for transects 2, 4 and 8 along the northern coast.

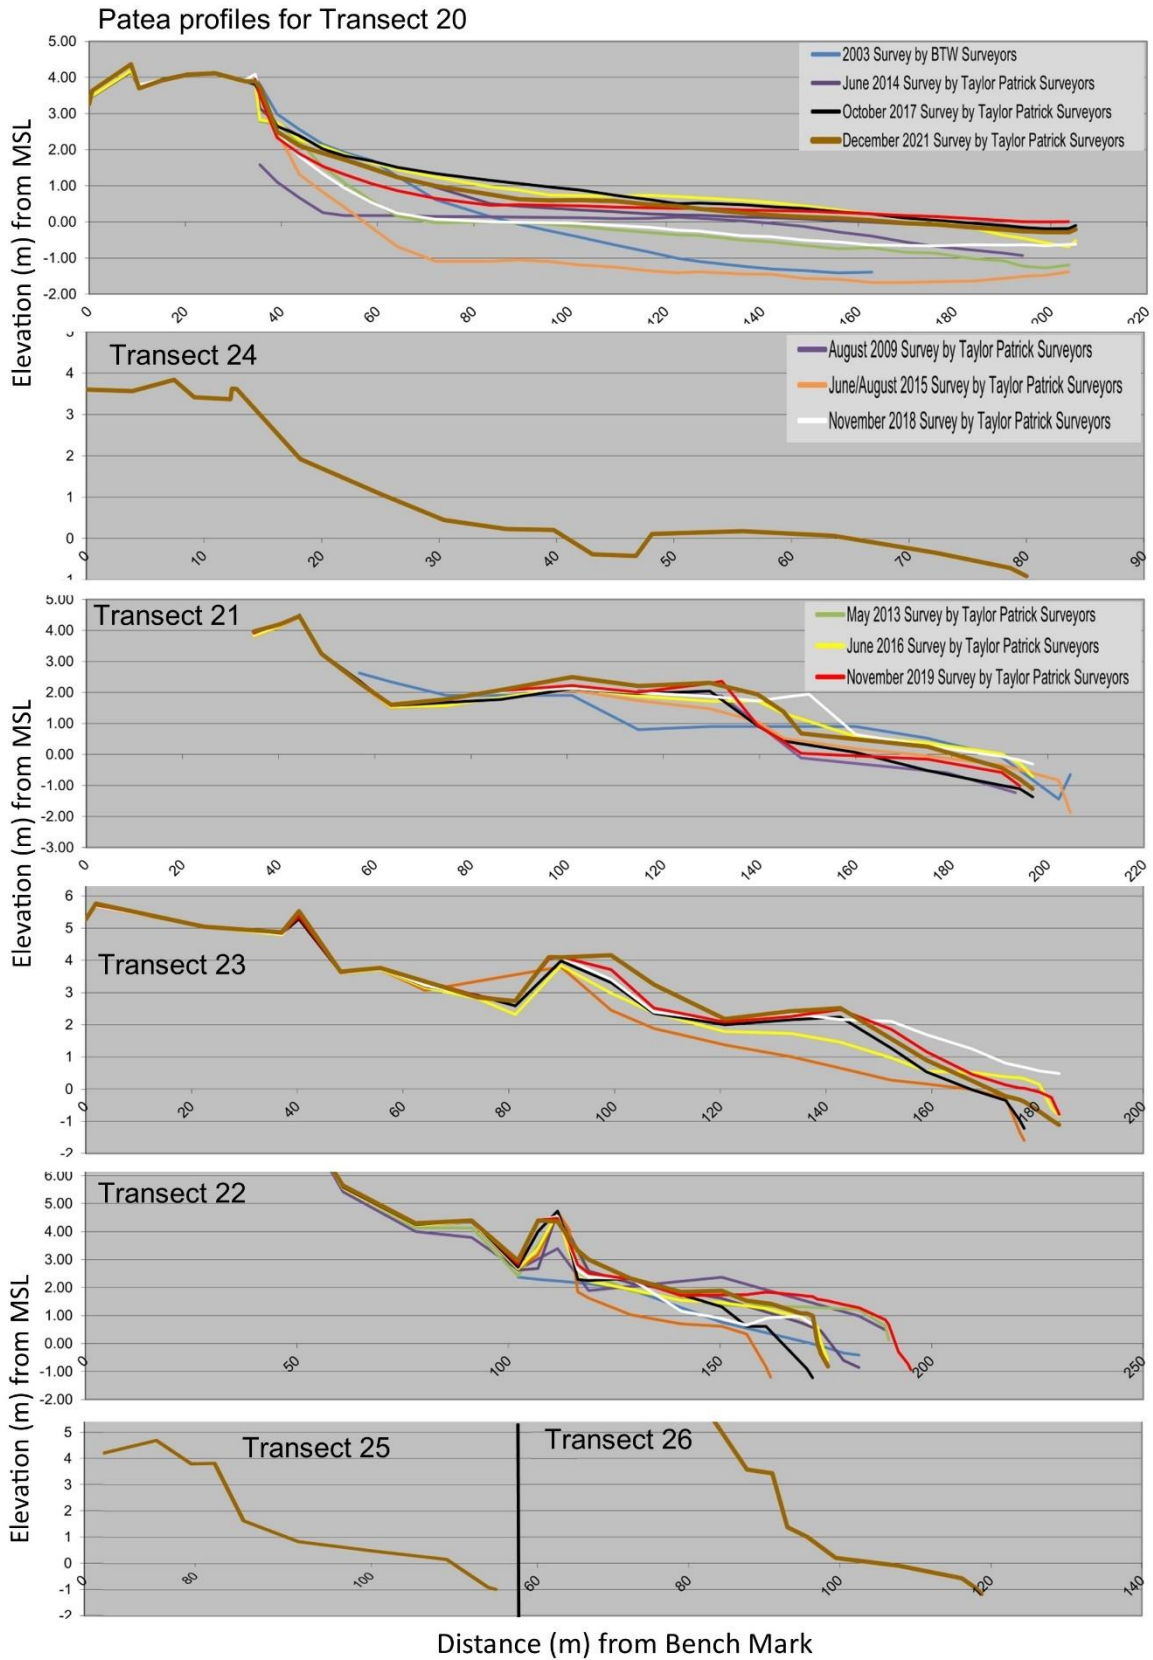
Previously established transects within the estuary (T20 and 22) were to track potential consequences of the shoreline/dune erosion episode on the north coast, this being for the Patea Sand Management Programme. Transect 21 and 23 were subsequently added as the Carlyle Bay transect (T22) was under threat of river erosion – however, it has survived. The three additional transects (24, 25 and 26) are to provide additional coverage required by the new measurement-based monitoring regime for coastal structures. All profiles are displayed/superimposed in Figure 4.7. Of particular note is the erosive effect of a severe flood in 2015 which lowered the bed some 1.5 m at T20 in Manu Bay and 2 m upstream at T22.

Figure 4.7 Superimposed profiles for inlet Transects 20 at top of figure to 26 at base). Note (irregular) transect numbering follows order of establishment.

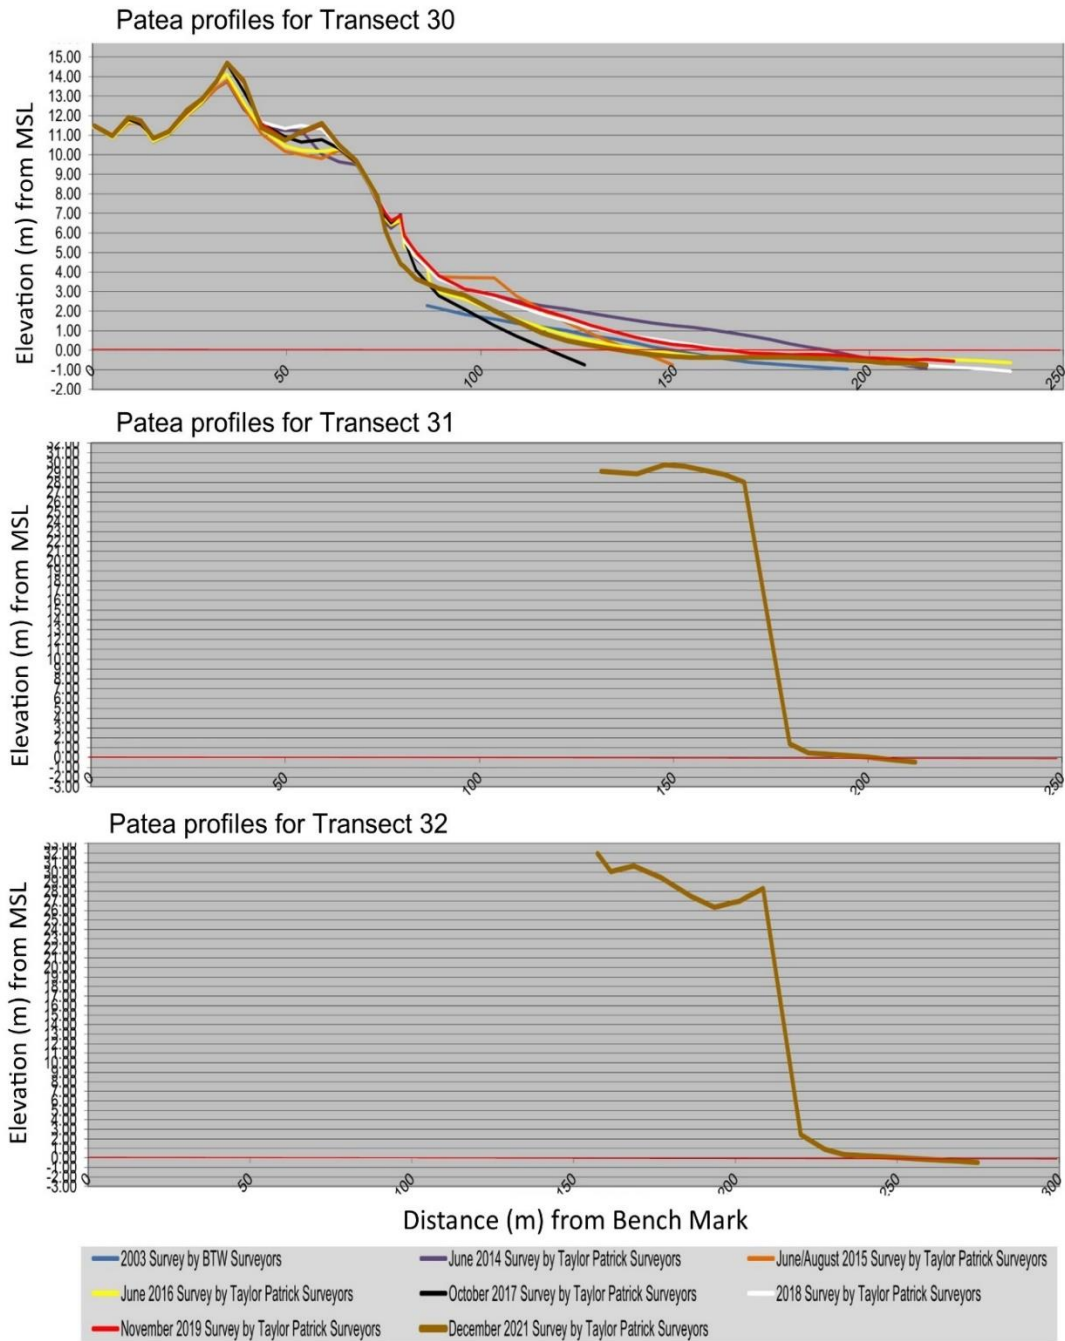
Figure 4.9 South coast superimposed profiles for Transect 30 (top) and the 2021 profiles for new Transects 31 and 32 below.

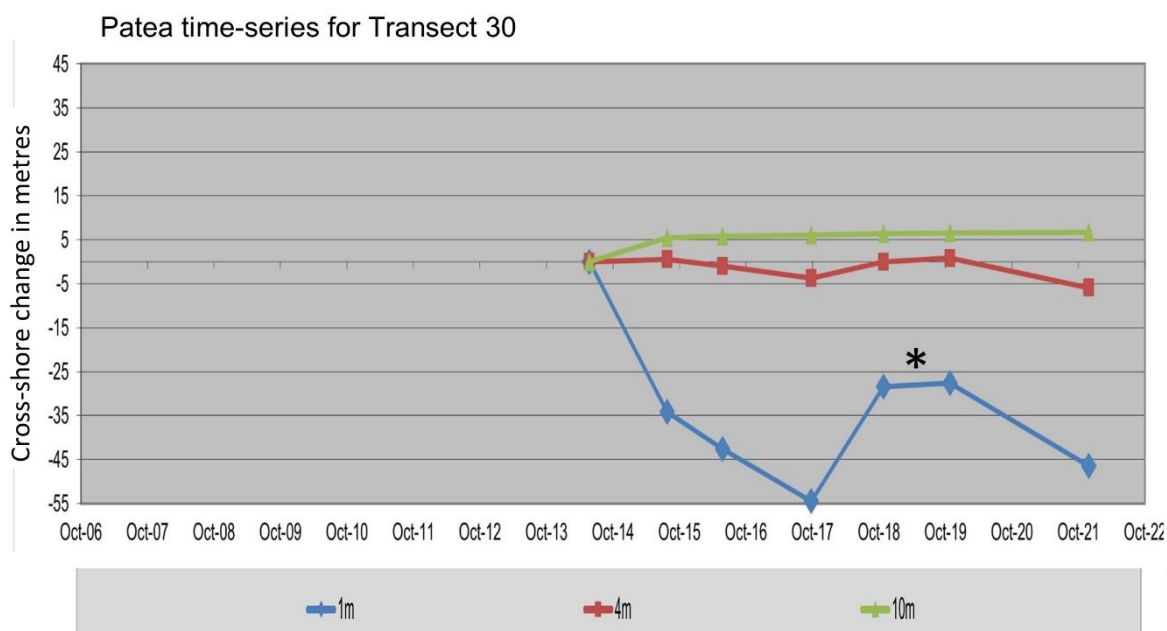
The upper tidal data (MSL +1m) in the T30 time-series graph continues to show a deficit of sediment relative to the 2015 start point with some possible recovery marked with the asterisk in Figure 4.10). The T30 time-series sediment wave in 2018/19 is very similar in form to the inlet time-series wave for T20 albeit lagging by about 2 years. This suggests (some) north to south travelling littoral sediment is diverted into the inlet before (some) being flushed seaward under higher river flow and ebb tidal flow – a process referred to as “inlet bypassing”. Littoral sediment is also likely to cross the rivermouth directly – a process referred to as “bar bypassing”. South Beach shoreline behaviour, and the ongoing deficit is discussed further in conjunction with the bathymetric monitoring output (Section 4.4).

The dune toe (MSL +4 m) change correlates with the upper beach (MSL+1m curve), albeit being considerably subdued as the 4 m level is affected by the less energetic aeolian processes c.f. wave processes. These MSL+4m data depict an erosive trend of 0.61 m/yr (using a linear regression model). The upper dune (MSL +10 m) is essentially stable reflecting a lack of available sand for dune development.

Figure 4.10 Time-series for Transect 30 on the southern coast. Positive values=accretion, Negative values=erosion. MSL+1m represents the upper tidal beach, 4 m the dune toe and 10 m the upper dune. The asterisk marks sediment wave discussed in test.

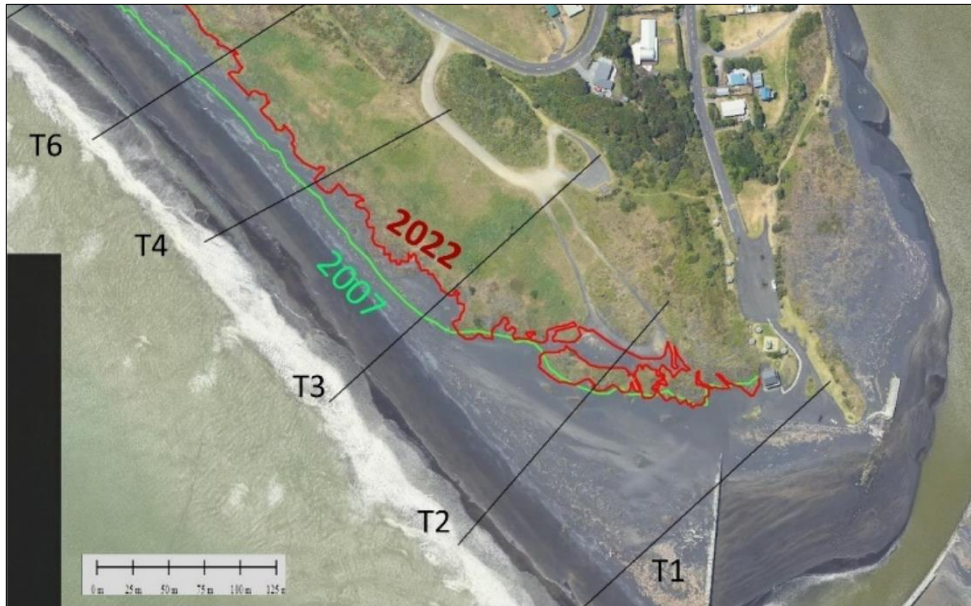
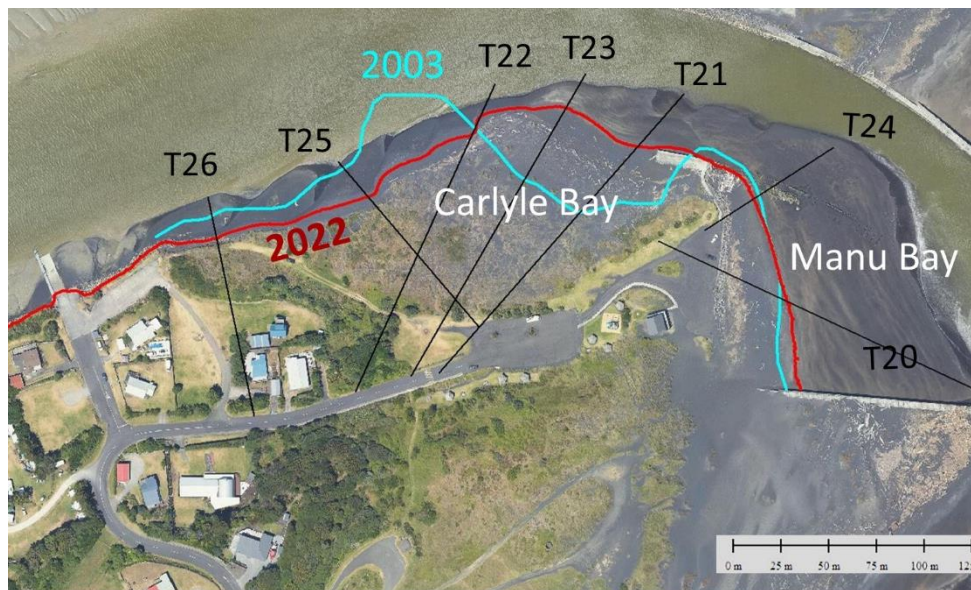
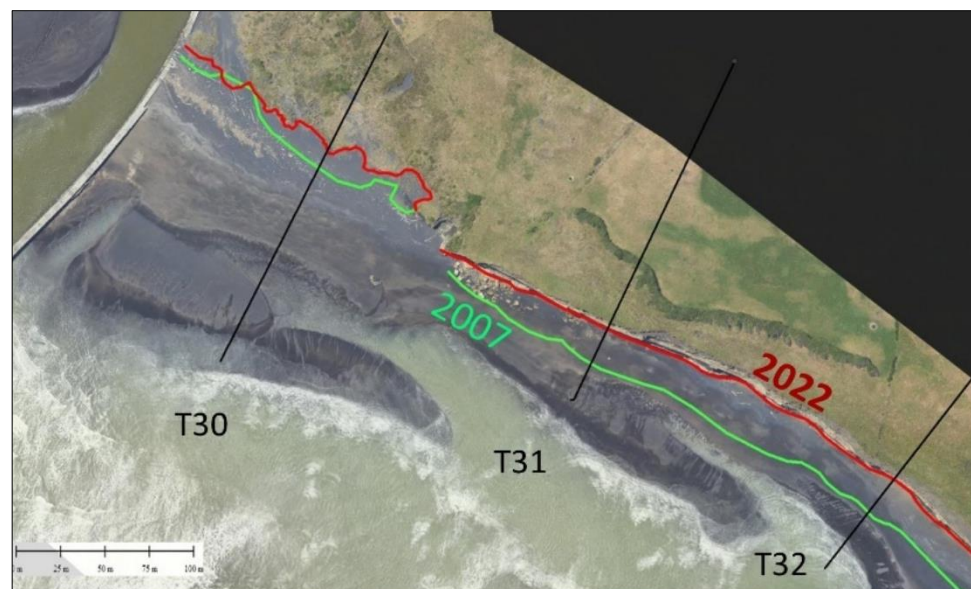
The uppermost photo in Figure 4.11 shows how cross-shore erosion (based on the vegetation-front) along the northern coast stops closer to the rivermouth where the foredune is set back from the beach and hence unaffected by storm waves. The 2022 vegetation line also shows substantial alongshore variation; in the centre/northwest this is associated with slope adjustment processes affecting the erosion scarp. Closer to the river the variation results from wind processes – funnelling through low areas of the dune crest to create a gut (blowout) with sand then burying vegetation as it drifts inland. These processes are described in the CSL annual Patea Beach sand management reports along with associated sand stabilisation works.

Figure 4.11 Sections of the Landpro 2022 aerial orthographic vertical photography with north beach at top, inlet in centre and south beach at the bottom. Open coast shorelines are marked based on the sand dune vegetation-front and cliff base. Within the inlet the 1 m (LIDAR-based) contour is marked. In addition, the vegetation-front and cliff base from the 2003 ortho photo and the 2007 BTW survey are shown. Patea profile transects are also marked for reference.

Within the inlet (central photo) the 2003 MSL+1m contour shows a well-defined indentation marking Carlyle Bay and the protruding point bar upstream. By comparison, the current 1 m contour shows the shoreline south of the boat ramp structures to have receded, the point bar to have shifted some 60 m downstream, and the Carlyle Bay indentation has all but disappeared. These contour data more accurately define the changes noted earlier in Figure 4.1. The transect locations for T20 to T26 can be seen to adequately capture the shoreline behaviour within the inlet.
