Coastal Geomorphological Change at Opunake Bay, Middleton Bay and in the Vicinity of the Patea Rivermouth

Based on a report to the South Taranaki District Council

By Dr Roger D Shand

Reference	2022-9 CRep
Reviews	TDS (CSL), SB (STDC)
Version	1.0
Status	Final
Date	23 August, 2022

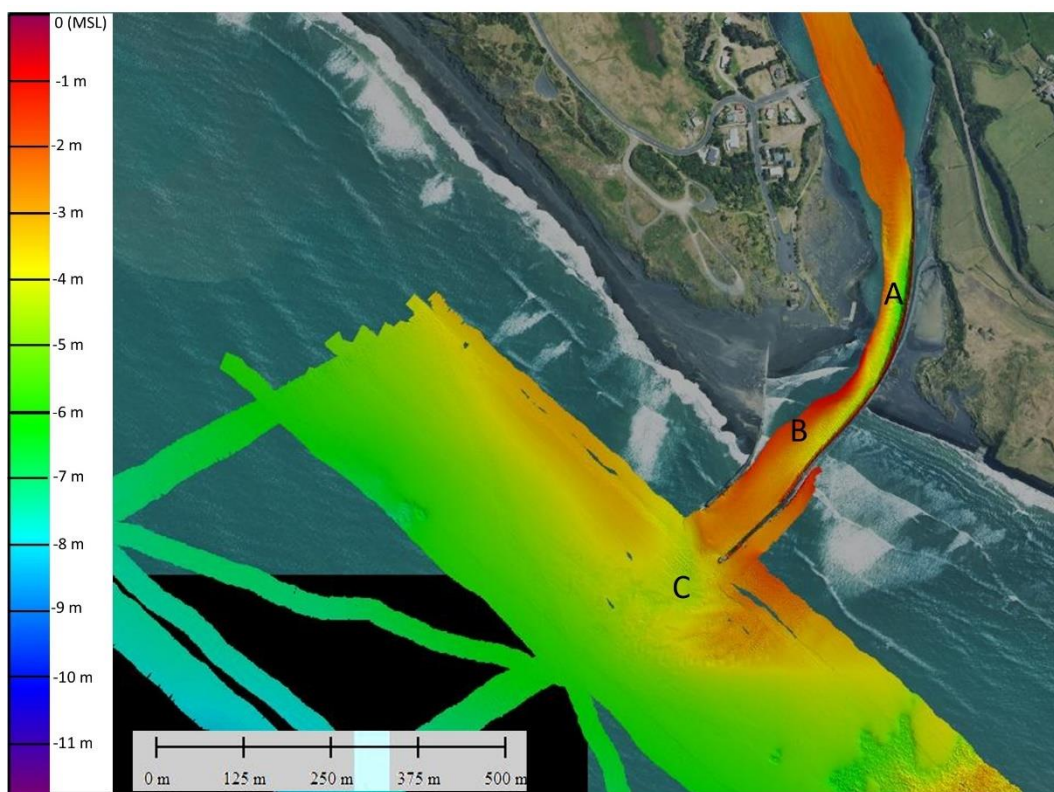
Figure 4.12 Fugro's January 2022 multibeam sonar survey extent and output. A B and C locate features described in the text.

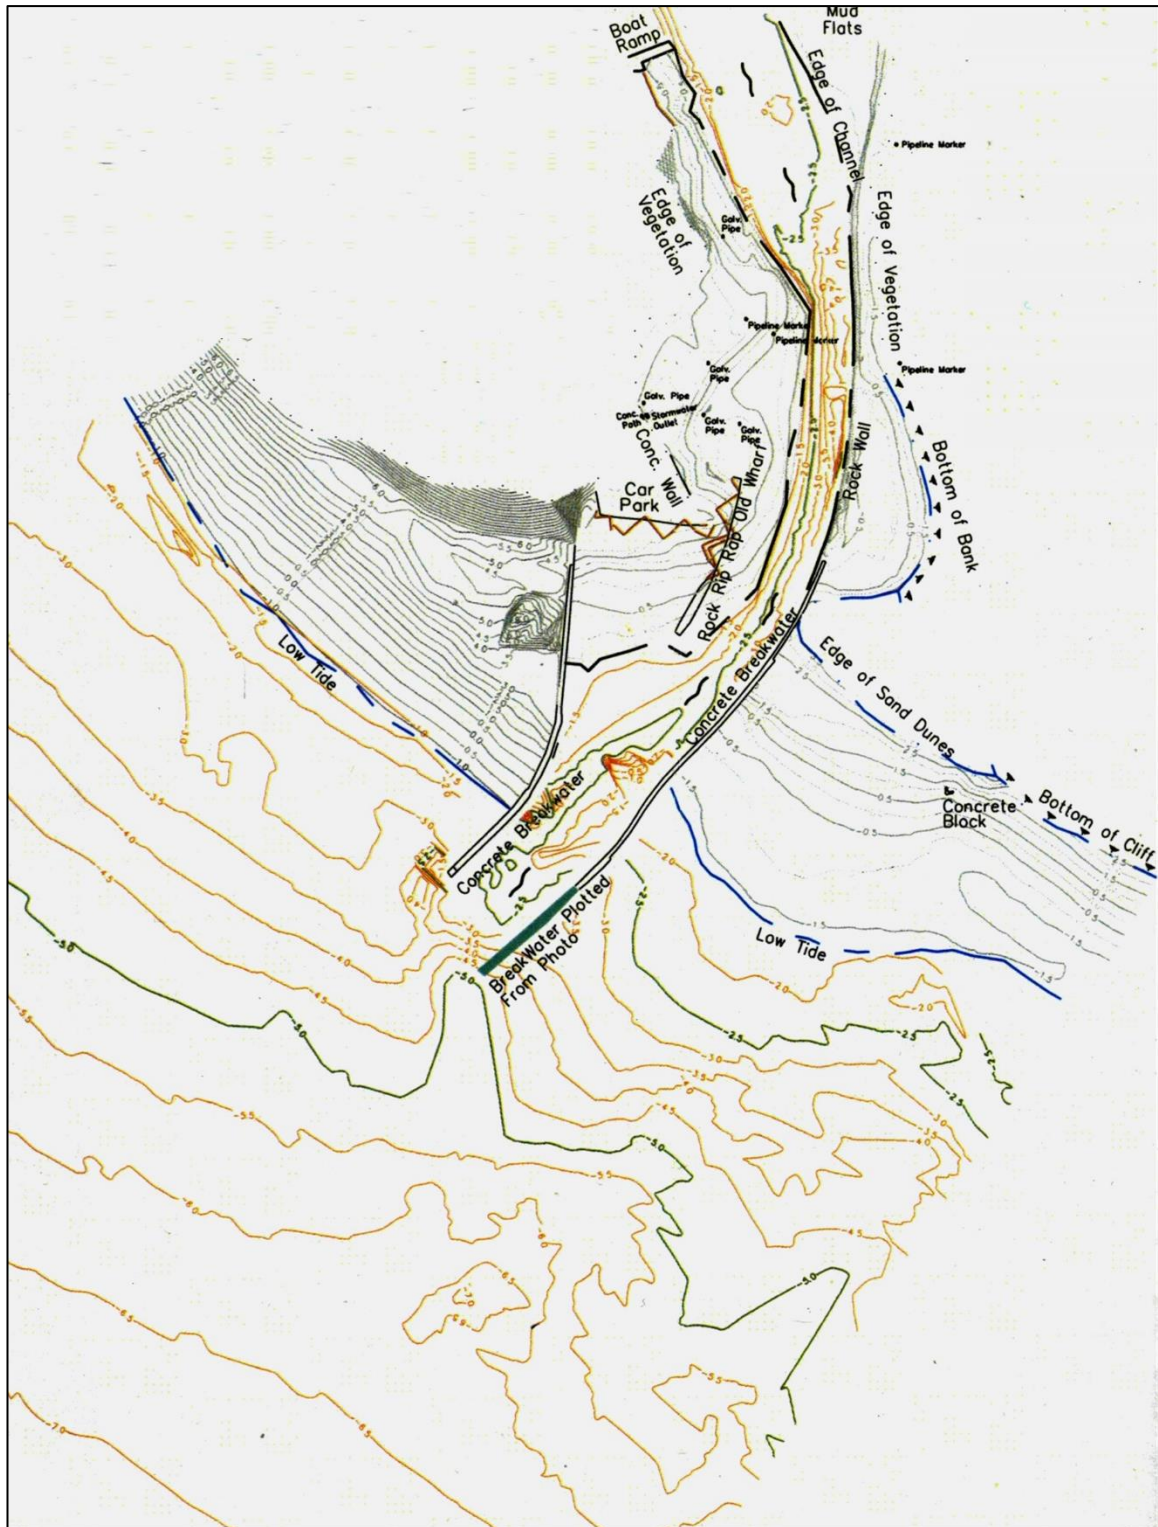
The 2003, BTW contoured bathymetry is reproduced as Figure 4.13 and the difference surface between 2003 and 2022 is shown in Figure 4.14. Because the 2003 survey used single side beam sonar and coarse spacing, a raster image was first generated by interpolating over 5 square metres. While the resulting difference-surface has coarse resolution and limited coverage on the settlement side of the river, it none-the-less enables broad change of the riverbed and seabed over this 19 year period to be identified.

Figure 4.13 Contoured output of BTW's March 2003 survey. Source Duffill, Watts and King (2003).
