Minor Coastal Structures: Consent Compliance, Asset Integrity and Hazard Management

A report prepared for the South Taranaki District Council

By Dr Roger D Shand

Reference	2022-8 CRep
Version	1.0
Status	Final
Date	19 July, 2022

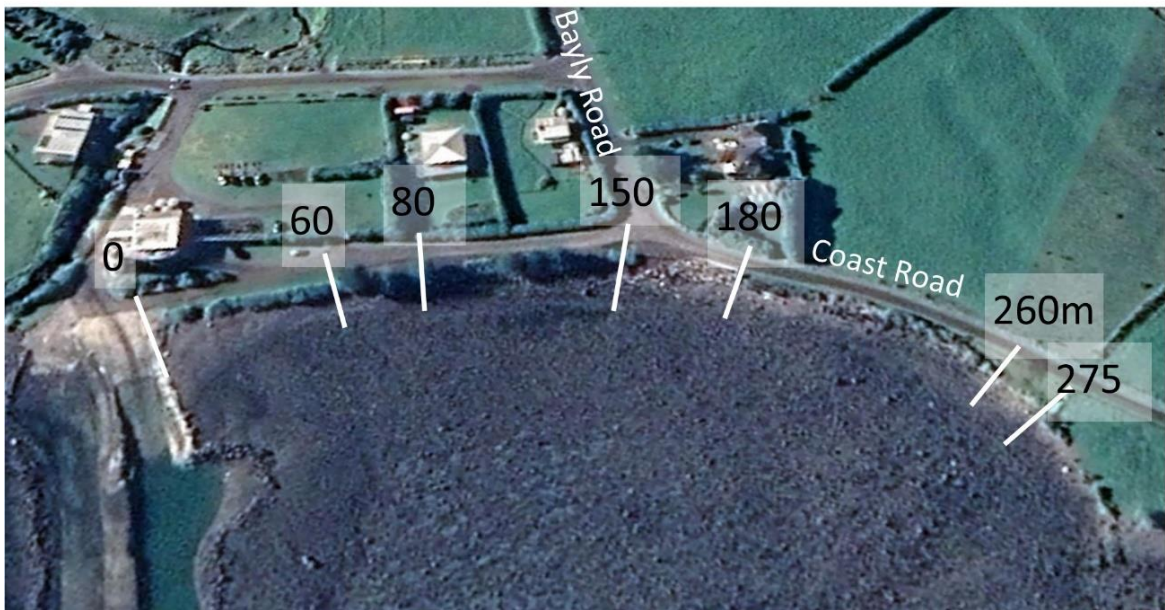
Figure 2.2 Bayly Road seawall location with chainage marked from the boat launching structure.

The first 30 to 40 m of the structure (chainage as marked in Figure 2.2) is buried or partially buried and stable.

Between 40 to 60 m: exposed upper bank and large trees being undermined creates an urgent intervention scenario. Rock and fill are needed to restore the structure, stabilise the large trees, and give long-term protection to the significant recreation area. Existing material should be removed down to a stable foundation level and a geotextile layer installed. Suitably graded armour rock placed with the appropriate stable slope, and backfilled with material of lesser size.

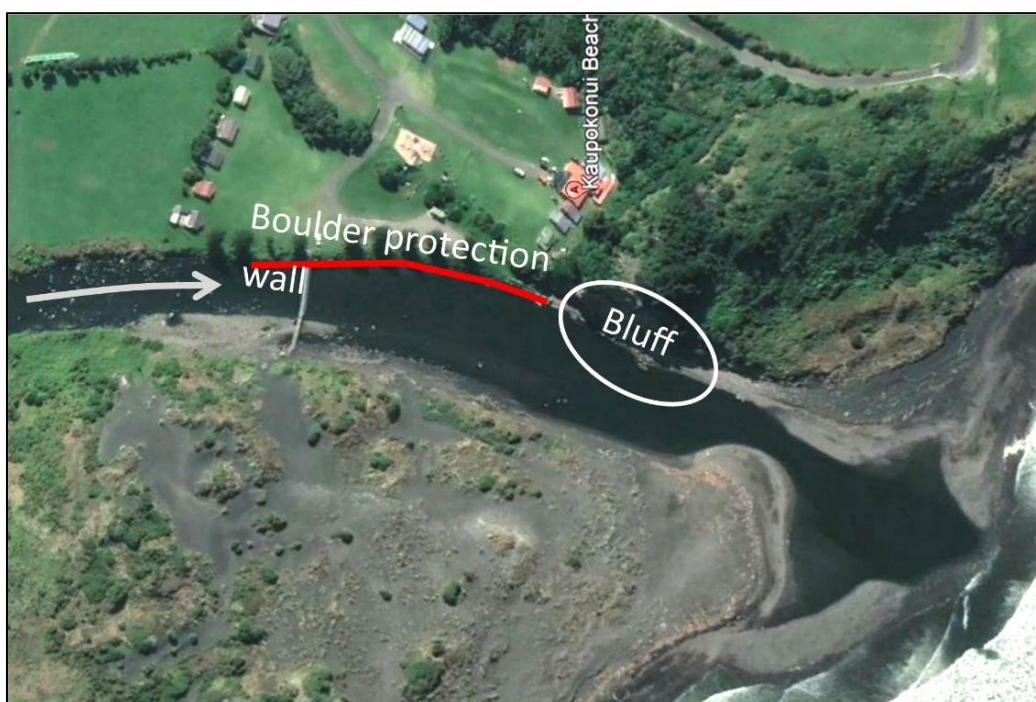
Figure 3.1 Location of the 170 m long boulder protection wall, the eastern bluff (Kaupokonui South Head), and footbridge (evident but not marked). The arrow indicates river flow and the beach is on the right.

The boulder protection wall is composed of large boulders. While the face is overly steep, it is well vegetated and there was no evidence of localised failure (Figure 3.2). The stability of the structure is further demonstrated by its resistance to high flow during the extreme rainfall event some week prior when both the natural bank upstream of the structure, and the bluff immediately downstream were both subject to significant failures (Figure 3.3). Slumping and rock slides at the bluff resulted in pedestrian access to the coast becoming hazardous and a report was made to STDC officers (Appendix A).

The wall is overly steep and toe support may be inadequate. For both consent compliance, asset management and hazard avoidance, a more detailed engineering inspection is recommended in the shorter term.

The bluff accessway condition requires urgent STDC attention to ensure public safety. The south beach access should be closed until the rock fall is stabilised - possibly by water sluicing, and then a long-term solution is required.

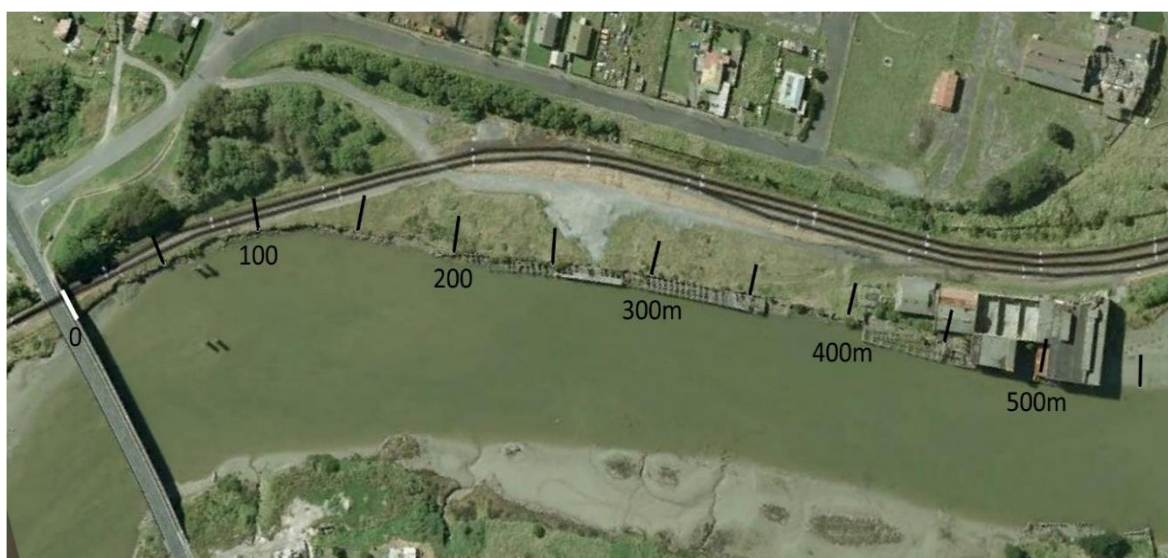
Figure 5.1 Patea river relating to consent 4575: rip-rap bank protection from chainage 0 to 200 m and the derelict wharf from 200 m to 530 m.

Between chainage 0 to 30 m, the rip-rap protection varies in condition from nothing to minimal coverage (Figure 5.1 upper photo), moderate coverage occurs between 30 m to 170 m with isolated sections having full coverage (Figure 5.2 middle photo). Minimal coverage occurs around the small embayment 170 to 200 m (Fig 5.2 lower photo). The shape of this embayment is characteristic of end-effect erosion from the 170 m revetment termination. Protruding railway iron is evident in the middle and lower (Figure 5.2) photos.

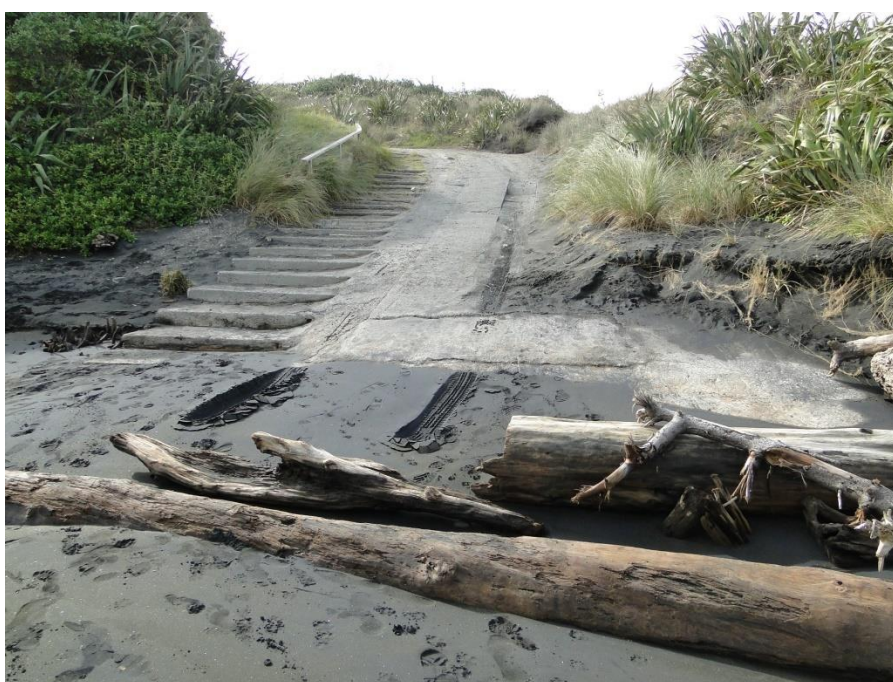
Figure 6.1 Caves beach access structure, showing pedestrian steps and handrail, vehicle ramp and broadened lower section.

The access ramp is located some 20 m west of the stream mouth. The ramp is cut into a mudstone-siltstone cliff some 15 m high. The structure is 20 m in length and 3 m wide, having been laid in 3 strips which are broken, or have settled unevenly, in places. The ramp is wider toward the base on its eastern side, suggesting a proclivity to erode there. In addition, a 2 m wide by 16 m long concrete pedestrian step-way is located next to the ramp with a hand rail along its western edge. The accessway leading down to the top of ramp is formed of shell rock. See Figure 6.1.

The ramp shows cracking from basecourse subsidence but is generally in stable condition. The pedestrian steps have been repaired and weeds removed between the steps and hand rails, to facilitate safe pedestrian access to the beach.

The STDC Recreation and Facilities team is responsible for this track. Further condition-based assessment can be considered for future monitoring programmes. Signage can be placed warning of slippery slope and gravel.
