PATEA BEACH SAND MANAGEMENT REPORT

January 2021 to May 2022

A report prepared for the South Taranaki District Council

COASTAL SYSTEMS Ltd

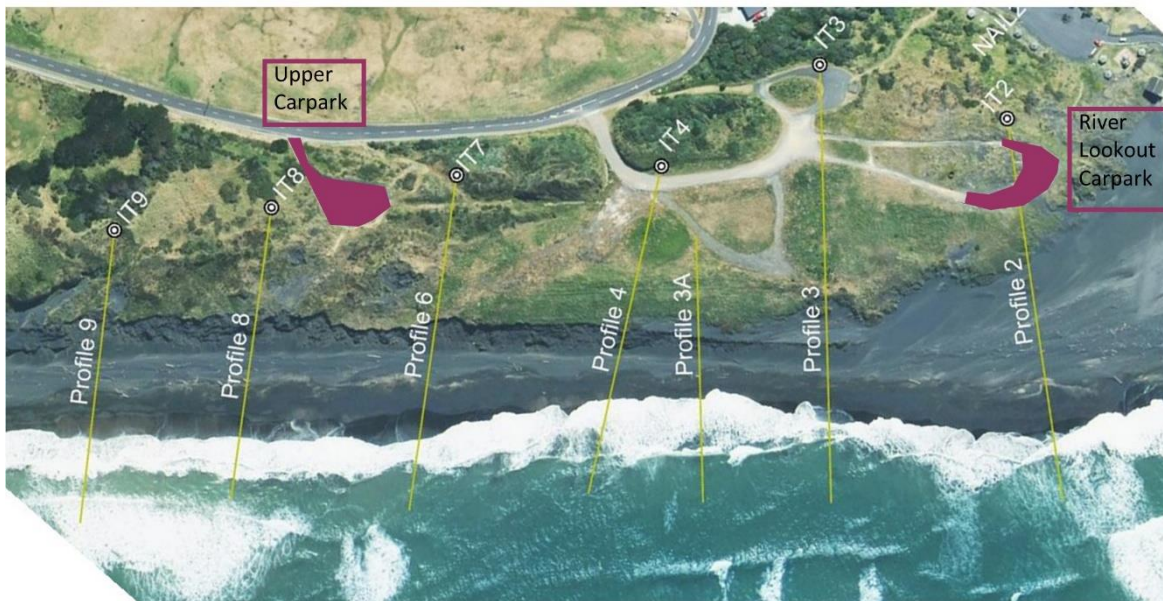
Profile surveys were carried out on 7/8 December 2021 and the 7 profiles surveyed (2, 3, 3A, 4, 6, 8, 9) are located in Figure 4. In future, profiles 3A, 6 and 9 will be excluded unless a significant episode of instability reoccurs. (These 3 were to be excluded from the December survey but were inadvertently included). Other profile lines within the inlet (7), along the south beach (3) and on the north beach near the mole (1) were also surveyed at the time, but these will be reported elsewhere as they are part of the Coastal Structure Monitoring programme.

Figure 4 Profile line locations and finder benchmarks surveyed by TPL on 7/8 December 2021.

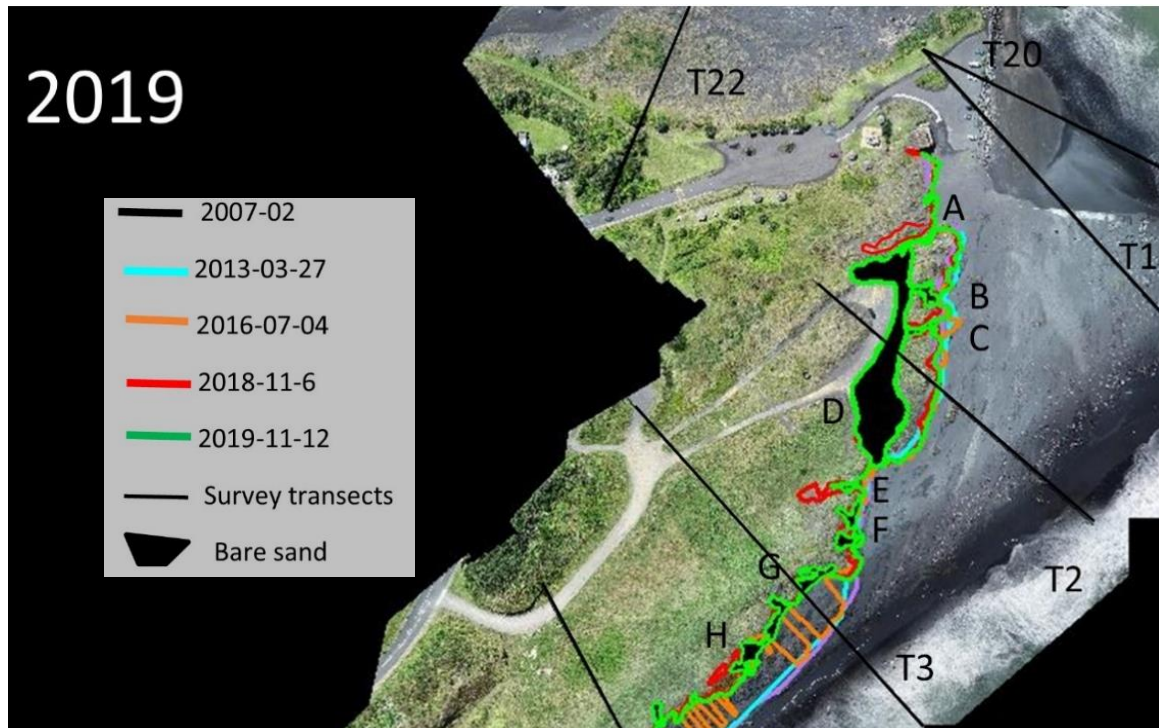
Sand instability Site D, see Figure 1 which is from the 2019 Annual Report: Patea Beach Sand Management Project, consists of a blowout (gut) through the dune crest and extensive wind drift to landward. The area is increasing in an exponential manner from 47 m² in 2016, to 140 m² in 2017, to 337 m² in 2018 and to 1260 m² in 2019 with sand now spilling down toward the beach utilities (Figure 2). Such a nonlinear increase in area is common when sand dunes become unstable, for example see Figure 3.

Figure 1 Areas of bare sand (black) and vegetation-fronts, from 2019 Annual Report

The 2019 Annual report recommended in the 2020 year that “green waste be placed at site D with planting carried out once it has settled”.

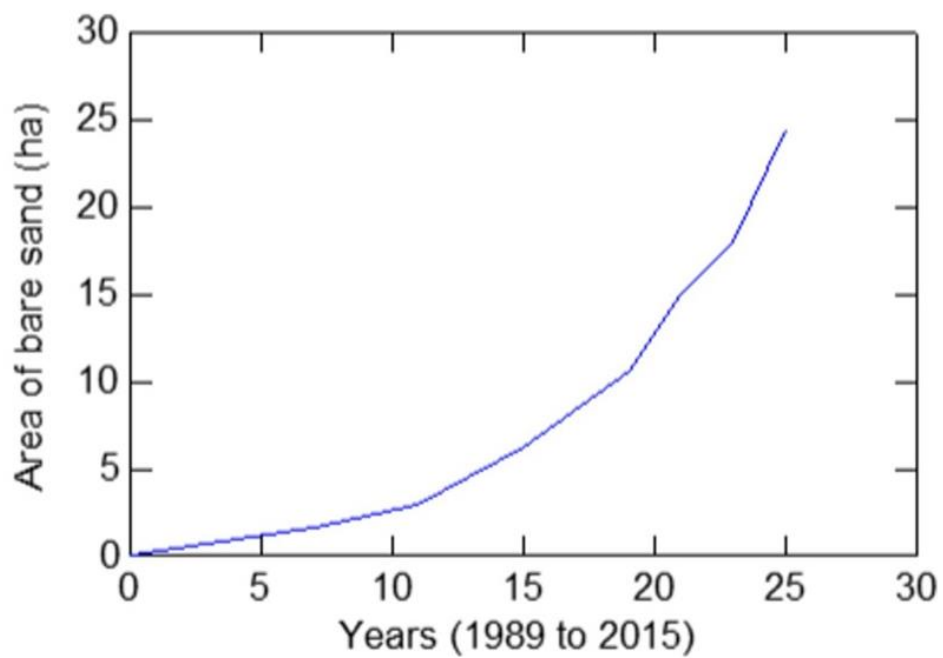
Figure 3 Example of exponential-type increase in bare sand area from frontal foredune erosion and landward wind-drifting on the Wanganui coast.
