Southland Coastal Hazard Assessment

Prepared by Dallas Bradley, September 2009

1. Introduction

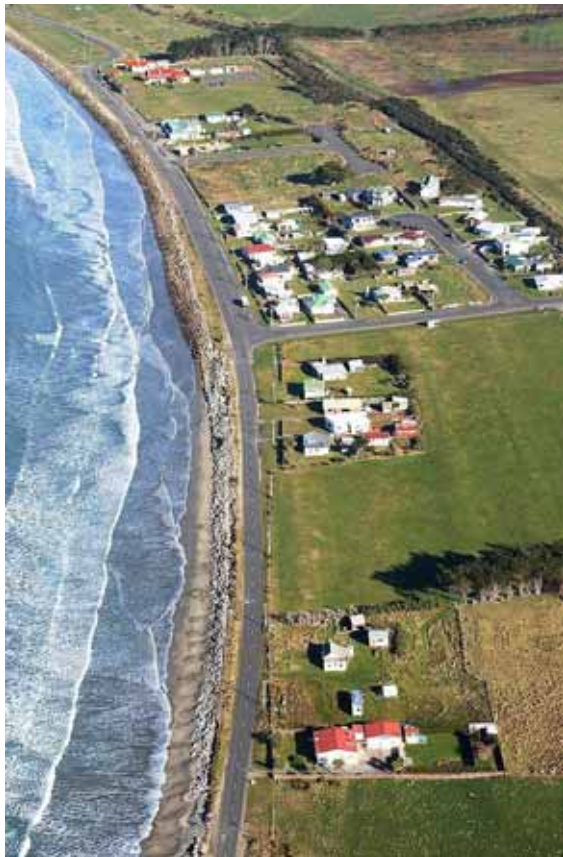
Huraki Creek - "Tihaka Sands" at the east end of Colac Foreshore Road	Sandy foreshore below rock protection works	flat - slowly rising. Approximately 5m amsl	Colac Bay township, Urupa, Marae and restaurant (See Figure X ST oblique aerial photo)	Colac Foreshore Road, power & telephone, Rock coastal protection works - See Figs 12, 13, 14 & 15.	Yes - coastal protection works in place for much of the reach but these are subject to overtopping and scouring in storms. Unprotected section is subject to active erosion.	No, hinge point between erosion and accretion is located in the vicinity of the east end of this reach ¹²	Slight wind erosion	Yes but not extensive to date See Fig 13	Yes ^{2,6} 1960 tsunami put debris on the Foreshore Road.	East to south east aspect but vulnerable to erosion/inundation in south - south west storms.	2. Berryman K (2005) "Review of Tsunami Hazard and Risk in NZ" Institute of geological and Nuclear Sciences Ltd. 6. Bradley, D. 2002 "Tsunami - Invercargill City Lifelines Hazard Report, Section 5, pages 1-13". Invercargill City Council. 10. Tonkin & Taylor Ltd, (December 1997) "Colac Bay Foreshore Protection"

Figure 12 Colac Bay 11 January 2003. Southland Times photograph

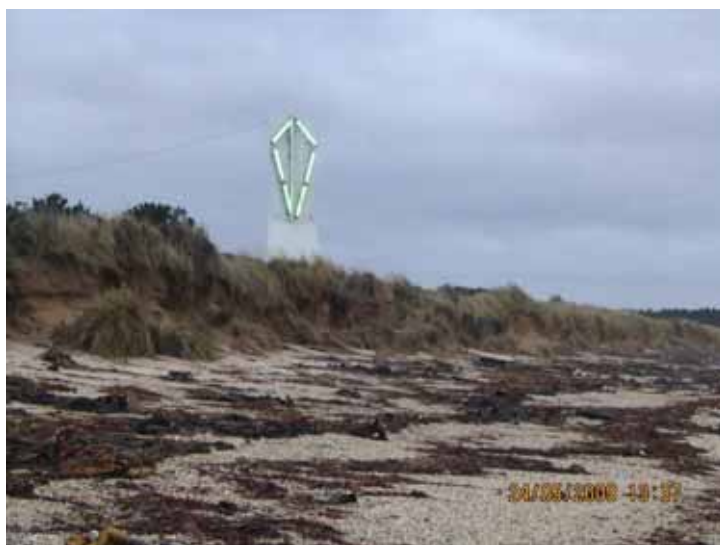
Tiwai Point to Fortrose	Generally steep coarse sand or gravel beaches	Generally gravel ridges or spits separating internal water bodies from the sea. Mostly DoC estate apart from land immediately around the NZAS	Aluminium Smelter	Navigation Aids [Rear Leading Light No 1 & Bushy Point light (See Figs 17a, 17b & 17c)], NZAS Outfall structure	General erosion, (significant around Bushy Pt) from Trig Q to the east end of Lake Waituna. See Figs 17d & 17e.	Historic accretion from Tiwai Point to Trig Q but currently eroding.	Moderate wind erosion on Toetoes spit, slight wind erosion elsewhere.	Potentially but few assets at risk	The standard floor height for NZAS buildings is 4.57m amsl (15 feet amsl) Pers.comment, Kevin Duke NZAS.

Figure 17a Bluff Harbour Leading Light, Tiwai Point

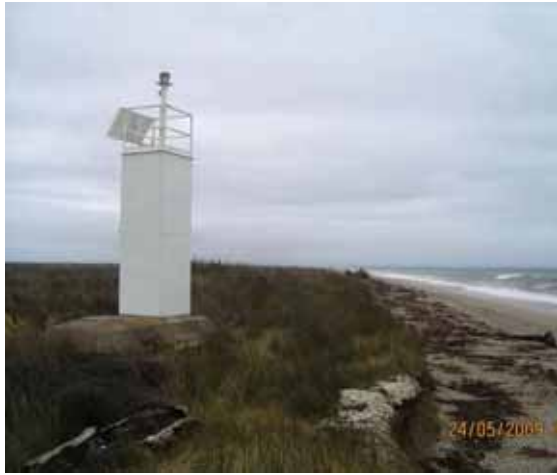
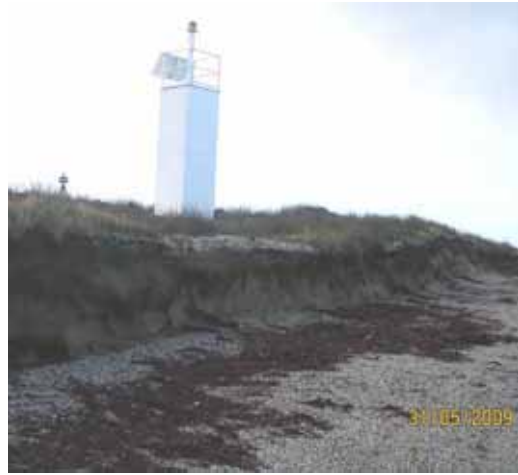
Figures 17b & 17c Bushy Point Light between Tiwai Point and Lake Waituna

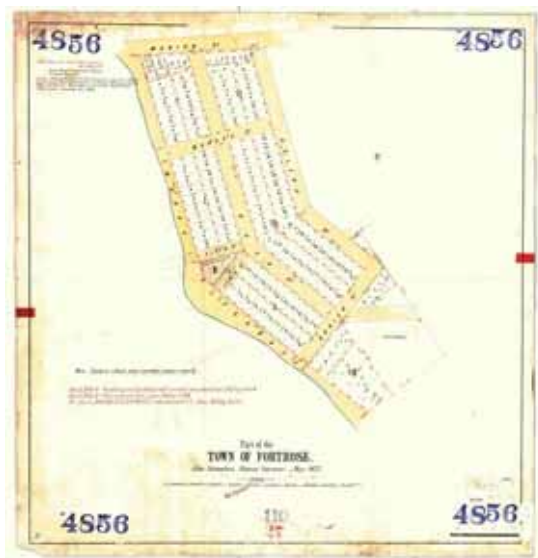
Figure 18b 1877 survey plan showing the mean high water mark as the western boundary of Moray Terrace. (Compare with Fig 17)

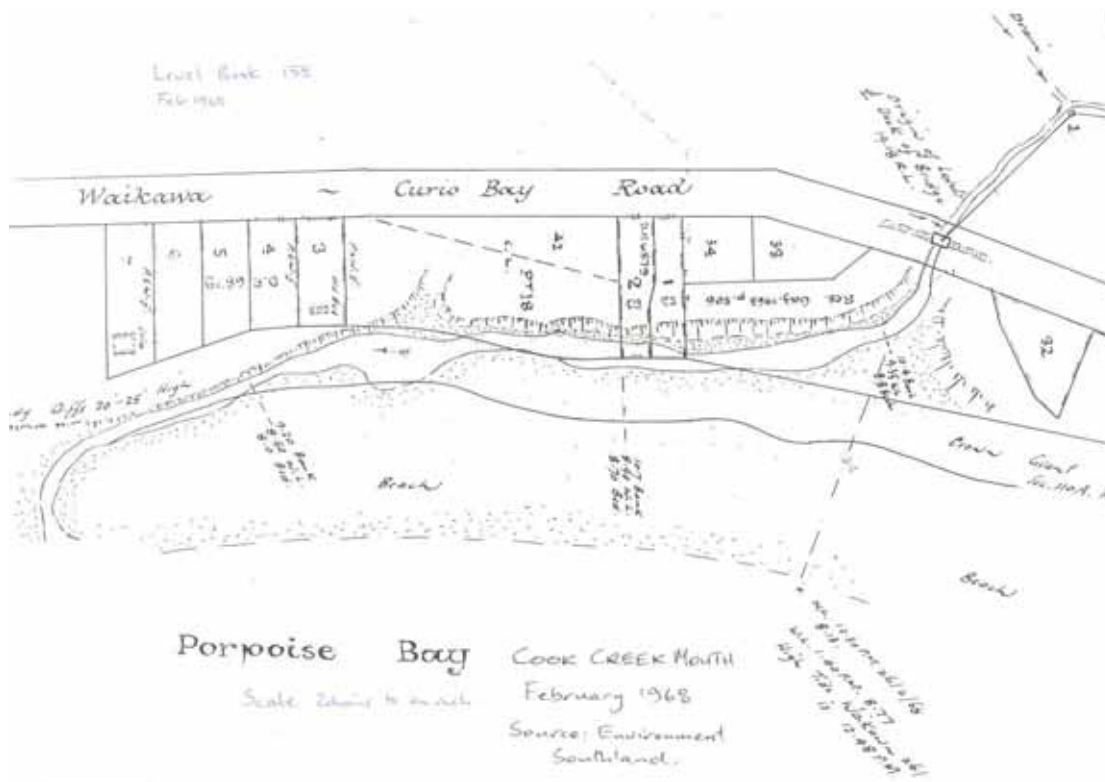
Figure 20 Cook Creek Mouth, Feb 1968

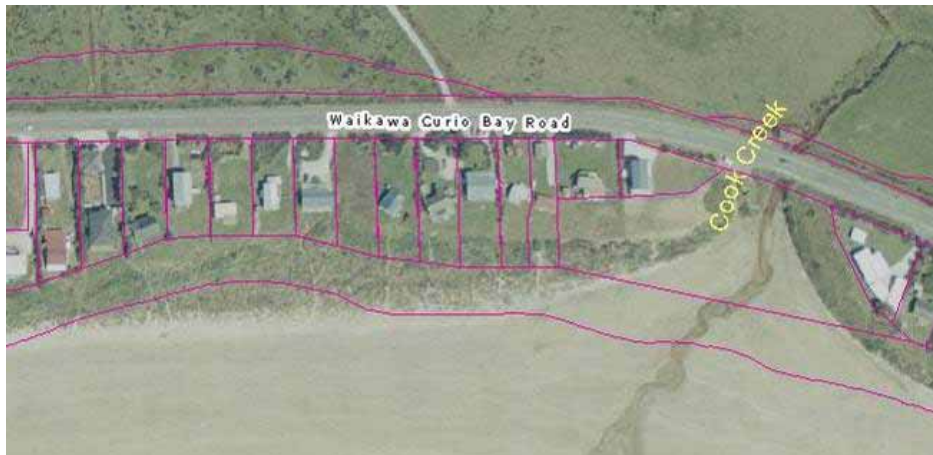
Fig 20a Cook Creek Mouth, January 2008.
