Prioritisation for restoration of out-flow stream habitat of coastal wetlands on the west coast of the Manawatu- Wanganui region

A report prepared for Horizons Regional Council, May 2009

Dr Alex James and Dr Mike Joy

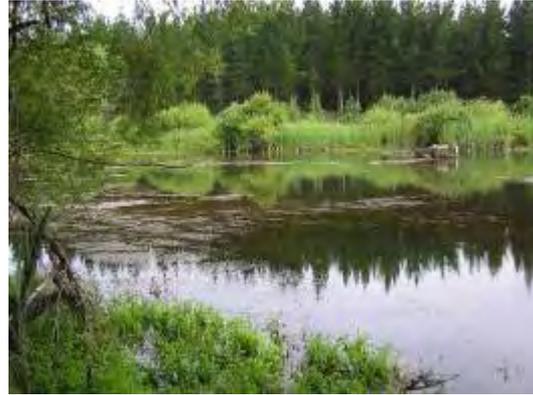
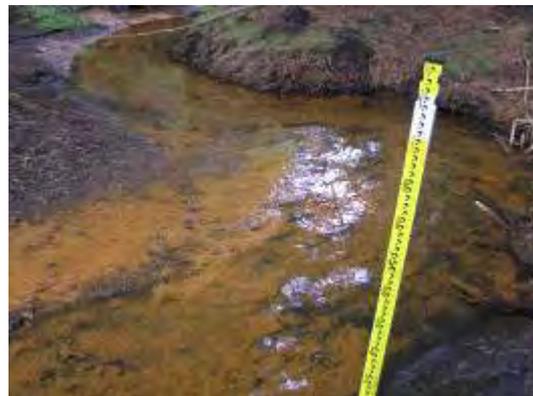
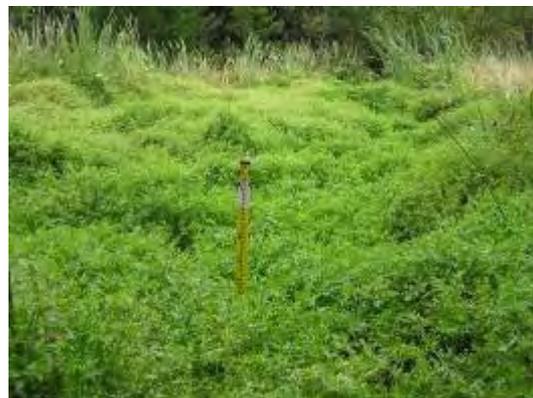
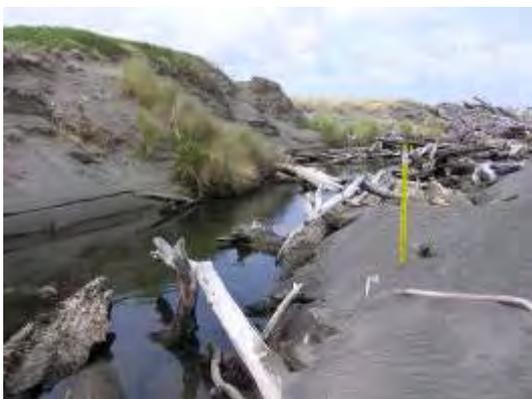
Top: The Artillerie Swamp lake.

Middle: Extensive iron floc deposits ~450 m from lake in heavily shaded reach.

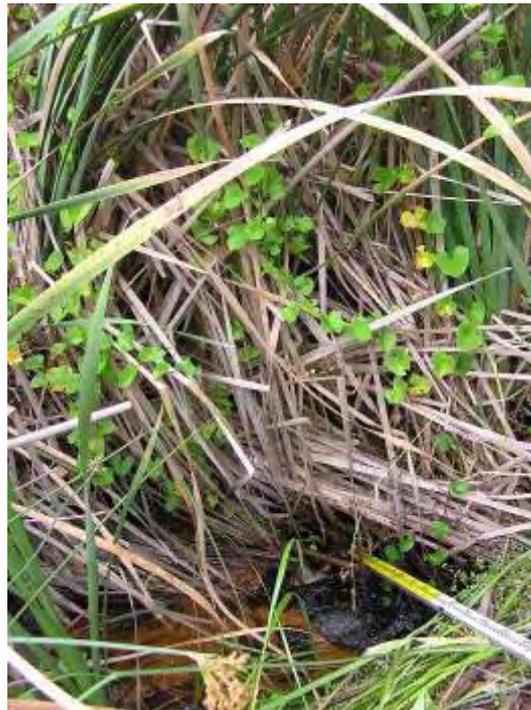
Above: A natural perched fall near the Artillerie Swamp lake. It may become submerged when water levels are high.

Below: This feature was only discovered amongst the raupo by the sound of running water.

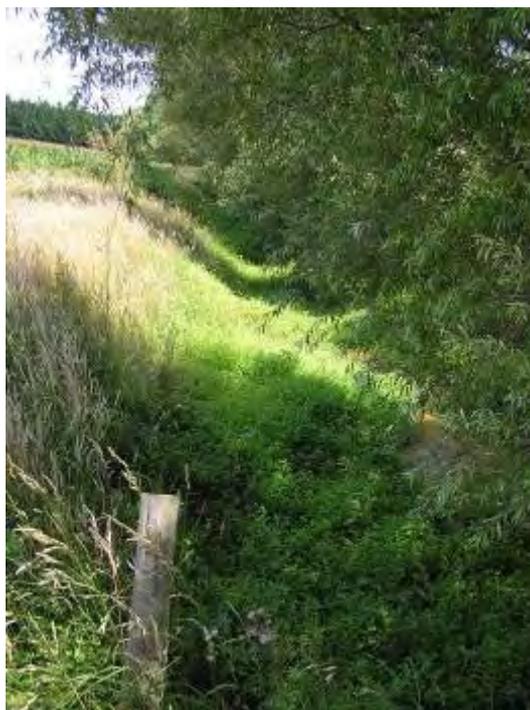
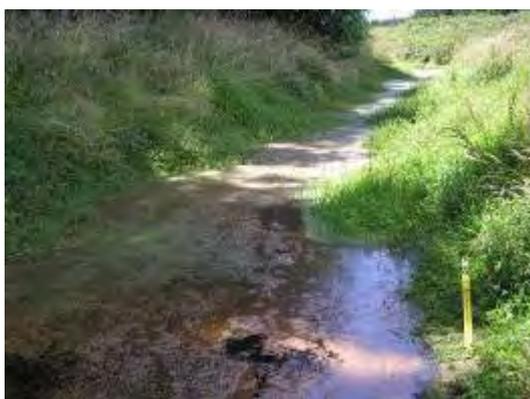
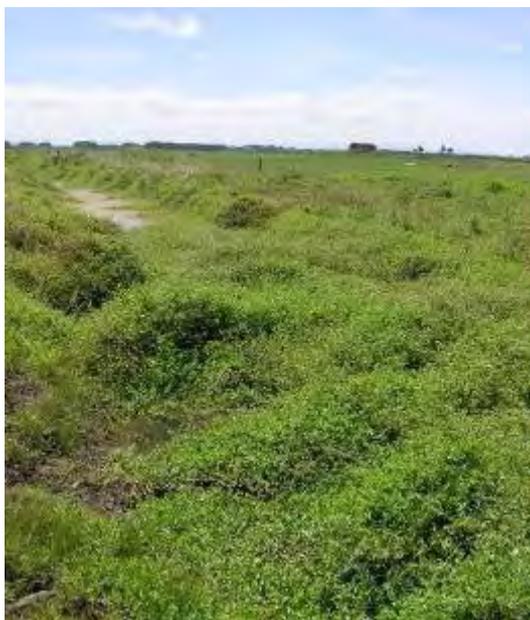
Middle: The stream near the entry to dairy farm. Here there is abundant duckweed and orange gunk.

Bottom: Typical nature of the channel through the dairy farm. Much of the channel is totally obscured by rampant wild parsnip growth.

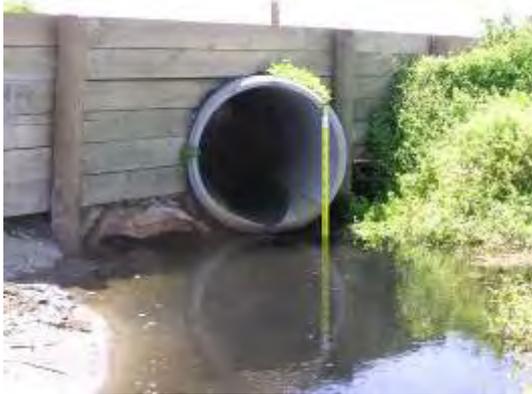
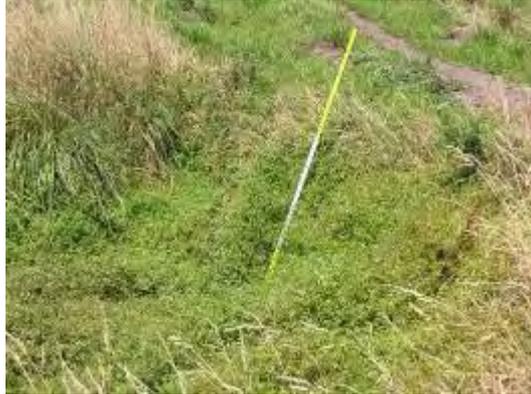
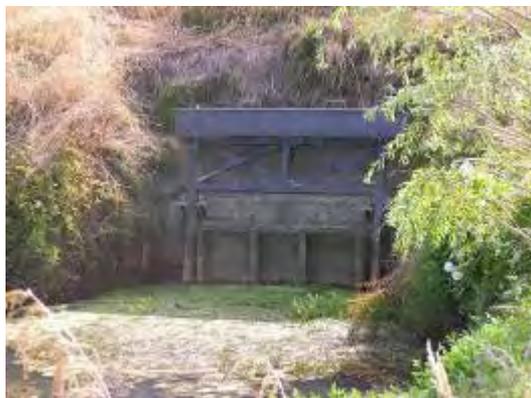
Forest Road Wetland outlet stream selected structures

Top left: Relatively new culvert installed on top of two older ones to add higher flow capacity.

Middle left: A large diameter culvert.

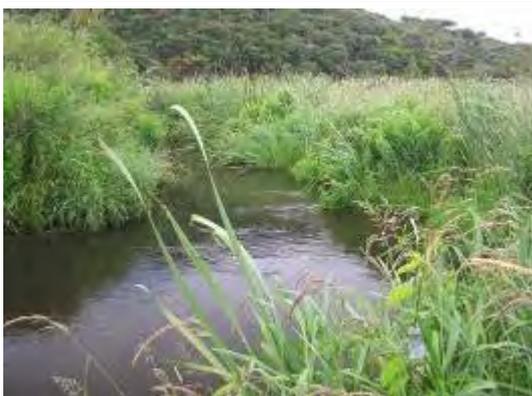
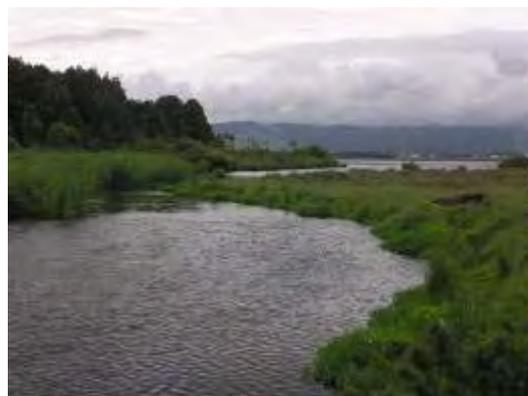
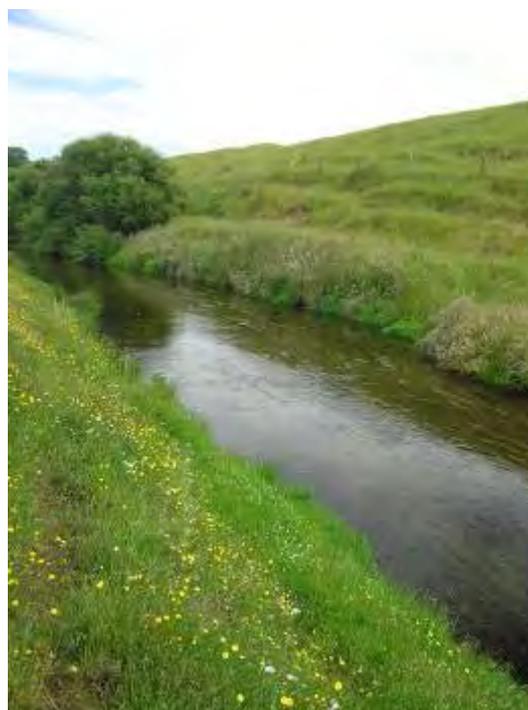
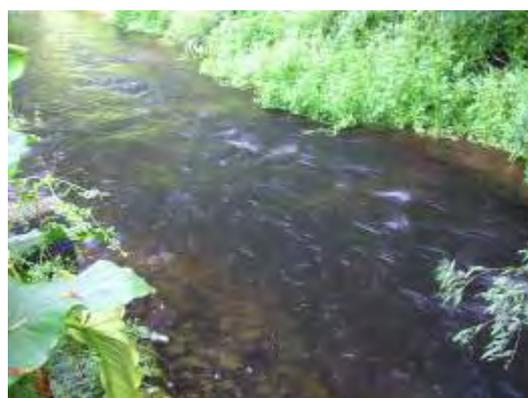
Top: Lake Horowhenua outlet.
Middle: Hokio Stream just downstream from Lake.
Bottom: Cobbled riffle downstream of Moutere Rd bridge.
Left: Hokio Stream near entrance to Hokio Beach settlement.

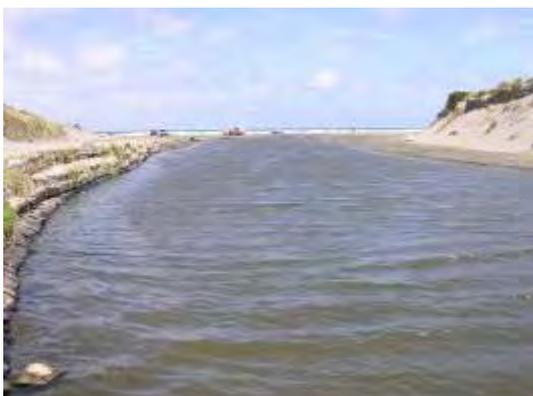
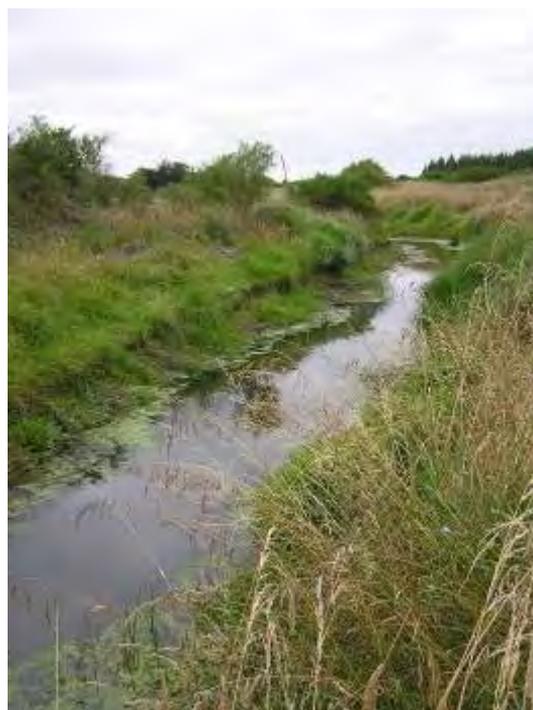
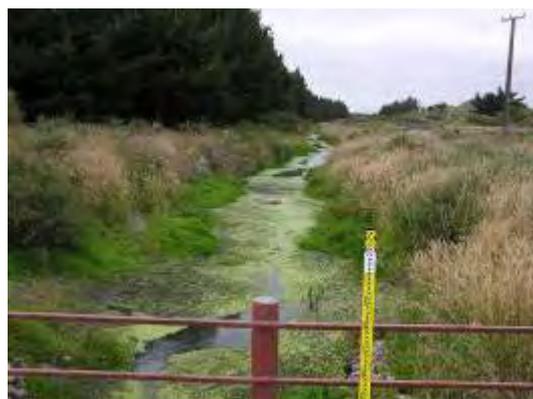
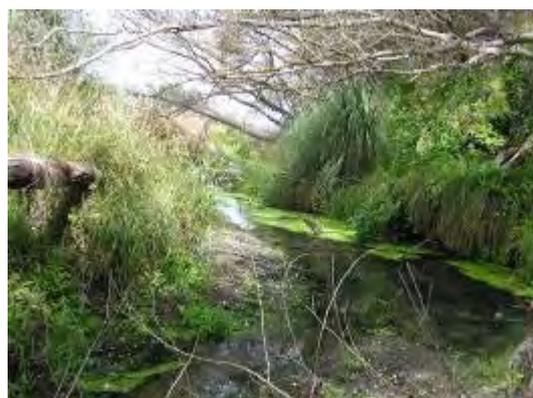
Top: Kaikokopu Stream at Pedersen boundary.

Middle: Kaikokopu Stream at exit from pine plantation.

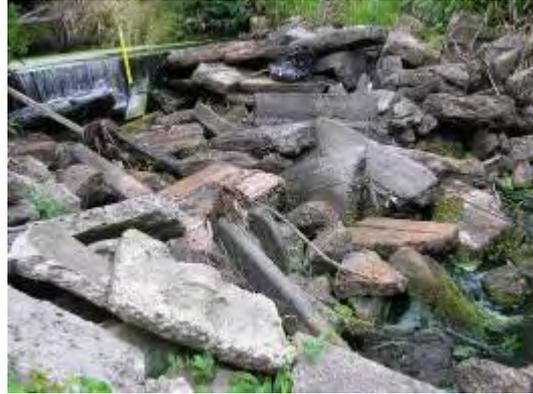
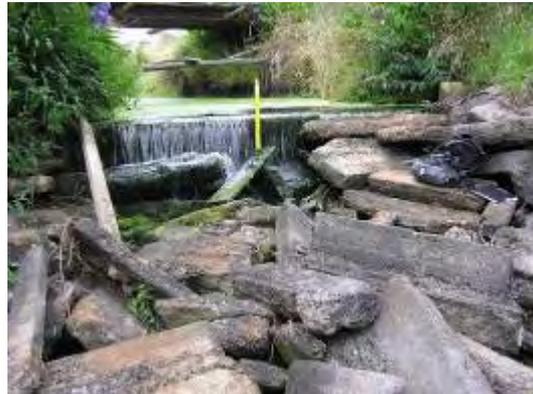
Location: weir at entrance to
Himatangi Beach

Easting	2700435
Northing	6090410
Date assessed	16/1/09
Structure	Weir
Type	Weir
Construction	Wood
Width	5.3 m
Water depth (inlet)	0.43 m
Water depth (outlet)	0.07 m
Inlet cross section	Pooled
Outlet cross section	Perched
If perched (height)	0.25 – 0.67 m
If perched (undercut)	0
Likely severity of barrier	Most flows
Instream structures known upstream	1
Instream structures known downstream	0

Top, bottom and left: The weir structure in the Kaikokopu Stream adjacent to the entrance to Himatangi Beach. A large amount of concrete rubble has been dumped at outlet presumably to prevent scouring of the stream bed.

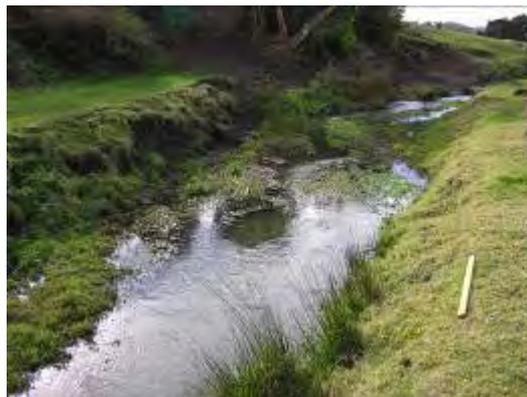
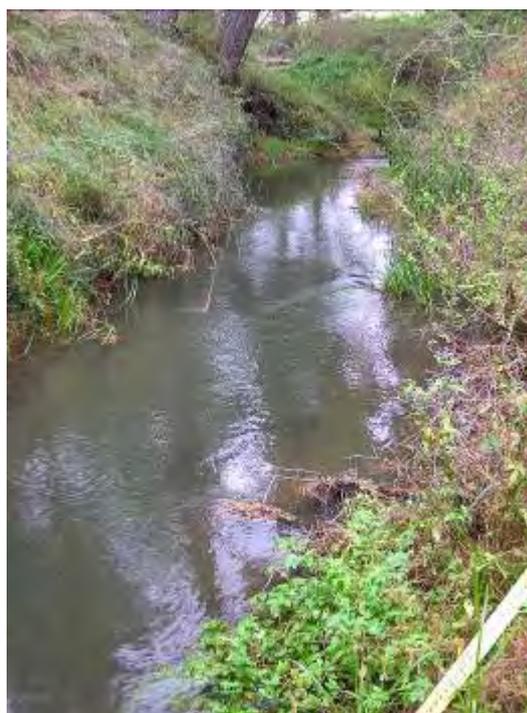
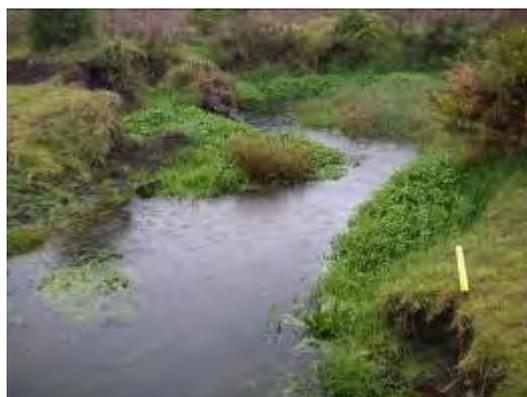
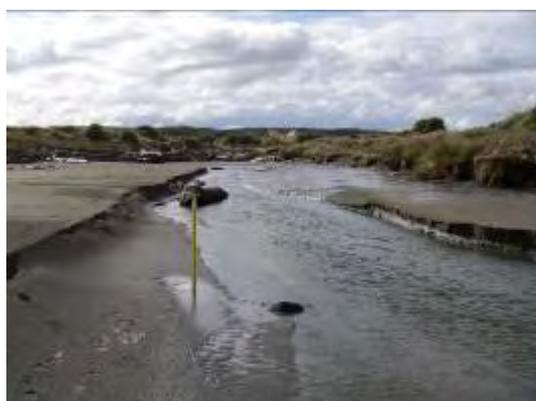
Top: The Kaitoke Stream just downstream of the lake.

Middle: The Kaitoke Stream in the pine forest.

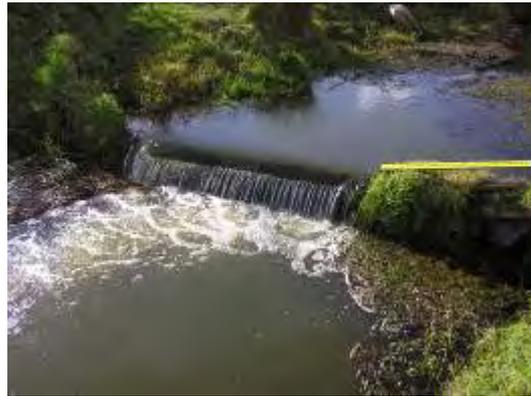
Location: lake level weir

Easting	2686420
Northing	6135865
Date assessed	15/5/09
Structure	Weir
Type	Weir
Construction	Wood and concrete
Width	4 m
Water depth (inlet)	0.45 m
Water depth (outlet)	0.67 m
Inlet cross section	Flat
Outlet cross section	Perched
If perched (height)	0.25 m
If perched (undercut)	0 m
Likely severity of barrier	Most flows
Instream structures known upstream	0
Instream structures known downstream	0

Top: The Lake Kaitoke water level weir facing upstream. The weir structure was on a lean.

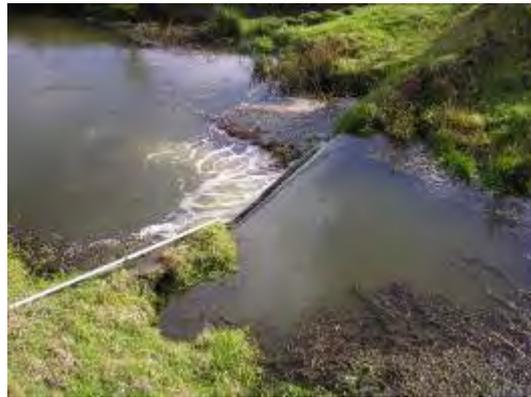
Bottom: The Lake Kaitoke water level weir facing downstream.

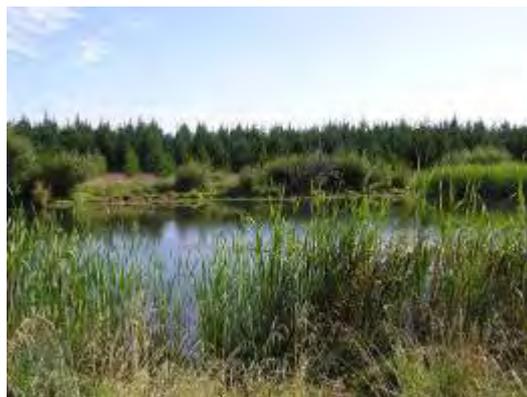
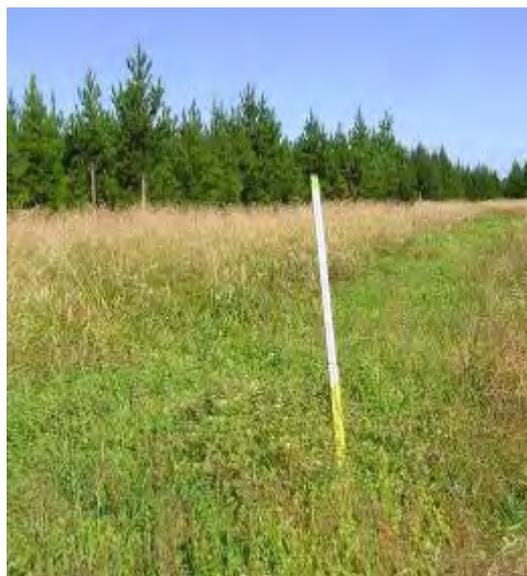
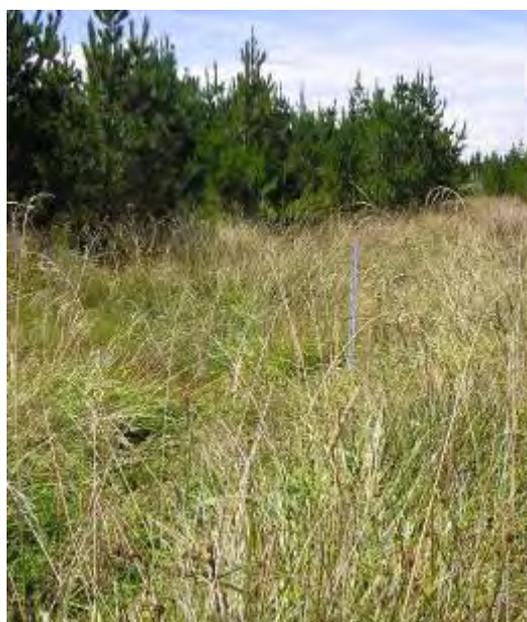
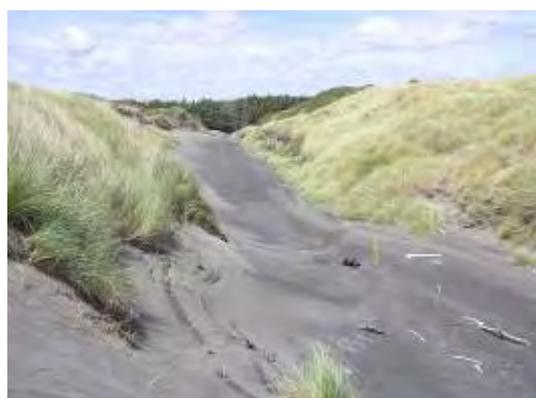
Top right: The Knottingly Swamp lake.

Middle right: The outlet stream just downstream of the lake. The channel is wetted here and totally choked with wild parsnip.

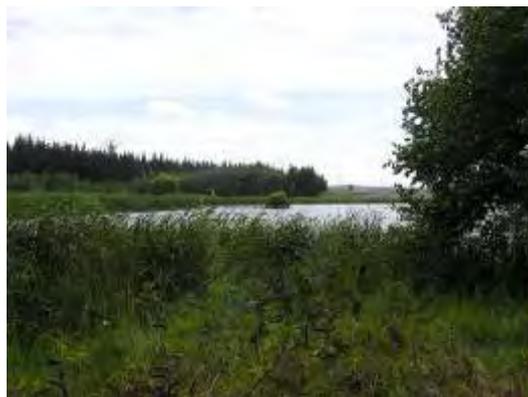
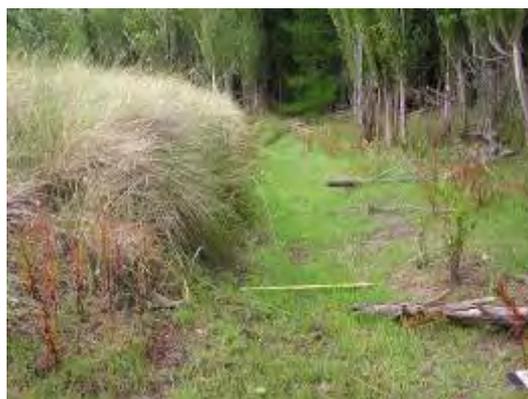
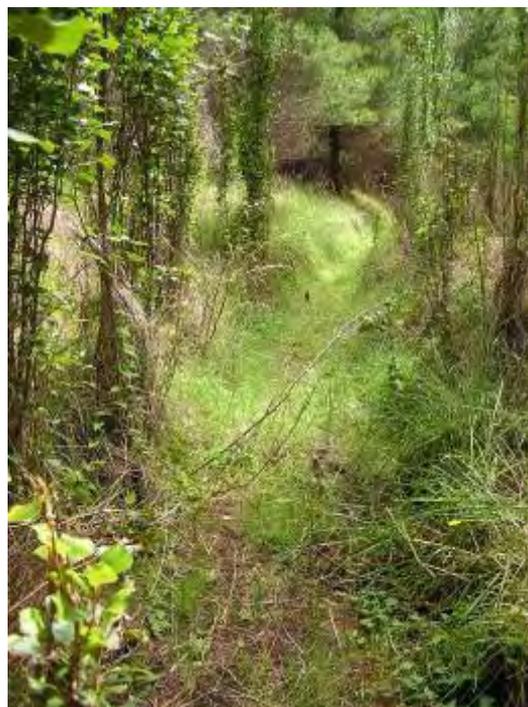
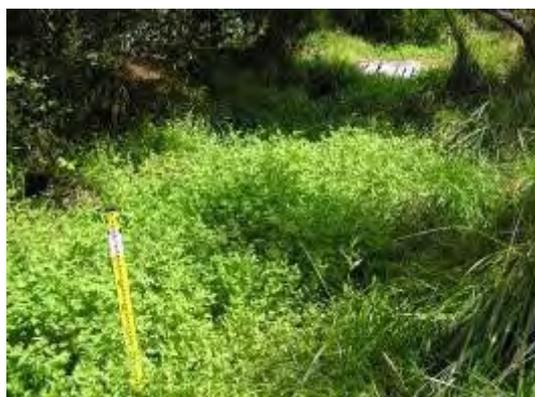
Top: Lake Koitiata
Middle and bottom: The typical dry channel habitat that comprised the majority of the outlet stream.
Left: The wetted reach was choked with wild parsnip.

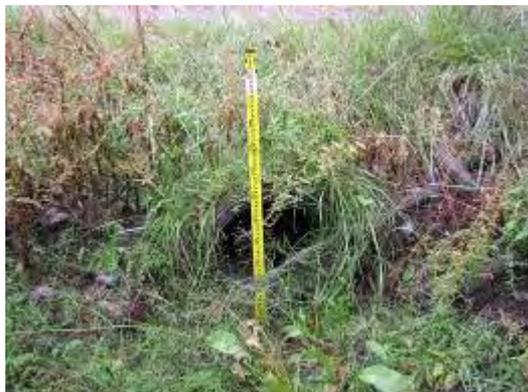
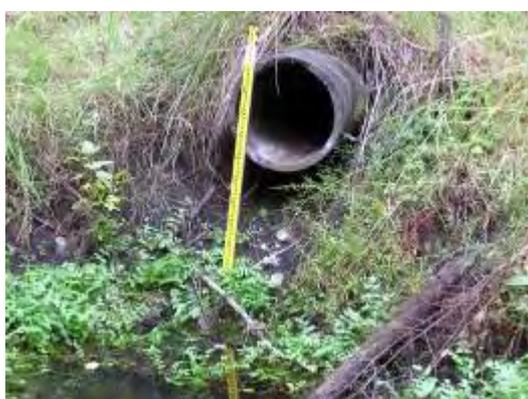
Lake Koitiata structure	
Location: First culvert downstream from lake	
Easting	2696775
Northing	6118330
Date assessed	27/1/09
Structure	Culvert
Type	Pipe
Construction	Concrete
Length	12 m
Diameter	0.45 m
Water depth (inlet)	0
Water depth (outlet)	0
Inlet cross section	Flat
Outlet cross section	Perched
If perched (height)	0.44 m
If perched (undercut)	0.91 m
Likely severity of barrier	Most flows
Instream structures known upstream	0
Instream structures known downstream	3

Top: Inlet of first culvert downstream of lake.

Bottom: Perched outlet of first culvert downstream of lake.

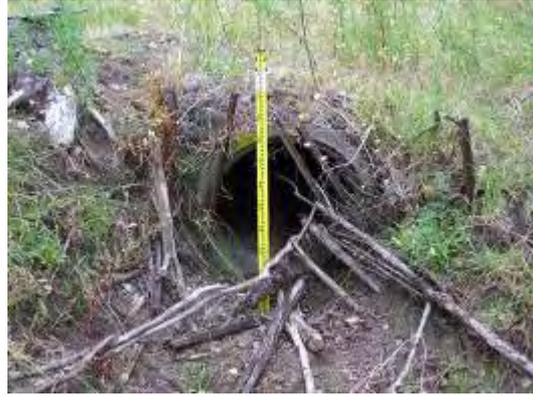
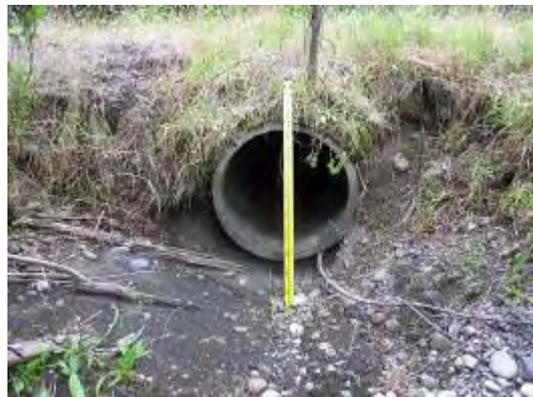
Easting	2696690
Northing	6117895
Date assessed	27/1/09
Structure	Culvert
Type	Pipe
Construction	Concrete
Length	7.5 m
Diameter	0.7 m
Water depth (inlet)	0
Water depth (outlet)	0
Inlet cross section	Flat
Outlet cross section	Perched
If perched (height)	0.17 m
If perched (undercut)	0.75 m
Likely severity of barrier	Most flows
Instream structures known upstream	1
Instream structures known downstream	2

Above: Inlet of second culvert downstream of lake.

Below: Perched outlet of second culvert downstream of lake.

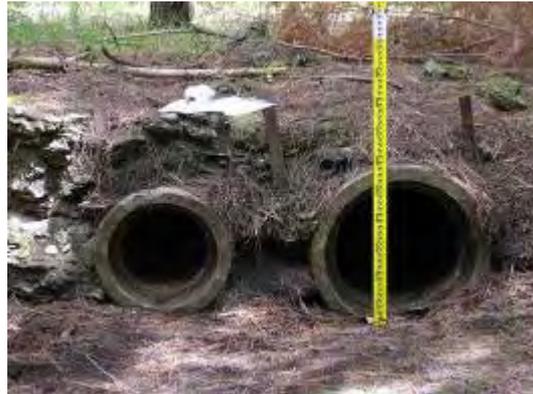
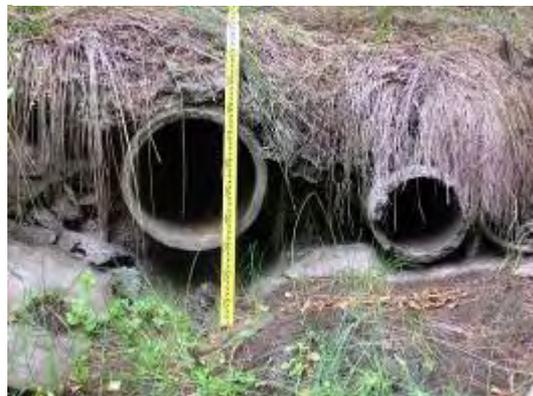
Easting	2696435
Northing	6117575
Date assessed	27/1/09
Structure	Culvert
Type	Pipe (double)
Construction	Concrete
Length	12 m
Diameter	0.3 / 0.45 m
Water depth (inlet)	0
Water depth (outlet)	0
Inlet cross section	Flat
Outlet cross section	Perched
If perched (height)	0.1 / 0.33 m
If perched (undercut)	0.92 / 0.48 m
Likely severity of barrier	Most flows
Instream structures known upstream	2
Instream structures known downstream	1

Above: Inlet of third culvert downstream of lake.

Below: Perched outlet of third culvert downstream of lake.

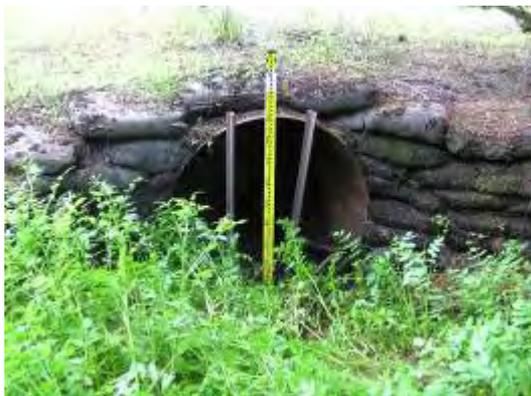
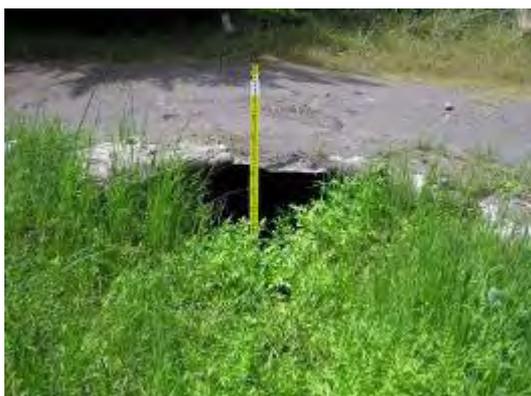
Top left: Inlet of the fourth culvert downstream of the lake. Here the channel was wetted.

Bottom left: Outlet of fourth culvert downstream of lake.

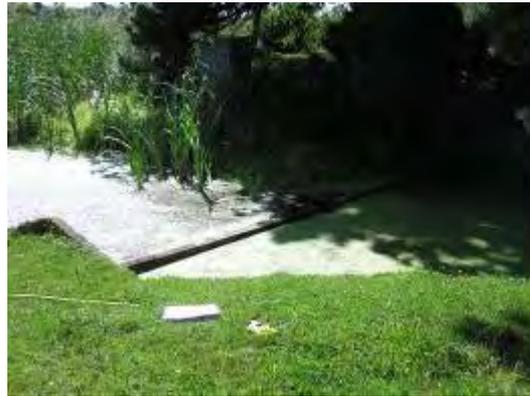
Easting	2701380
Northing	6086675
Date assessed	14/1/09
Structure	Weir
Type	Weir
Construction	Concrete
Width	~8 m
Water depth (inlet)	0.34
Water depth (outlet)	0.65
Inlet cross section	Pooled
Outlet cross section	Perched
If perched (height)	0.1 m
If perched (undercut)	0
Likely severity of barrier	Low flows
Instream structures known upstream	1
Instream structures known downstream	2

Top and bottom right: The Lake Koputara water level weir. At the time of visit water was pooled on either side with only a slight trickle flowing over the weir.

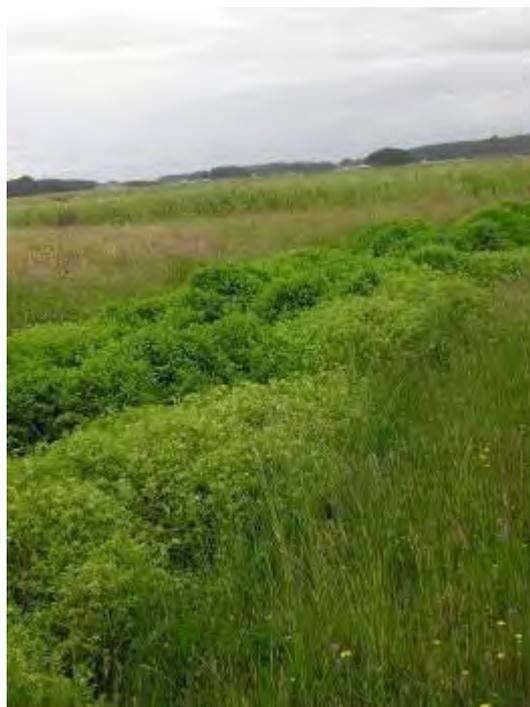
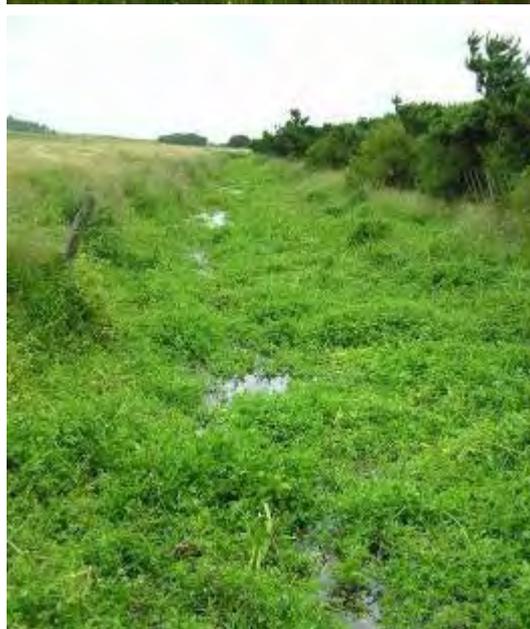
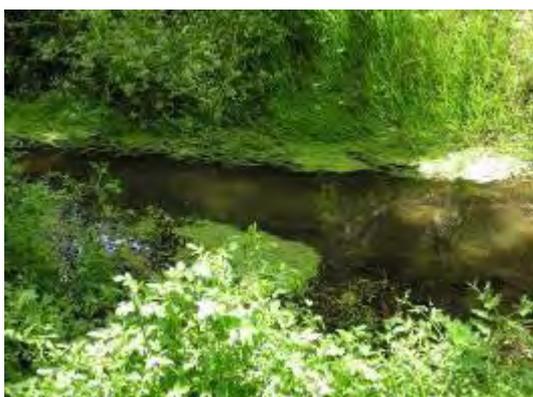
Top: The outlet stream between Koputara lakes '2' and '3' choked with wild parsnip.

Bottom: The outlet stream just downstream of Lake Omanu.

Left: The outlet stream in the pine plantation just before flowing through Foxton Beach.

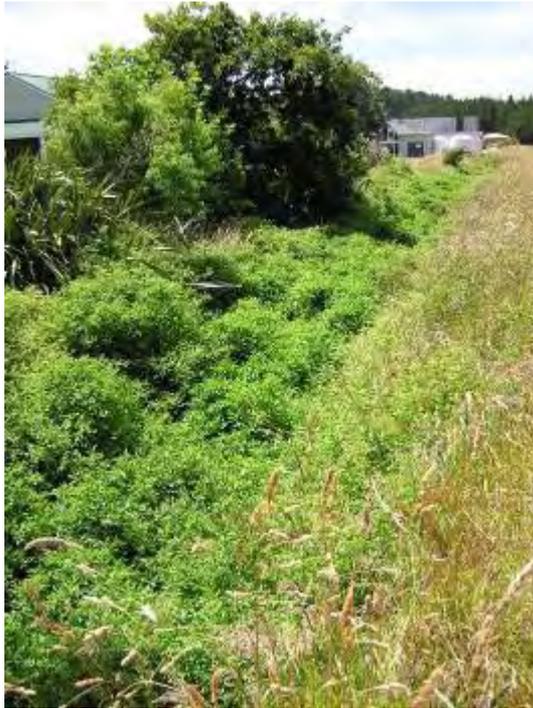
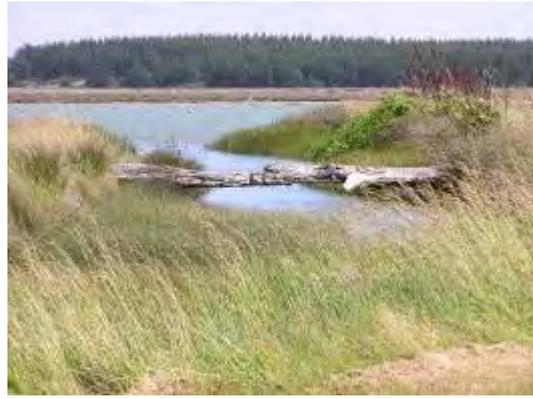
Above: The outlet stream entering the Manawatu estuary.
 Left: The outlet stream is totally obscured by wild parsnip as it flows through Foxton Beach.

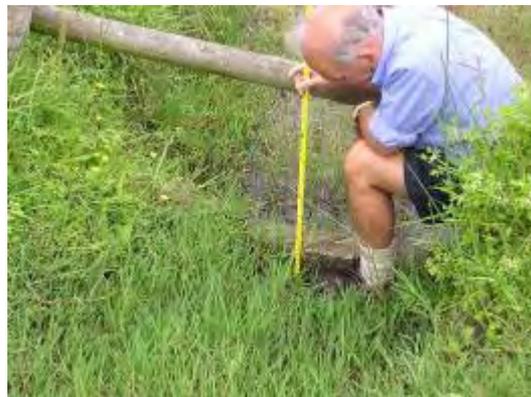
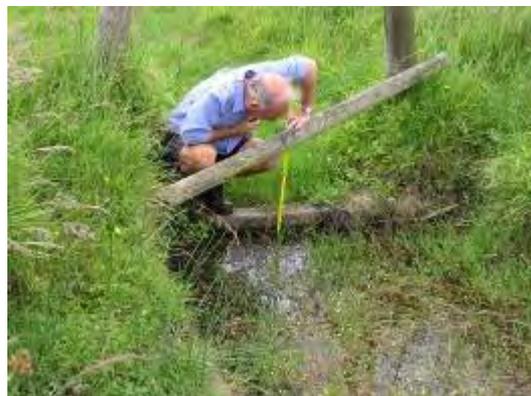
Lake Koputara '2' structure	
Location: Lake level weir	
Easting	2701390
Northing	6083550
Date assessed	16/12/08
Structure	Weir
Type	Weir
Construction	Concrete
Width	~1.5 m
Water depth (inlet)	0 (dry)
Water depth (outlet)	0.18 m
Inlet cross section	Dry (likely pooled if water present)
Outlet cross section	Perched
If perched (height)	0.1 m
If perched (undercut)	0
Likely severity of barrier	Low flows
Instream structures known upstream	0
Instream structures known downstream	6

Top: The Koputara '2' lake level weir facing downstream.
 Bottom: The Koputara '2' lake level weir facing upstream

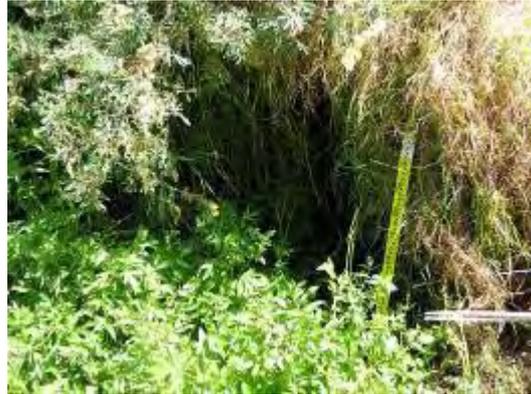
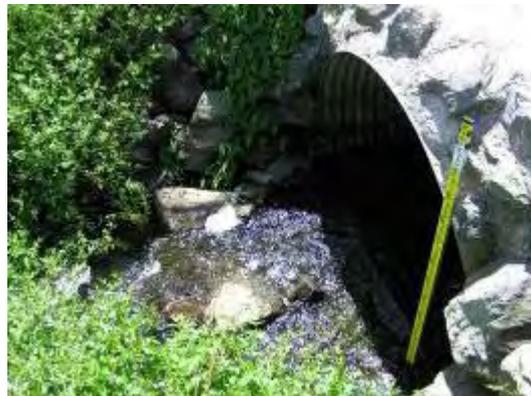
Easting	2700040
Northing	6079520
Date assessed	18/12/08
Structure	Culvert
Type	Pipe (1/2 circle)
Construction	Corrugated iron
Length	~20 m
Diameter	1.08 m
Water depth (inlet)	0.2
Water depth (outlet)	0.05
Inlet cross section	Pooled
Outlet cross section	Flat
If perched (height)	0
If perched (undercut)	0
Likely severity of barrier	Low flows
Instream structures known upstream	6
Instream structures known downstream	0

Top right: The overgrown inlet of the Seabury Ave culvert.

Bottom right: The outlet of the Seabury Ave culvert has boulders placed to prevent scouring and was the only location in the outlet stream where swift flows were encountered. At low flows this could potentially be a barrier to some fish because of the shallow water depth.

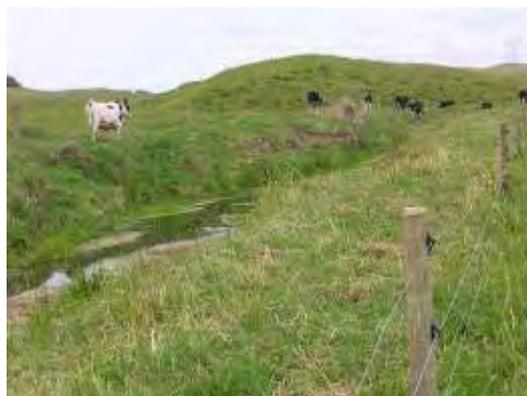
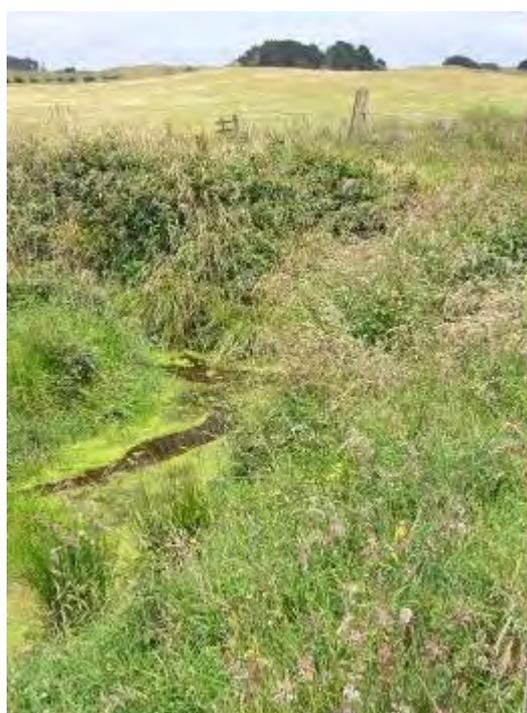
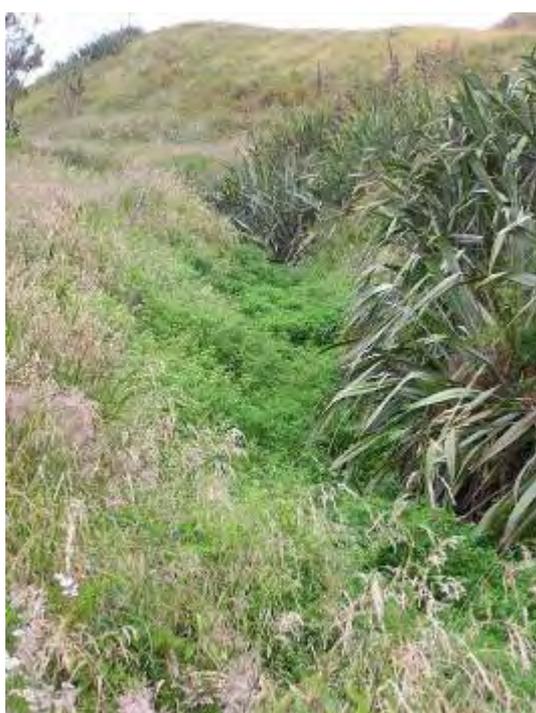
Top: A totally fenced reach near the Lake Papaitonga outlet. Here there is a lot of open water. Unfortunately the cattle are inside the riparian buffer zone.

Bottom: Waiwiri Stream just downstream of the Lake Papaitonga outlet.

Left: Waiwiri Stream near where it enters the outer dunes. Here the channel is choked by wild parsnip.

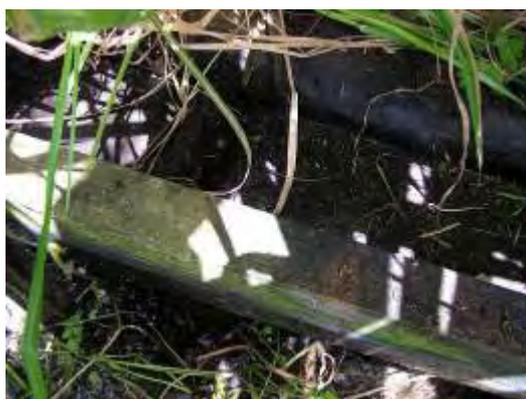
Easting	2697580
Northing	6060025
Date assessed	17/12/08
Structure	Weir
Type	Weir
Construction	? Sandbags visible
Width	? at least 2 m
Water depth (inlet)	?
Water depth (outlet)	?
Inlet cross section	? probably pooled
Outlet cross section	Perched
If perched (height)	? at least 0.5 m
If perched (undercut)	0 m
Likely severity of barrier	Most flows
Instream structures known upstream	0
Instream structures known downstream	3

Top: The overgrown lake level weir where the Waiwiri Stream exits Lake Papaitonga

Bottom: The wooden fish pass which lacked water at the time of assessment.

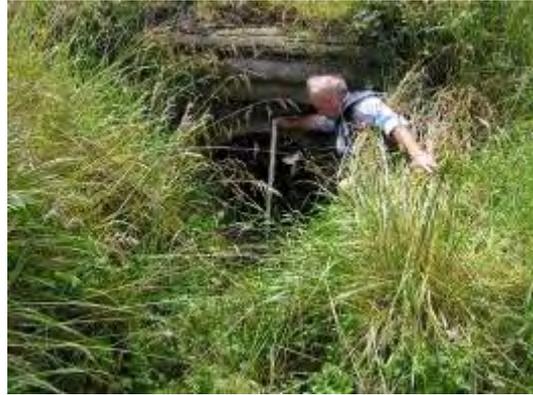
Easting	2697485
Northing	6060055
Date assessed	17/12/08
Structure	Culvert
Type	Pipe
Construction	Concrete
Length	5 m
Diameter	0.9 m
Water depth (inlet)	no access
Water depth (outlet)	0.09 m
Inlet cross section	Flat
Outlet cross section	Flat
If perched (height)	0 m
If perched (undercut)	0 m
Likely severity of barrier	Low flows
Instream structures known upstream	2
Instream structures known downstream	1

Above: Culvert outlet. The minimal amount of water flowing through this culvert at the time of assessment lead to the conclusion that this structure could be a fish barrier at low flows.

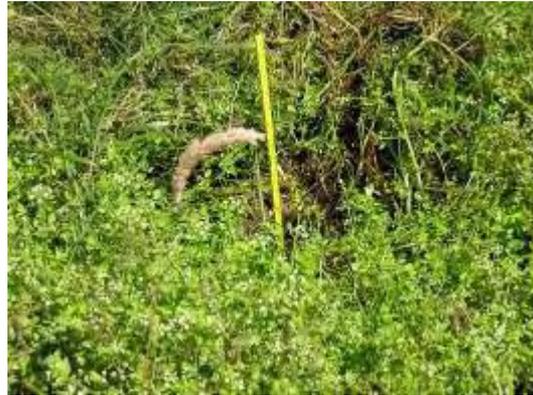
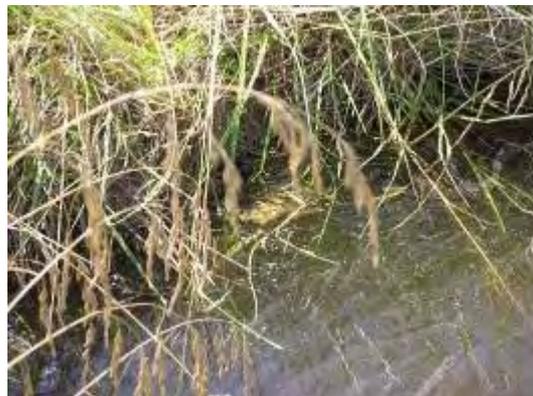
Ohau Dune Lakes	
Location: culvert at outlet into Waikawa Stream	
Easting	2692120
Northing	6056125
Date assessed	13/1/09
Structure	Culvert (capped)
Type	Pipe
Construction	Concrete
Length	~ 7 m
Diameter	0.5 m
Water depth (inlet)	0.33 m
Water depth (outlet)	Underwater
Inlet cross section	Pooled
Outlet cross section	Pooled
If perched (height)	0
If perched (undercut)	0
Likely severity of barrier	Most flows
Instream structures known upstream	2
Instream structures known downstream	0

Top: Inlet overgrown by macrophytes.

Bottom: Capped culvert outlet. The cap is jammed and was underwater at time of visit.

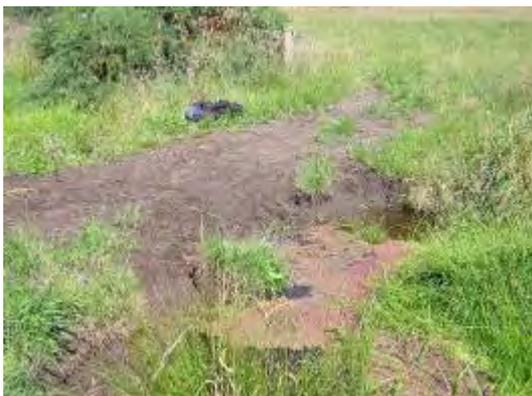
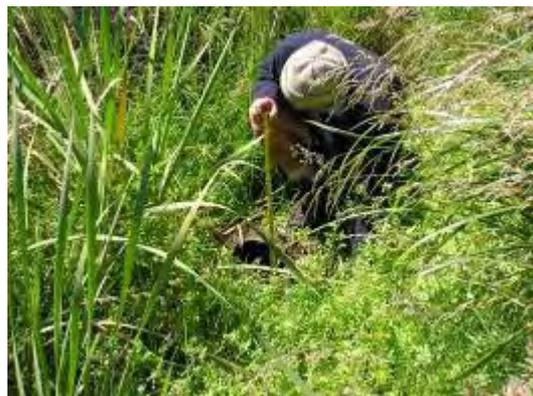
Above left: The sides of this crossing had crumbled obscuring this culvert but there appeared to be good water flow.

Above right: Abundant macrophyte growth obscures this culvert.

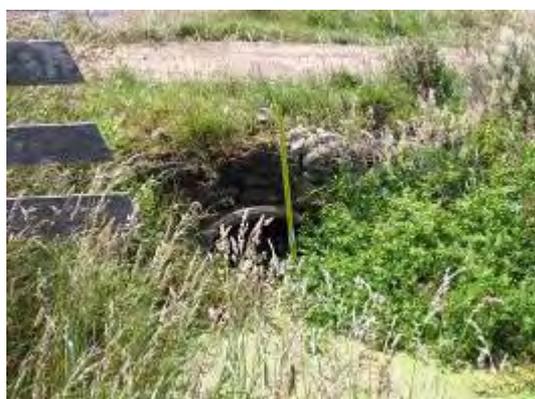
Top: The channel totally obscured by macrophytes.

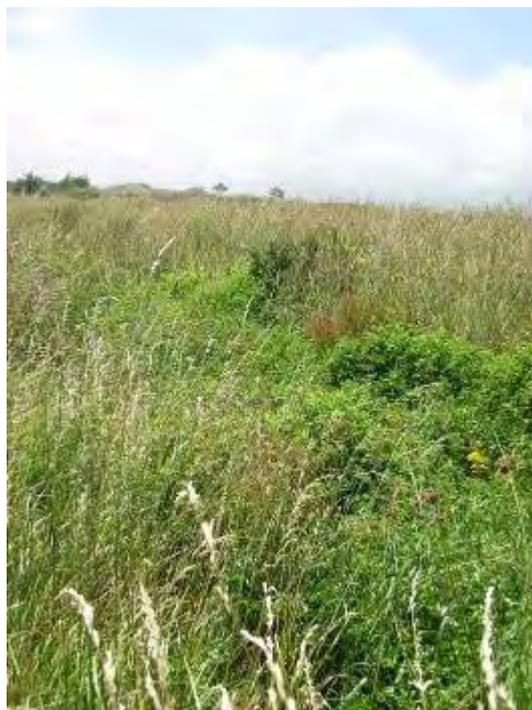
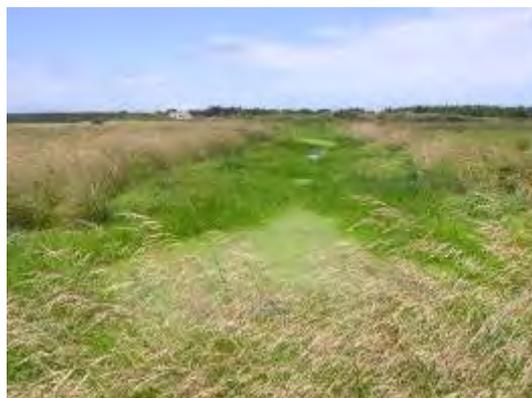
Bottom: The outlet channel widens after the first 100 m.

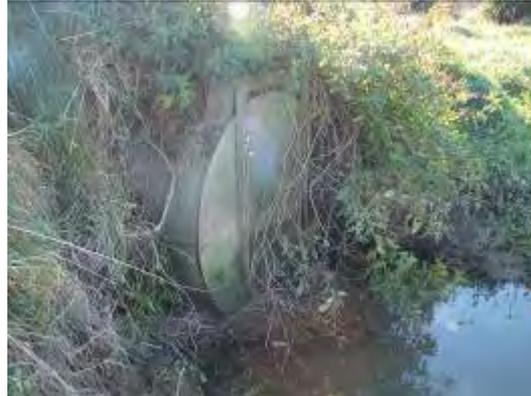
Ohau LoopLocation: Outlet floodgate structure

Top*: The Ohau Loop flood gated culvert was not visited but would likely be a barrier at low flows when water flow is insufficient to keep the gate open wide enough to allow fish passage.

Bottom and left*: The flood gate mechanism is overgrown with vegetation. This may affect its operation. Regular maintenance of the flood gate is required.

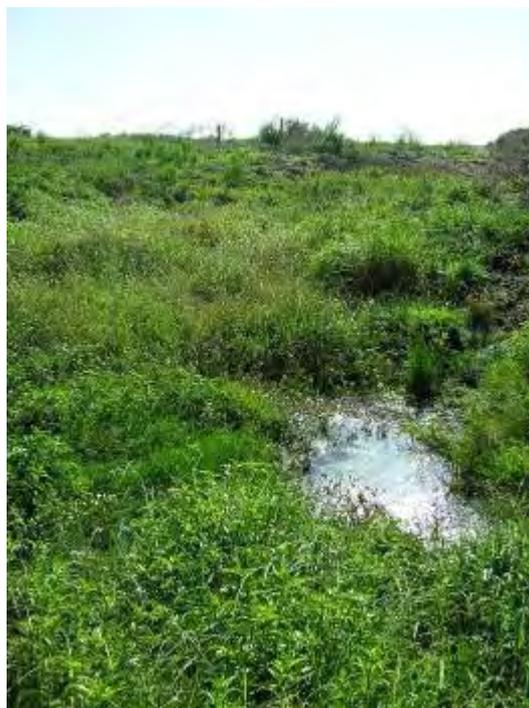
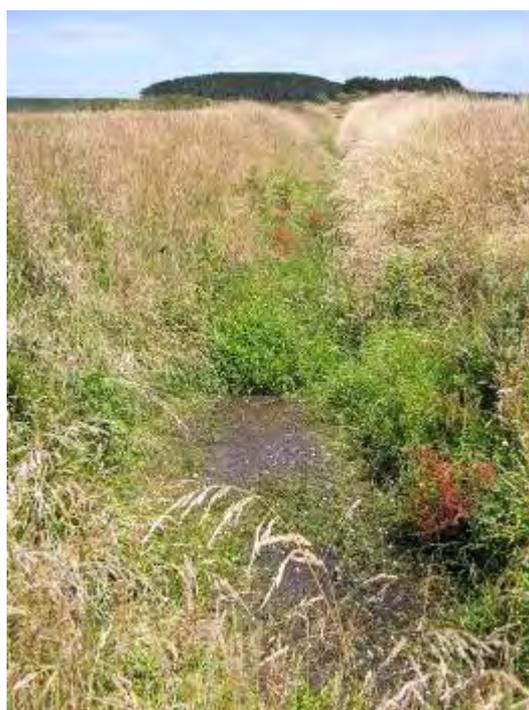
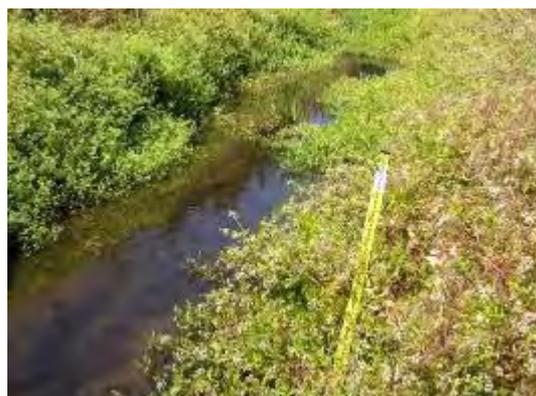
Top: The channel not far downstream of the upper dry reach.
Bottom: The channel upstream of Pukepuke Lagoon.
Left: The channel downstream of Pukepuke Lagoon with significant areas of open water.

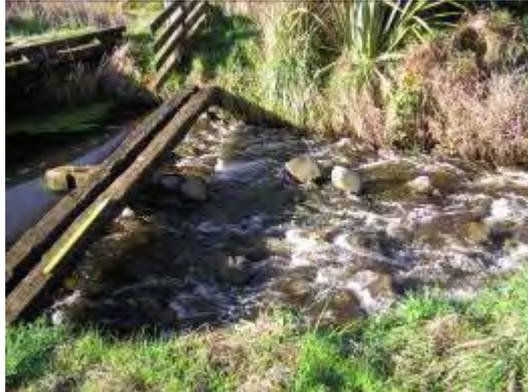
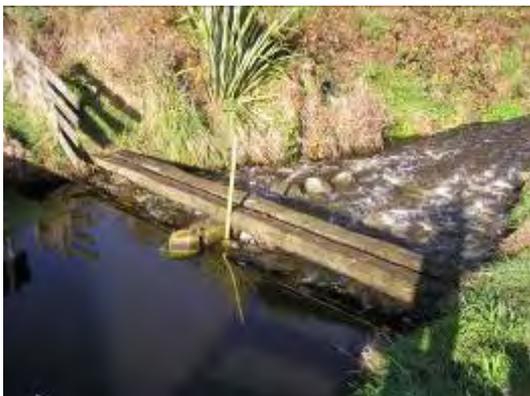
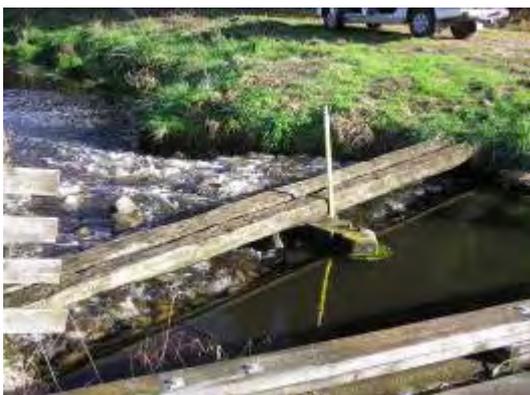
Location: Pukepuke Lagoon lake level weir with new fish ramp

Top, bottom, top left, bottom left:
The Pukepuke lake level weir. A fish ramp has been installed this summer to improve the fish passage potential of the weir. There may still be fish passage issues during lower lake levels when the water level is below the lip of the weir and no water flows down the ramp.

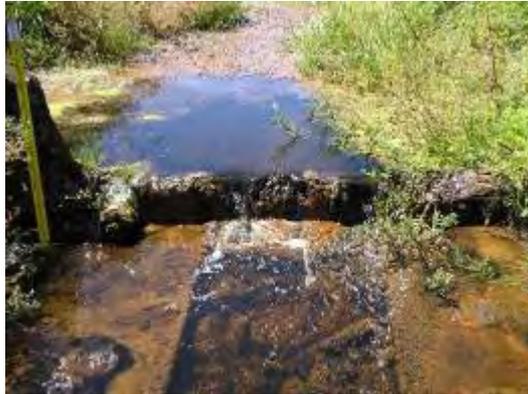
Location: Old, partially destroyed Pukepuke Lagoon lake level weir

Top: This old weir structure has had the middle knocked out of it sometime in the past but still is a perched barrier.

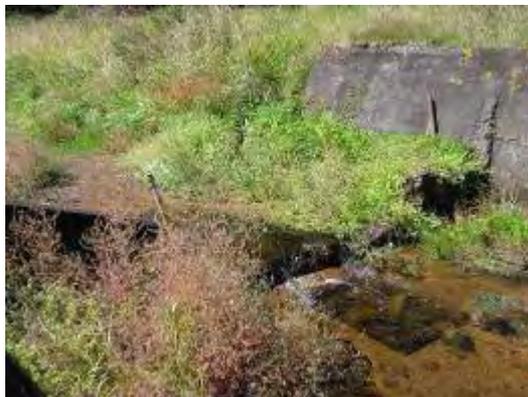
Bottom: From the scale of the concrete surrounds, it is obvious this was once a substantial structure.

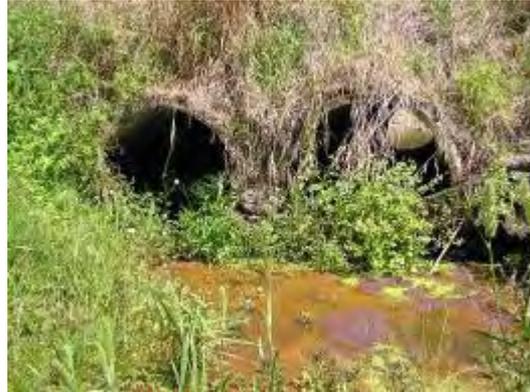
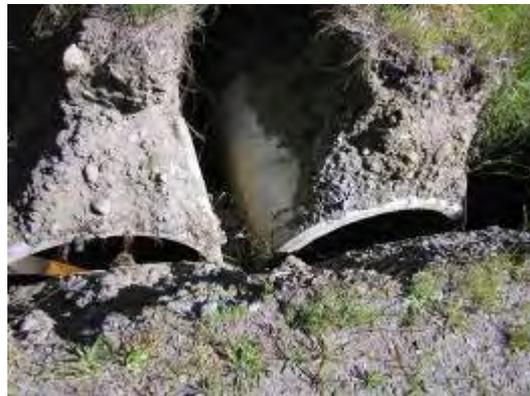
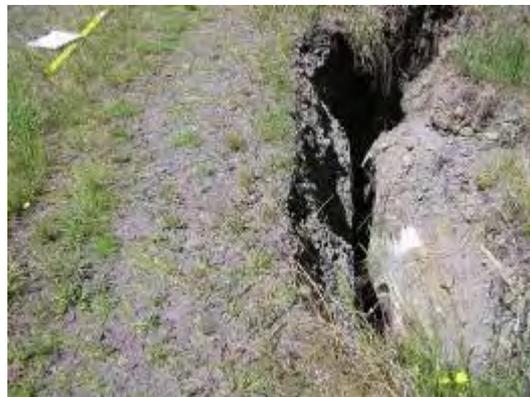
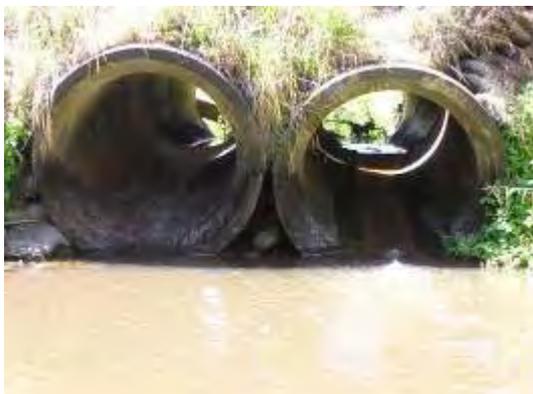
Location: Snapped double culvert just downstream of old weir.

Top: The culvert inlet
 Middle and bottom: The end section of both pipes has been undermined and has snapped.
 Left: The culvert outlet. The left hand pipe is totally separated such that no water flows down the end section. The right hand pipe maintains continuous flow. From the angle of the pipes it is likely they were perched and undercut prior to snapping.

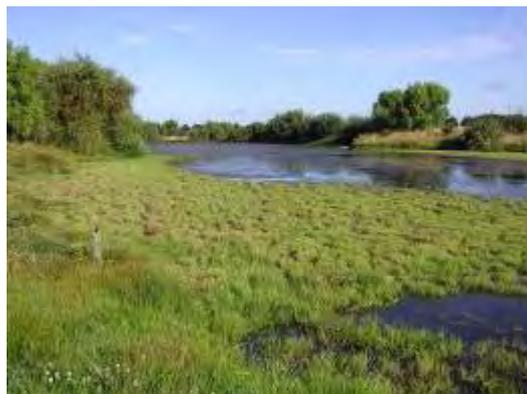
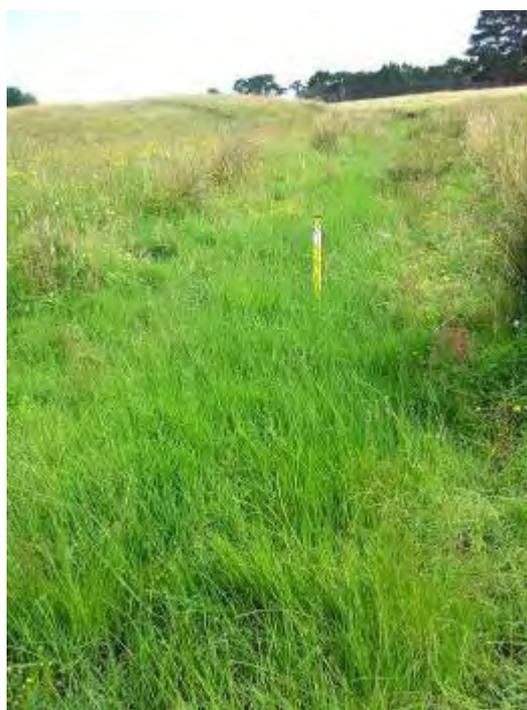
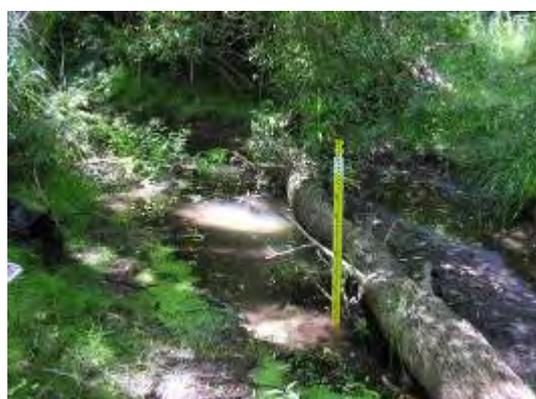
Top: Pukemarama Lagoon
Bottom: The Pukemarama Lagoon outlet stream habitat where the channel is wetted but not flowing.
Left: The Pukemarama Lagoon outlet stream habitat on the Rangitikei River floodplain where there was surface flow at the time of assessment.
