Prioritisation for restoration of out-flow stream habitat of coastal wetlands on the west coast of the Manawatu- Wanganui region

A report prepared for Horizons Regional Council, May 2009

Dr Alex James and Dr Mike Joy

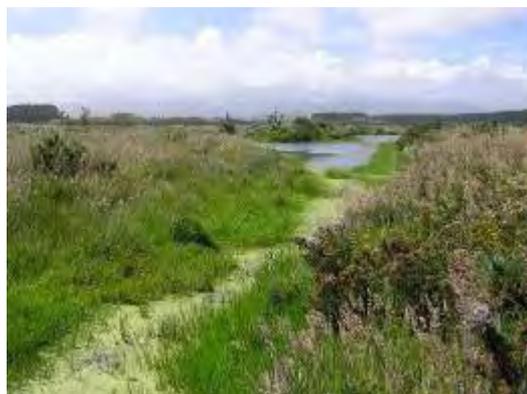
Top: The start of the Te Hakari outlet stream.

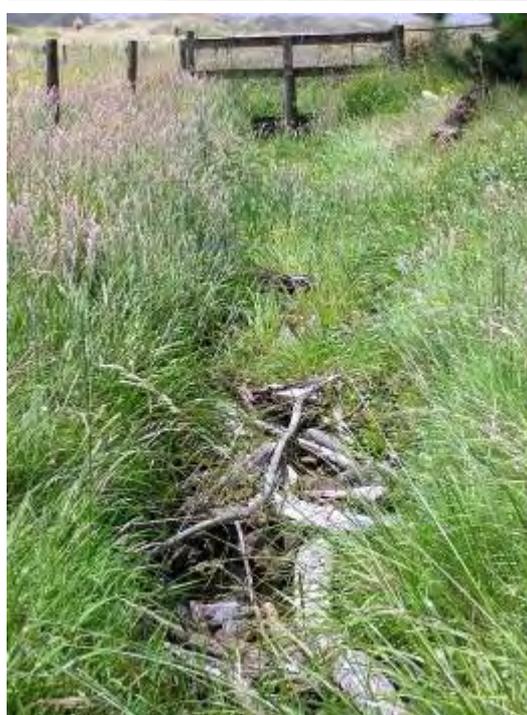
Bottom: The Te Hakari outlet stream channel full of woody debris just downstream of the downstream-most culvert.

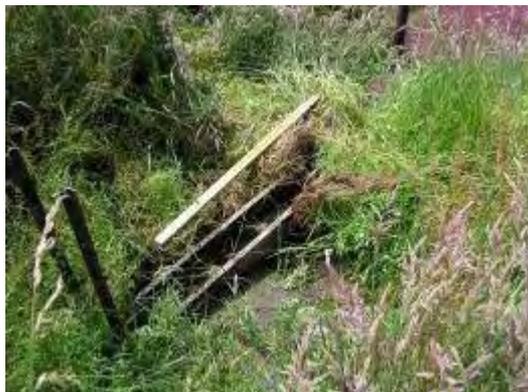
Location: lake level weir

Top: The Te Hakari lake level weir and fish pass was totally overgrown by long grass.

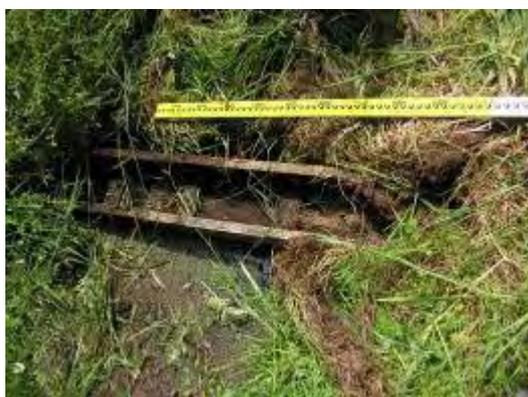
Bottom: The fish pass was lacking water and blocked with grass at the time of assessment.

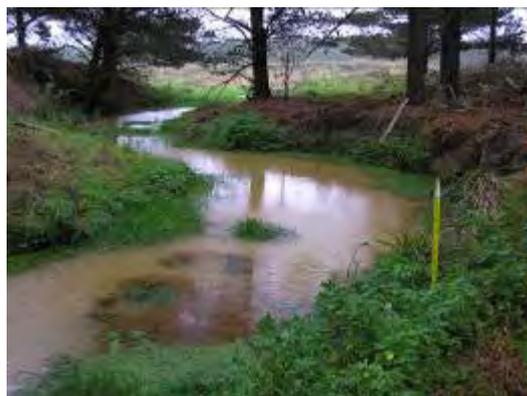
Top: Lake Waipu outlet stream just before exiting stand of mature pine trees.

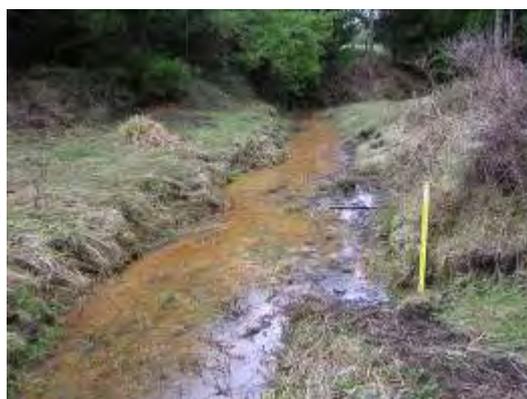
Upper middle: Waipu outlet stream reach with iron floc.

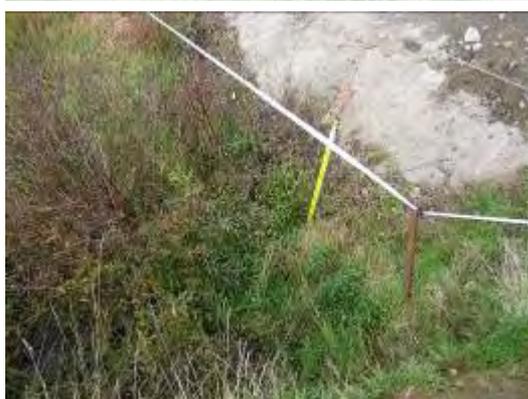
Bottom: The main vehicle crossing culvert perched inlet concealed by vegetation.

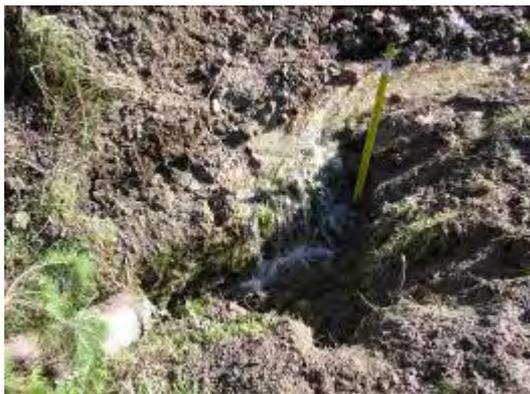
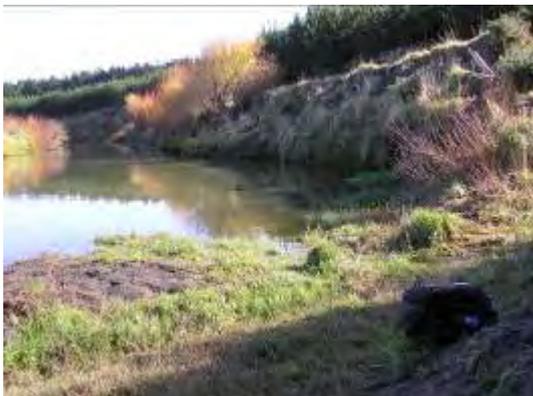
Above and bottom: Recent earthworks on a vehicle crossing just upstream of the Waipu outlet confluence with the Turakina River. The soil has been removed exposing the mudstone bedrock and the stream has created a fall over this.

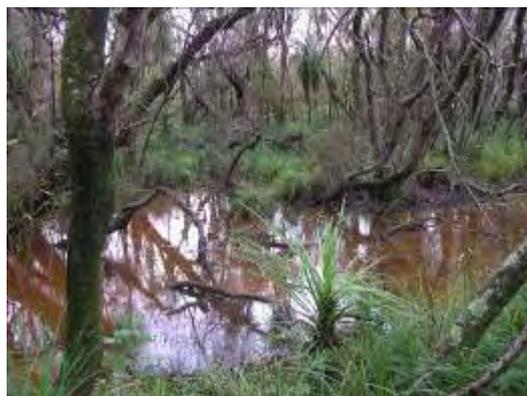
Top: The wetland between Lake Pauri and Lake Wiritoa. The only distinct channel between the lakes occurs at a vehicle crossing which has a culvert.

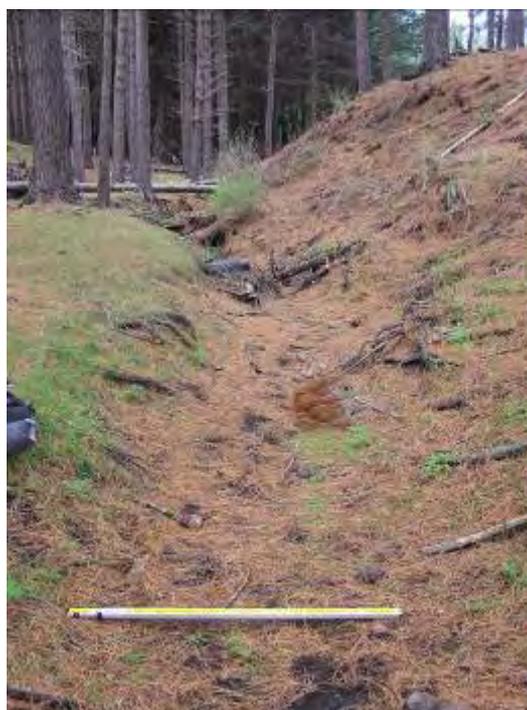
Bottom: The dry Lake Wiritoa outlet channel in the first stand of pine trees downstream of the lake. Surface water flow here appears rare.

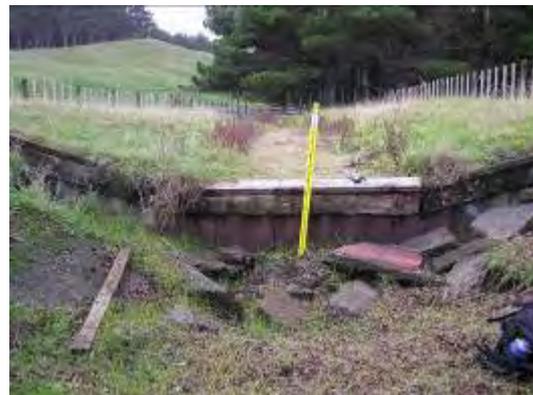
Above: Artificial weir a few hundred metres upstream of where the channel becomes wetted. The purpose of this weir was unclear.

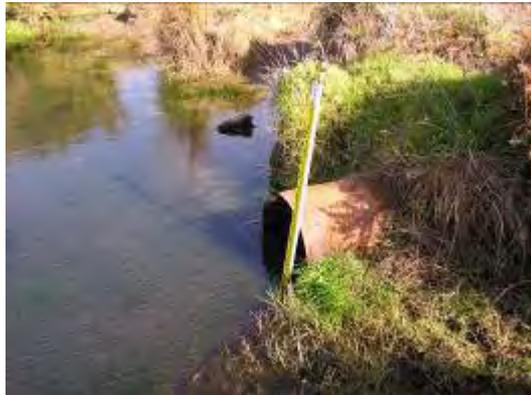
Top: The dam culvert inlet.
