# Lake Ōnoke Freshwater Improvement Fund Project- Restoration Plan

Prepared for the Department of Conservation

March 2018

Graeme, M. & Dahm, J., 2018: Lake Ōnoke Freshwater Improvement Fund Project - Restoration Plan. Focus Report No. 18/128. Prepared for Wairarapa District Office, Department of Conservation by the Focus Resource Management Group.

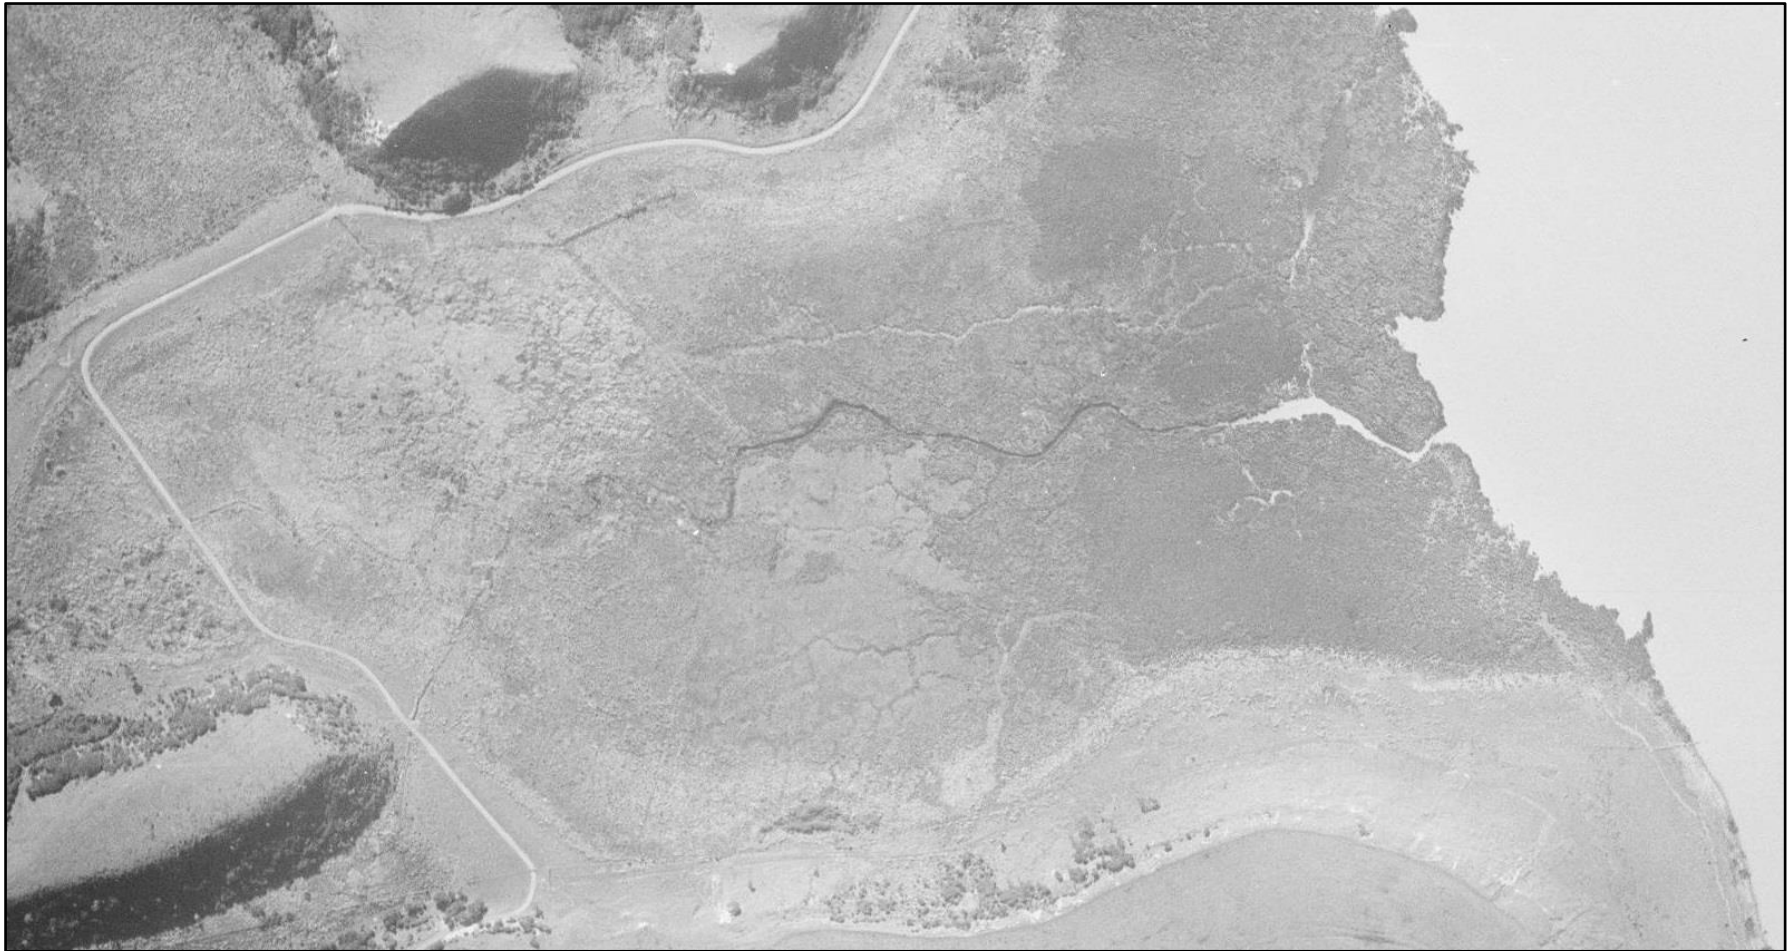
**Figure 5: Aerial view of original embayment from 17 February 1941 prior to the installation of stopbanks. (Photo reference 172/22 - sourced from Retrolens).**

Early aerial photographs taken prior to extensive human modification indicate that the more seaward areas of the embayment were vegetated with dense saltmarsh grading to saltmarsh ribbonwood and then to some bare areas and lighter vegetation (possibly freshwater wetlands) further upstream (Figure 5). Close examination of early aerial photos indicates a complex network of minor channels extended to central and central-upper areas of the embayment; typical of tidally influenced areas (Figure 5). Many of these former minor channels are also still evident in the field. Long-standing locals indicate that there were large areas of flax/harakeke (*Phormium tenax*) in upstream areas and patches of kānuka remnants on higher areas (Joe Houghton pers. comm. 2017).

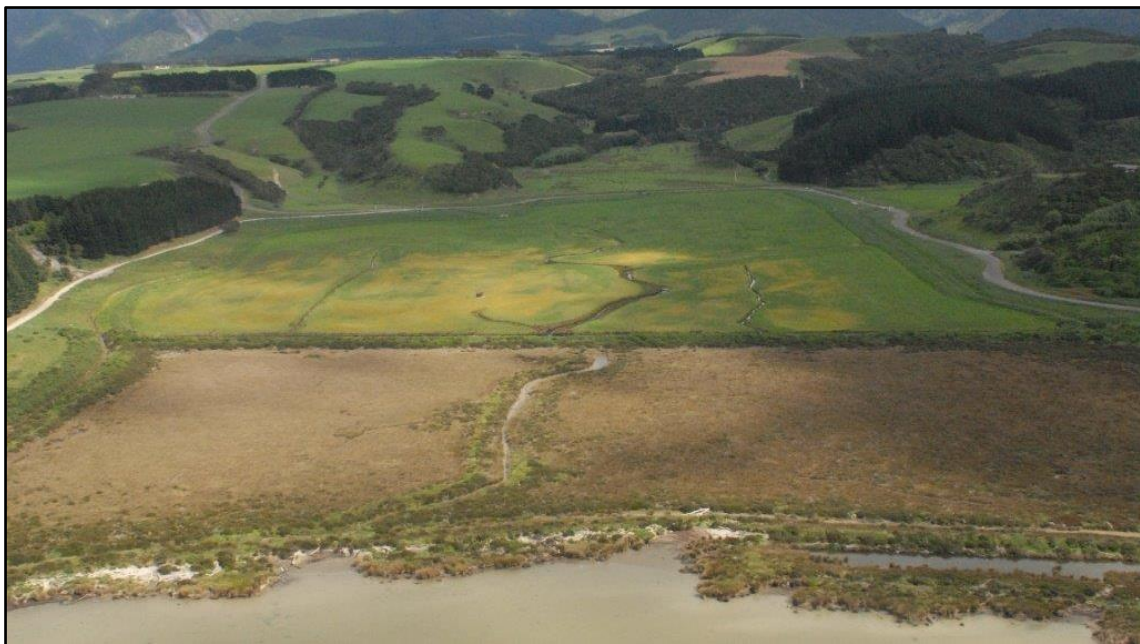
Figure 8: Recent oblique aerial view of the project area looking west showing the seaward and inner stopbanks 2/11/2017 (Photo: Tony Silbery, DOC).

Figure 8 shows a recent aerial view of the restoration site showing the older seaward stopbank and newer inland stopbank.

The outer stopbank across the seaward edge of the embayment allows inflows from the lake which maintains the saltmarsh (see Figure 8). The inner stopbank has flap-gated culverts and primarily allows only discharges. Nonetheless, observations and photographs provided by locals (J. Houghton, D & D MacKenzie pers. comm. 9&13/11/2017) indicate that the restoration area is subject to flooding (Figure 9). Field inspections indicate that the area

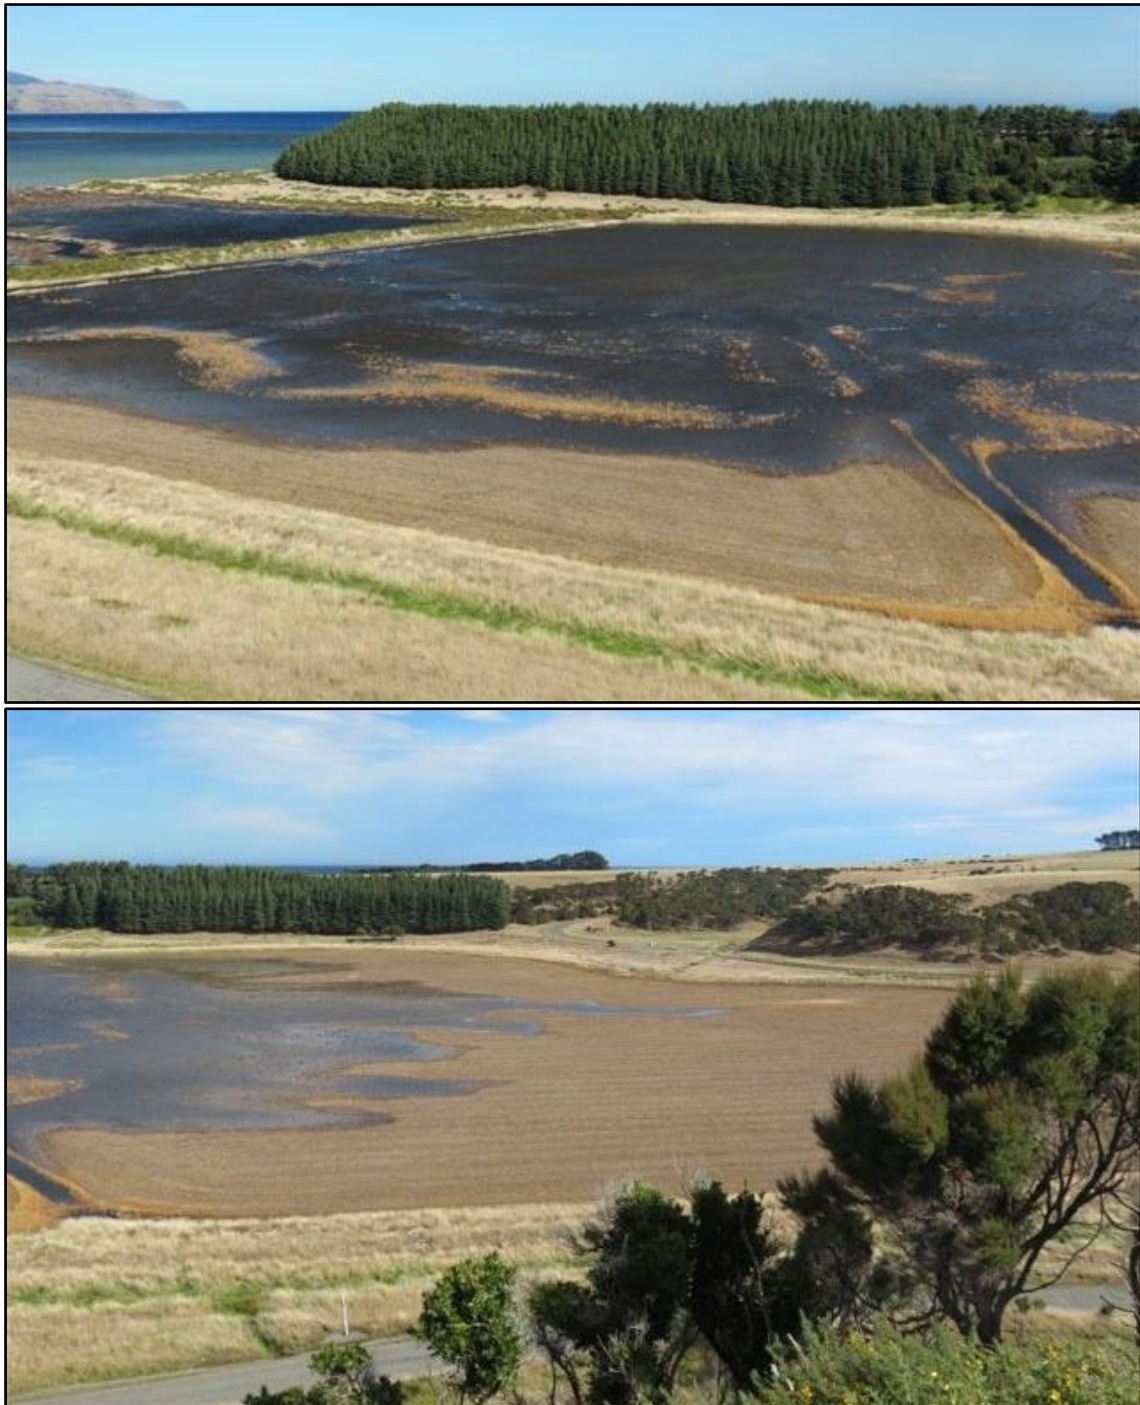
Figure 9: Views of the project area showing a flood event in April 2016. (Photos: Dougal MacKenzie)

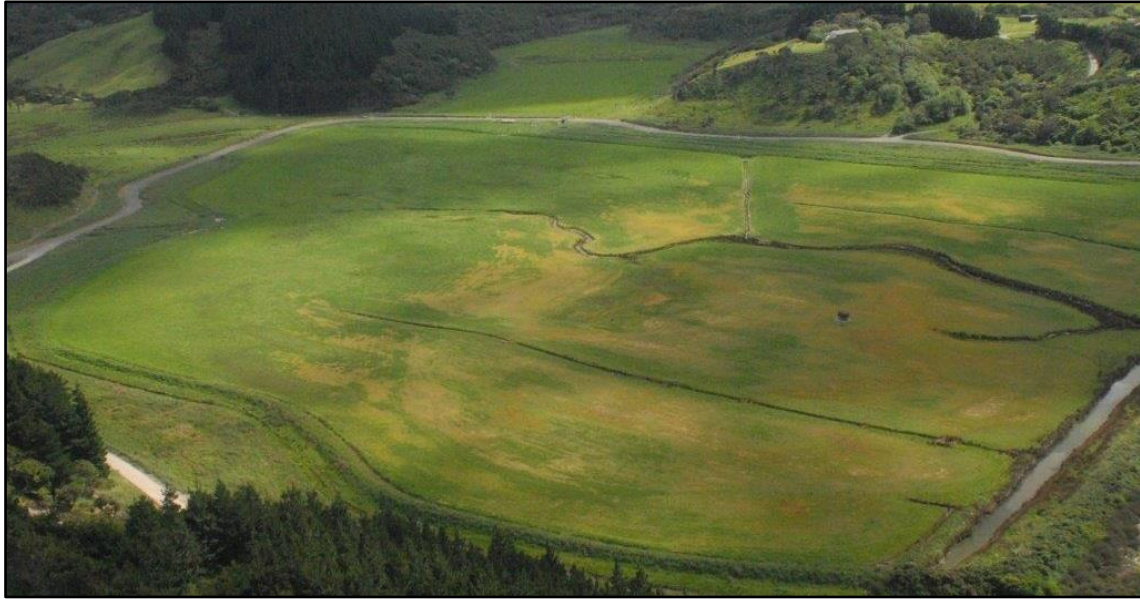
**Figure 10: Aerial view of project area showing the original central water course and constructed drains. The area of yellow bachelor's button corresponds to the area most regularly affected by flooding and indicates the flood waters are brackish. (Photo: Tony Silbery 2/11/2017)**

commonly flooded is dominated by the native bachelor's button (*Cotula coronopifolia*) (Figure 10) which is a salt tolerant wetland species; suggesting the flooding is probably brackish water from the lake rather than runoff from local areas impounded during high lake levels. Accordingly, the various works do not entirely protect the area from flooding. These flooding events occur when the lake mouth has closed (ranging from 5 to 15 times a year) for an extended period and there is a build-up of water from the upper catchment (Vorster, 2018; D. MacKenzie pers. comm.).

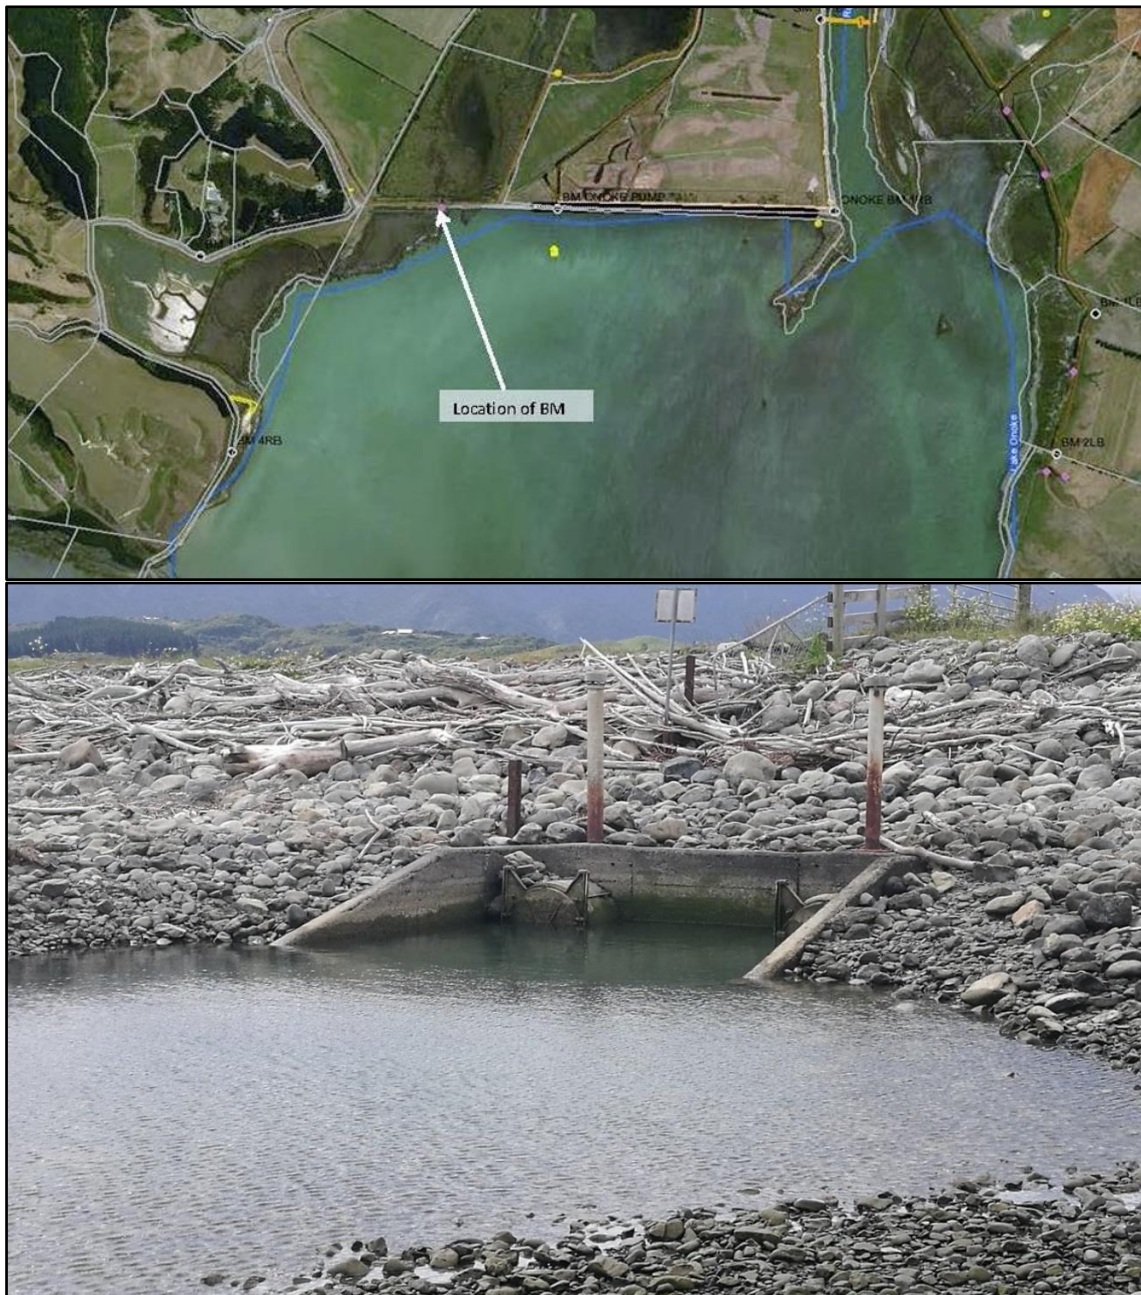
**Figure 12: Location of former Wairarapa Catchment Board benchmark (BM) levelled during the field investigations. The elevation of this former WCB benchmark is not presently known but it can be readily levelled using other nearby benchmarks of known elevation. This would enable more accurate correction of the surveyed bed levels to MSL if required.**

A local Wairarapa Catchment Board (WCB) benchmark (Figure 12) was also surveyed to allow more accurate correction of bed levels to MSL at a later date if required. Discussion with Greater Wellington Regional Council (GWRC) flood engineer Mr Ranjan Cyril indicates that the elevation of the former WCB benchmark is not presently known by GWRC. However, there are other former WCB benchmarks nearby with known elevations which can be readily used to level the benchmark at a future date if required.

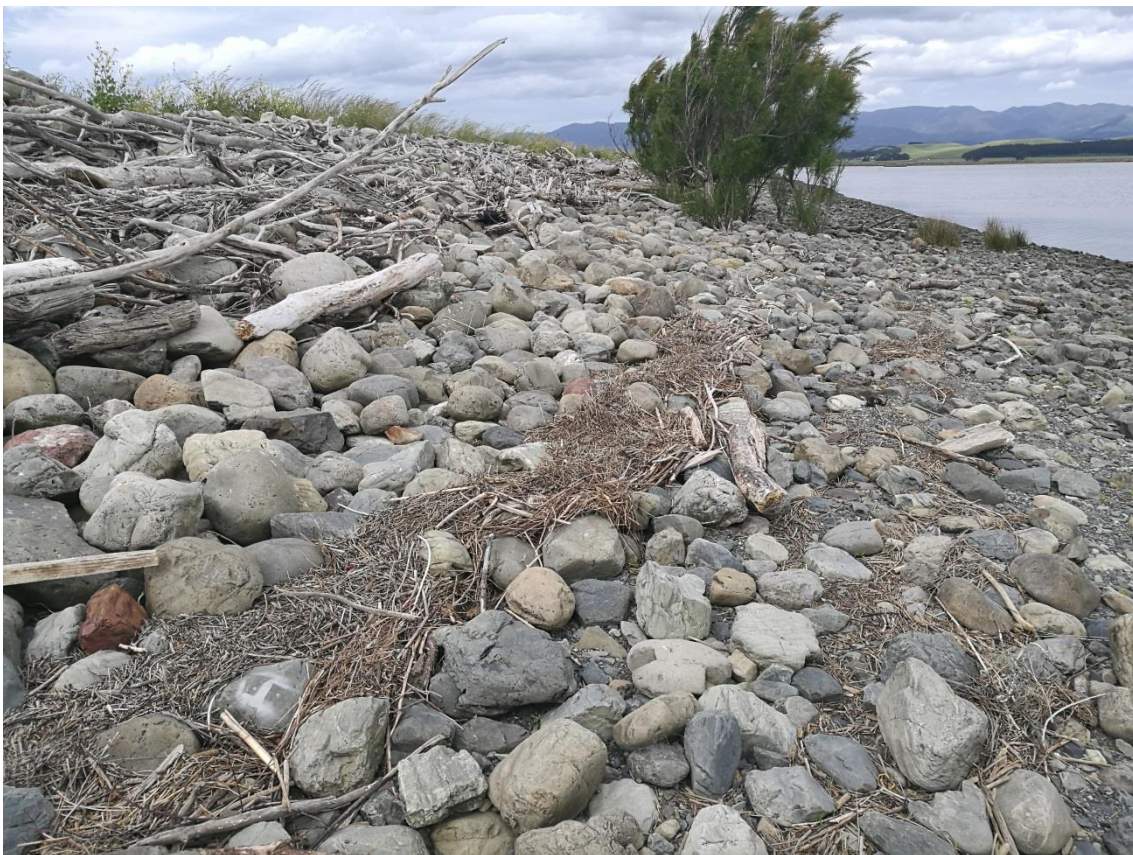
**Figure 18: Wooden debris deposited on the exposed margin of the causeway road (Paul's Bank).**

- Exposed lake margin areas along the causeway to the river entrance (Paul's Bank) - being locations with no or only narrow saltmarsh wetlands to seaward (see Figure 18).

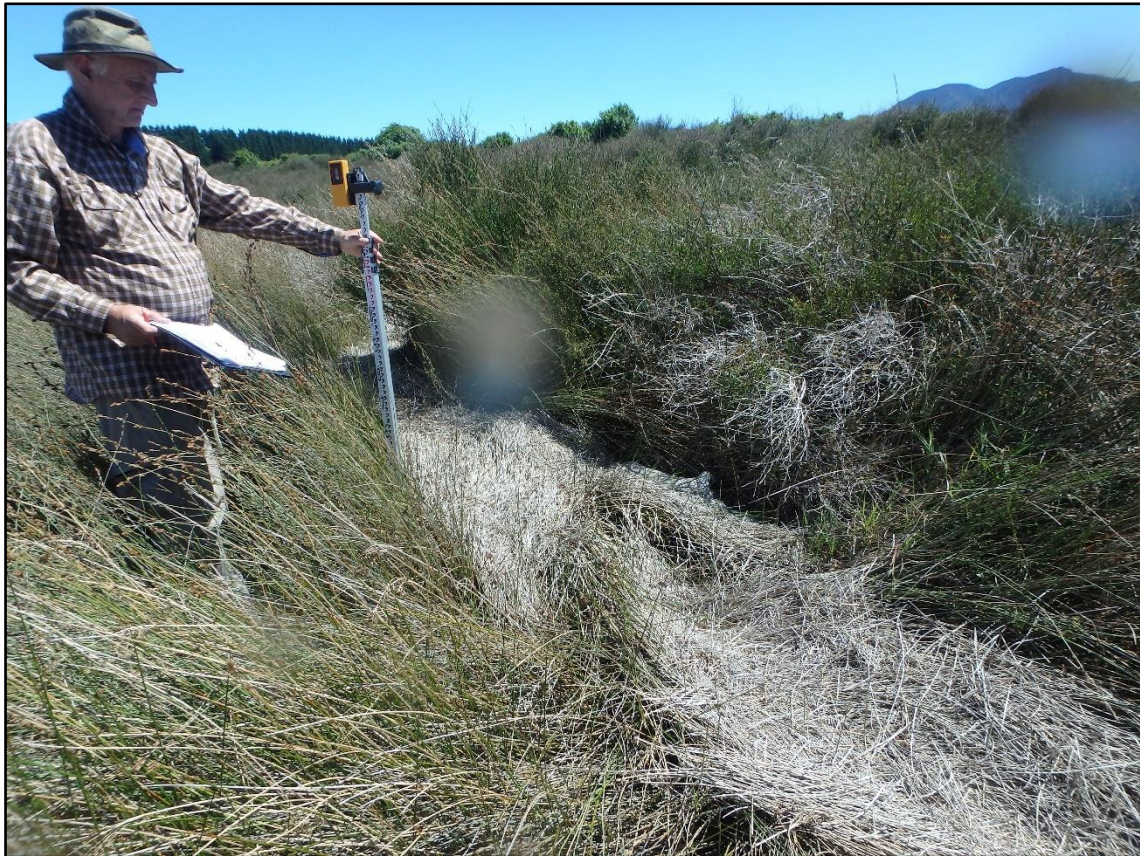
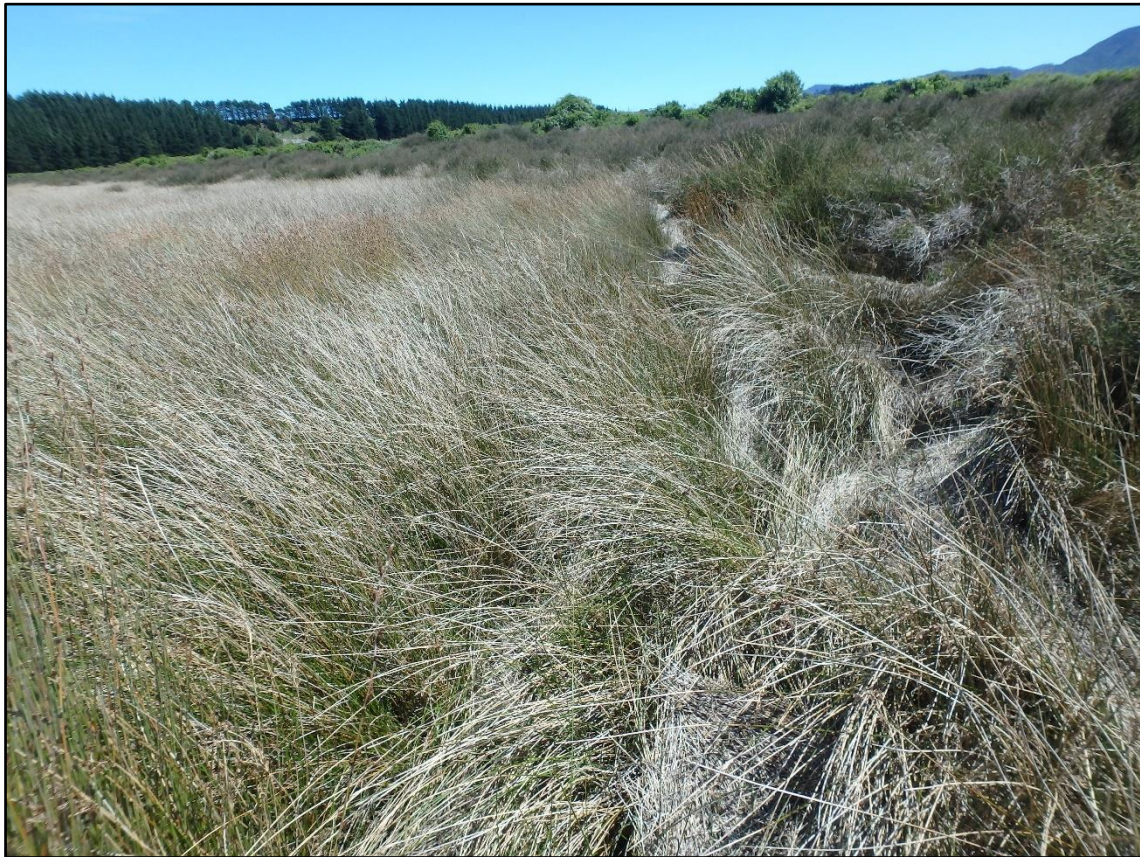
**Figure 19: Fine debris deposited in the sheltered saltmarsh immediately seaward of the restoration area. Note the clear boundary between the saltmarsh and taller saltmarsh ribbonwood communities (9/11/2017)**

No similar wood debris levels were noted in the sheltered saltmarsh immediately seaward of the restoration area. However, a fine debris level from a flood event was noted and levelled. (see Figure 19). The results are summarised in Figure 20.

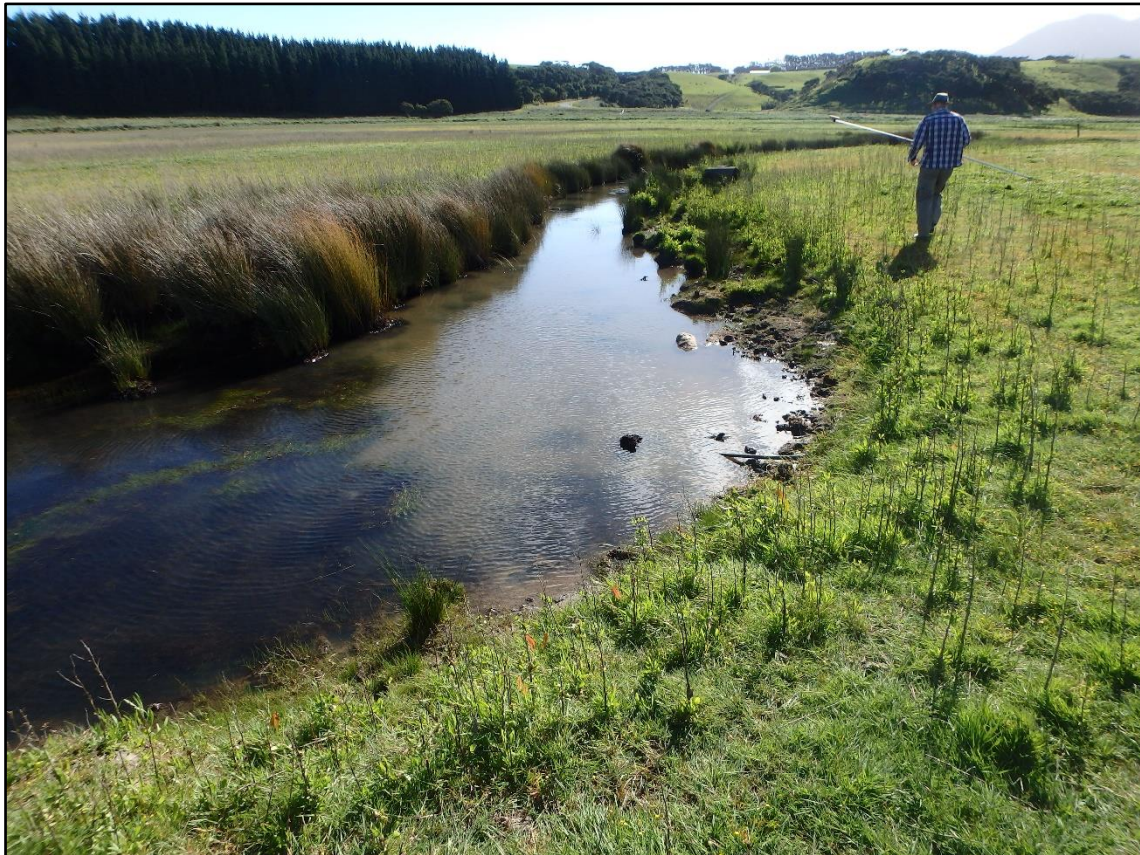
**Figure 23: A fringe of sea rush and oioi lining the original natural channel in the restoration site with *Ruppia megacarpa* growing in the lower channel bed. Note the degraded channel edge where stock have easy access. (8/11/2017)**

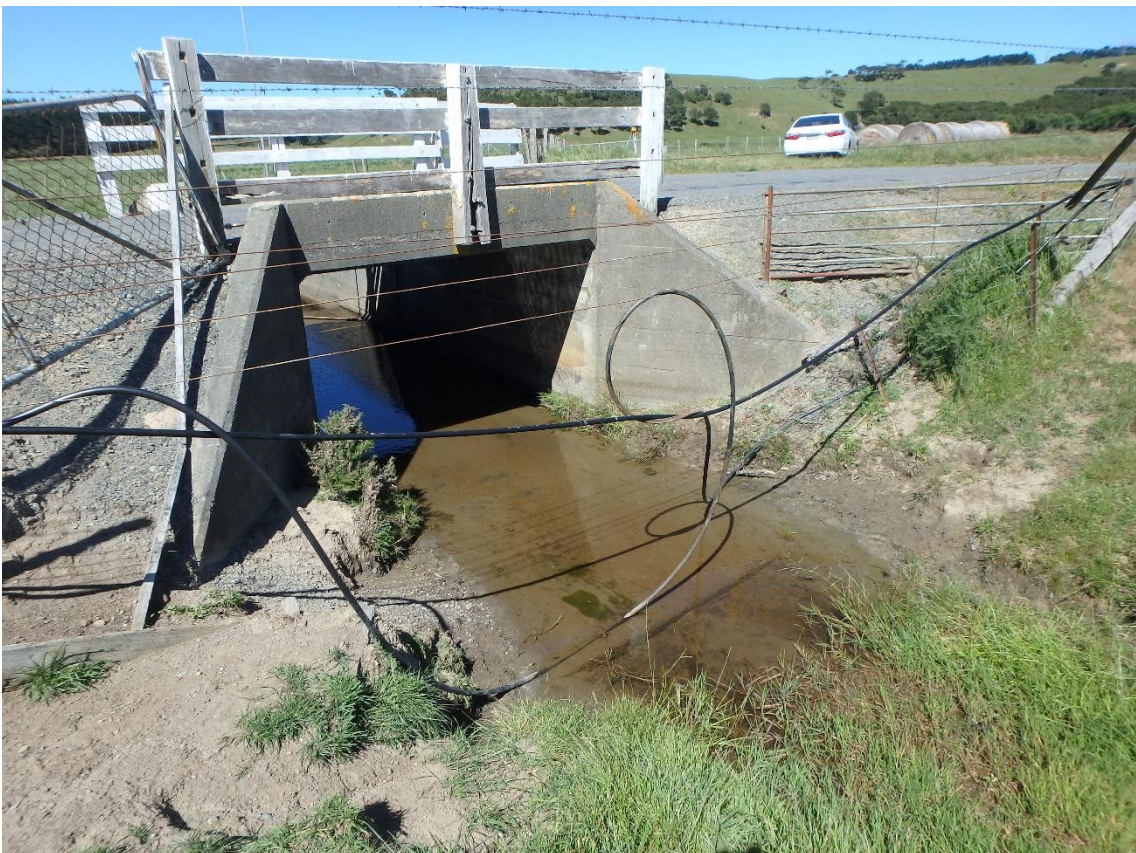
**Figure 27: The box culvert under Western Lake Road. Note this culvert does not provide ideal fish passage but īnanga were seen upstream. 8/11/2017**

The original route of the natural stream channel from the road bridge (Figure 27) to the centre of the embayment is unclear on the available early (i.e. pre-diversion) aerial photography. On the basis of our brief field inspection we believe it will be possible simply to use existing drains as the low flow channel as shown in Figure 25. The adequacy of these channels (i.e. do they need to be widened?) will need to be examined further during detailed design. Flood flows are likely to disperse over the floodplains and this is desirable.

The channel downstream of the stopbank is offset from the channel upstream and so the connecting channel cut through the stopbank will form a bend in the stream. It is possible there may be some erosion on the outside of this bend although this seems unlikely as there have not been issues with erosion on tight bends in the existing diversion channel. Nonetheless, the works should ensure a good channel waterway area to avoid locally accelerated velocities. The design of this channel through the stopbank will require further work during detailed design but we recommend a minimum invert (channel bed) width of 6m for the low flow channel; with the stopbanks either side battered no steeper than 1V:1H and ideally more gently (e.g. 1V:2H) where practicable. This suggests the cycleway bridge will probably need to be at least 15-20m wide. The existing upstream road bridge (actually a box

culvert, see Figure 27) has a lesser waterway and according to advice from local landowners acts as something of a choke during floods; which will limit the flood flows passing through the new waterway. However, ensuring a wide waterway will help minimise the risk of erosion and help future proof the restoration (e.g. if the upstream bridge is ever replaced with a wider structure).

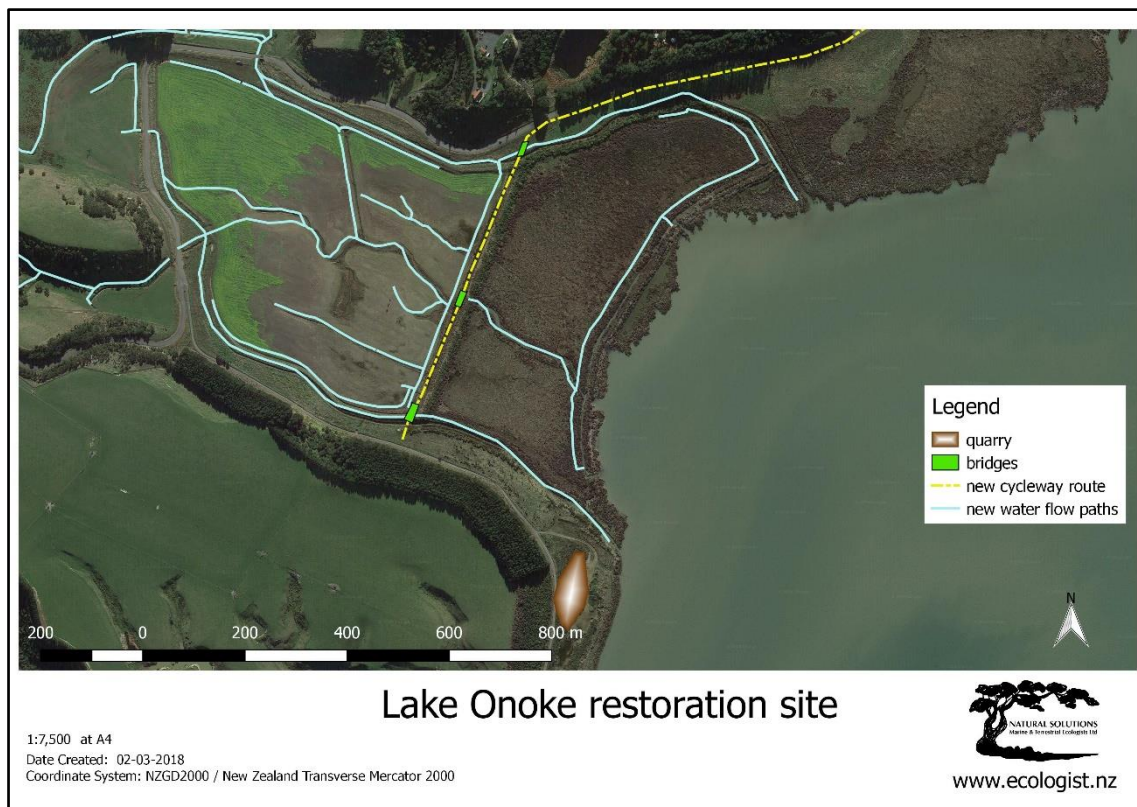
Figure 29: Proposed cycleway route across the wetland restoration site and gravel quarry.

Figure 29 shows the proposed new cycleway route and associated bridging that will be necessary.
