**QUEEN ELIZABETH PARK
COASTAL DUNES MANAGEMENT
DISCUSSION DOCUMENT**

Prepared for
Wellington Regional Council

Boffa Miskell Ltd

June 2001

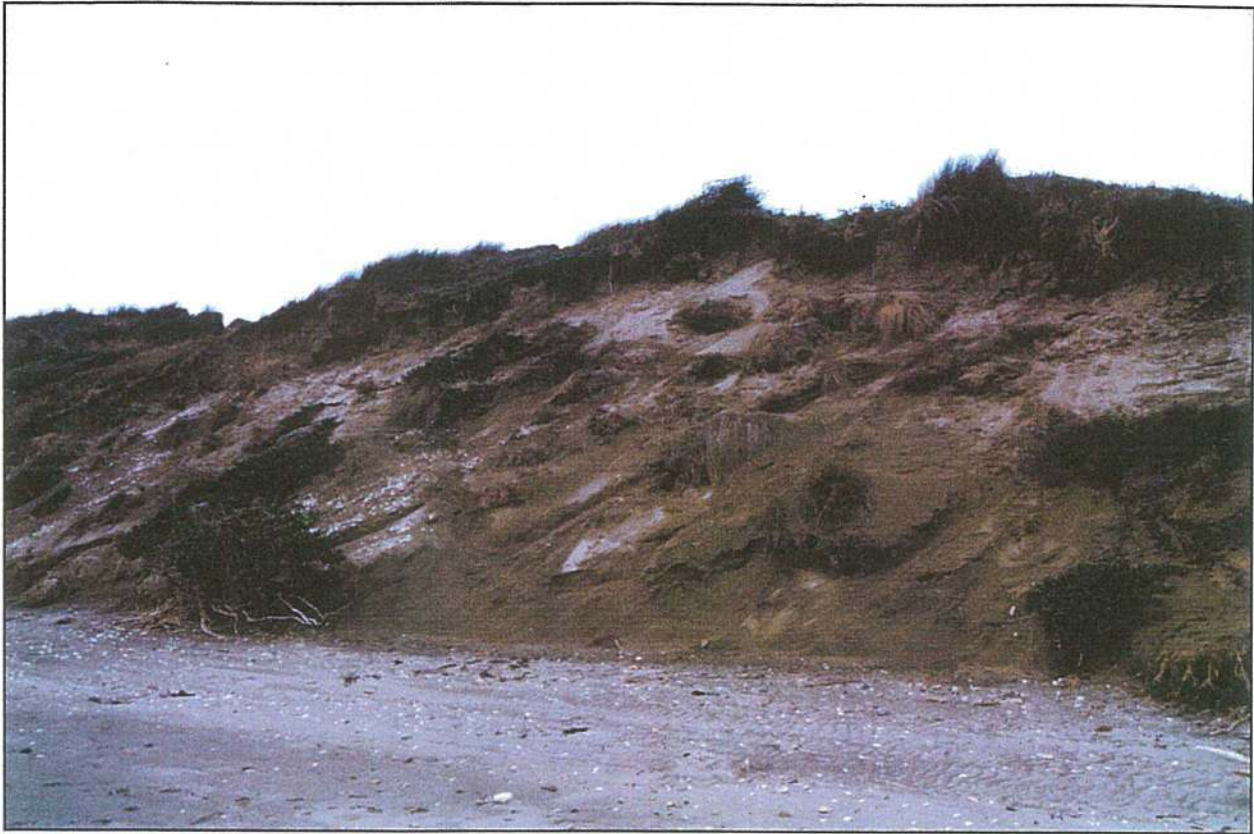
PHOTOGRAPH 3: Active foredune, south of Whareroa Stream. Note exposed midden and "rafted" vegetation on and at the bottom of the dune.

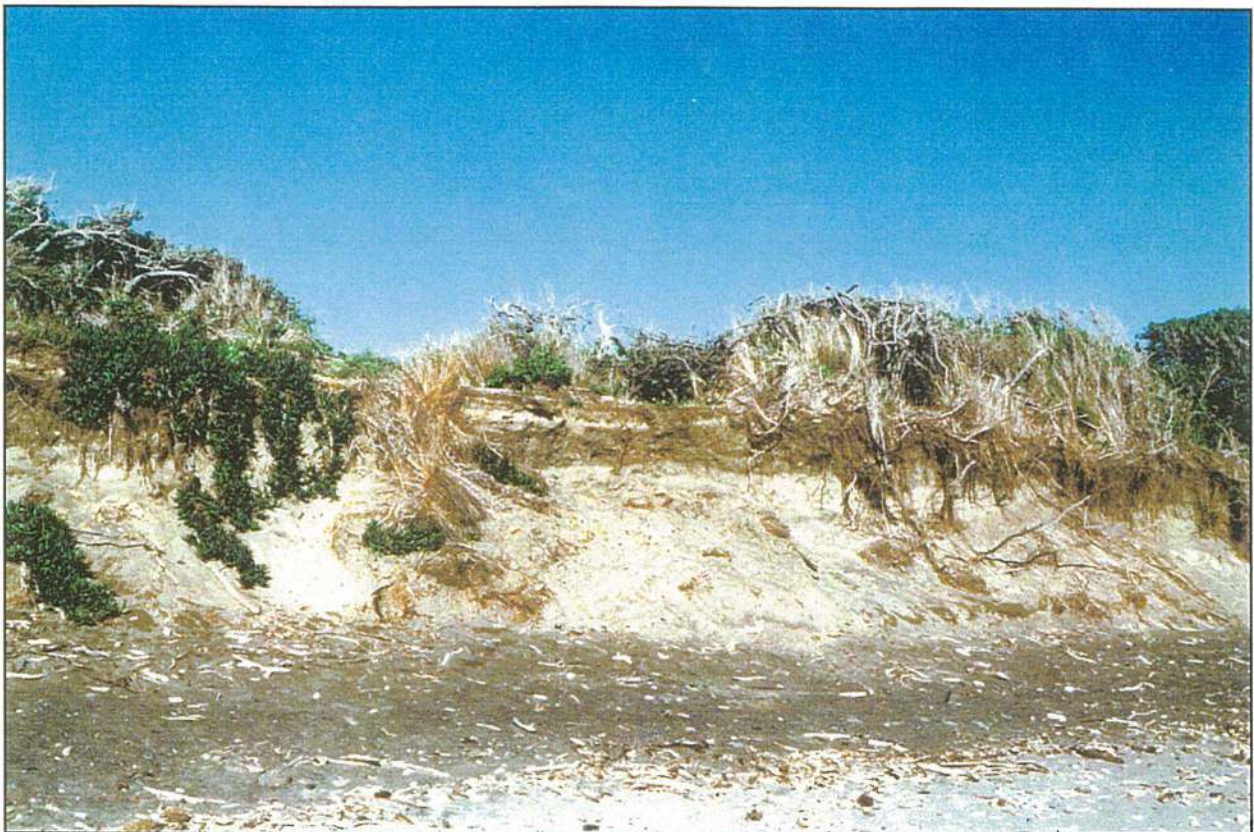
PHOTOGRAPH 4: Eroding inter-dune terrace, between Raumati and Whareroa Stream. Erosion at these points is very difficult to stop and can move the dune edge inland rapidly.

There are only very small areas of “unconsolidated dunes” or “unstable foredune complex”, the two other main physiographic units recognised in the southwestern North Island sand country. These are mainly at the northern end of the Park (Photos 2 and 8). However, between the high dunes there are relatively large inter-dune hollows, which are lower and in height, have more gentle concave topography and therefore collect moisture and more well-developed and slightly peaty soils (Photos 7 and 8). Most of the woody vegetation remaining in the coastal dune area is found in these inter-dune hollows. The presence of the hollows coastal dune area also means that not all the coastal edge is high above ground level; some of the fringe has appearance of a low (<1m) and flat narrow coastal terrace (Photos 4 and 10).

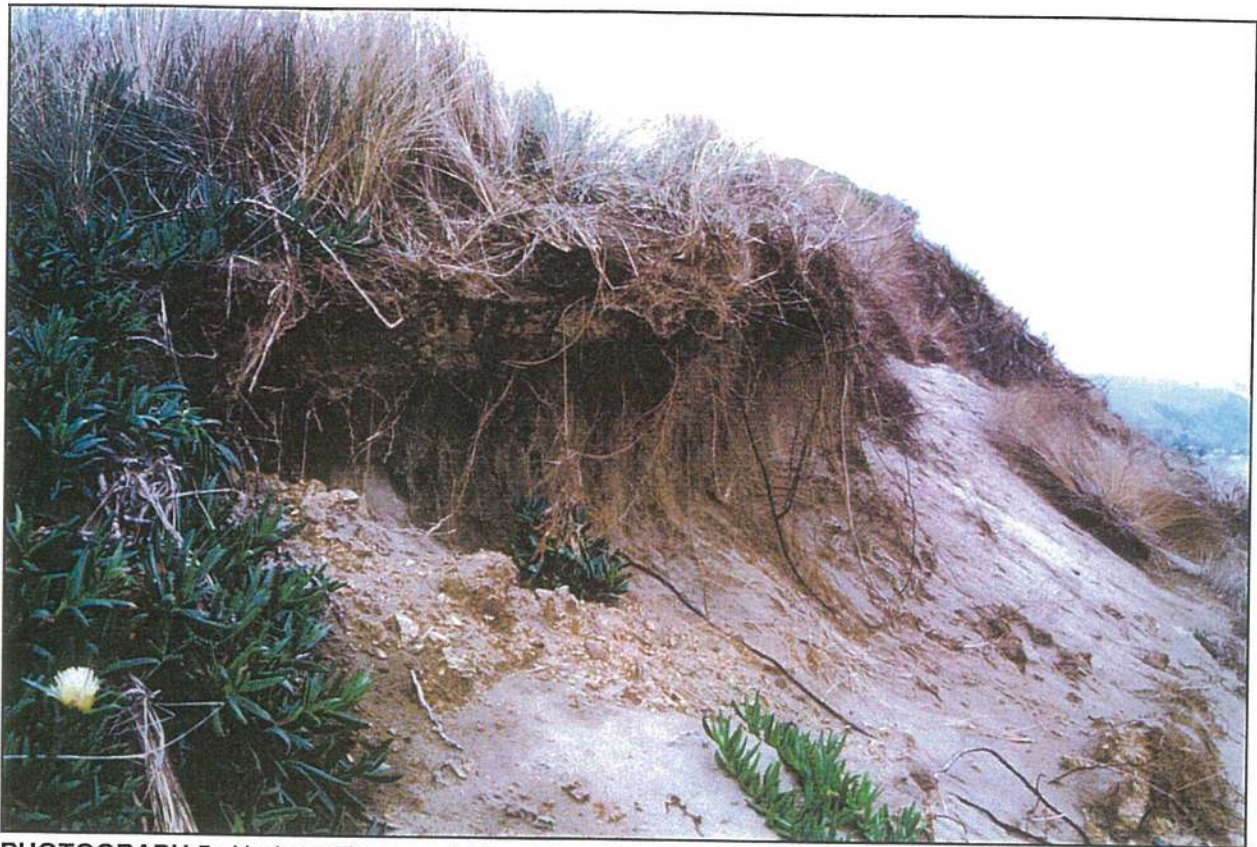
PHOTOGRAPH 5: Undercutting vegetation at top of dune, south of Whareroa Stream.

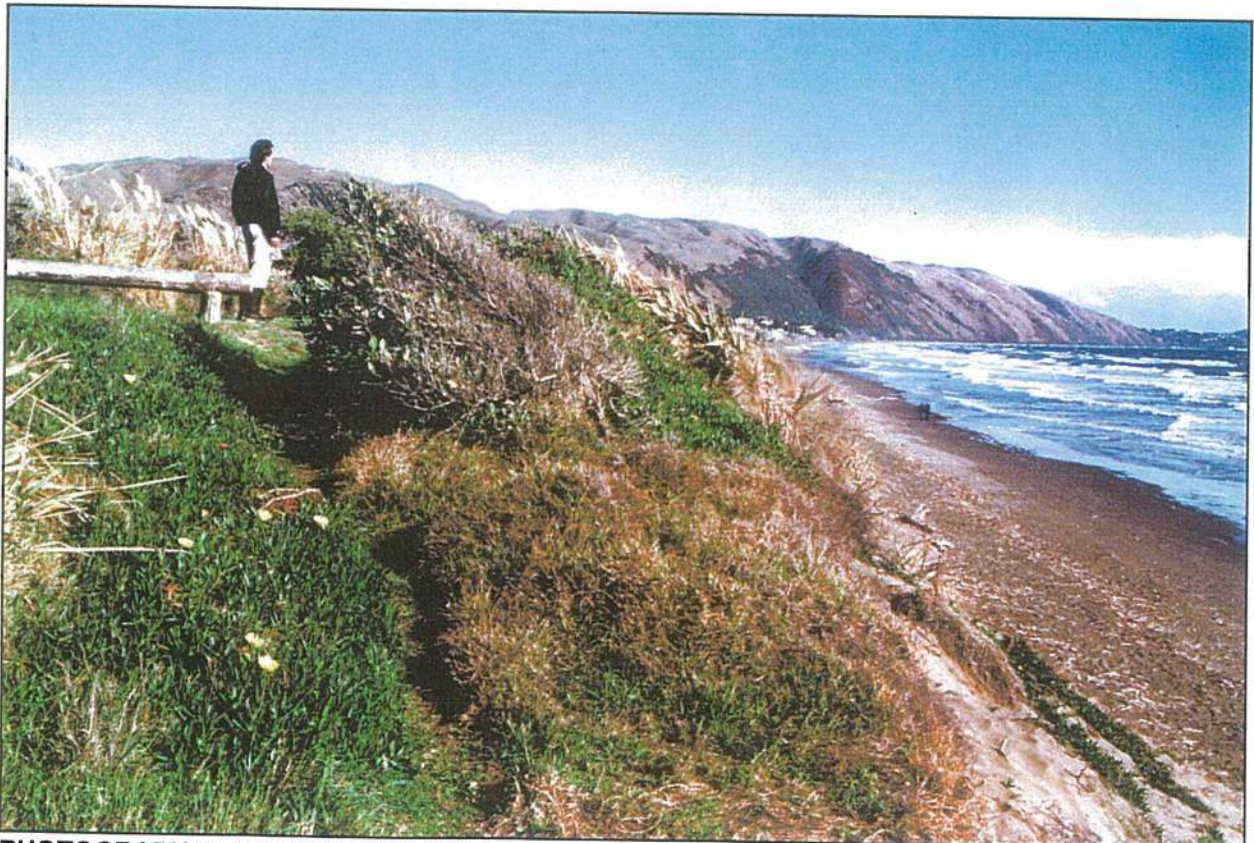
PHOTOGRAPH 6: Semiactive dune edge (right), within a few metres of edge of parking area (left), Wainui area. Even with slower rates of erosion at this end of the park, such areas can be expected to be at risk

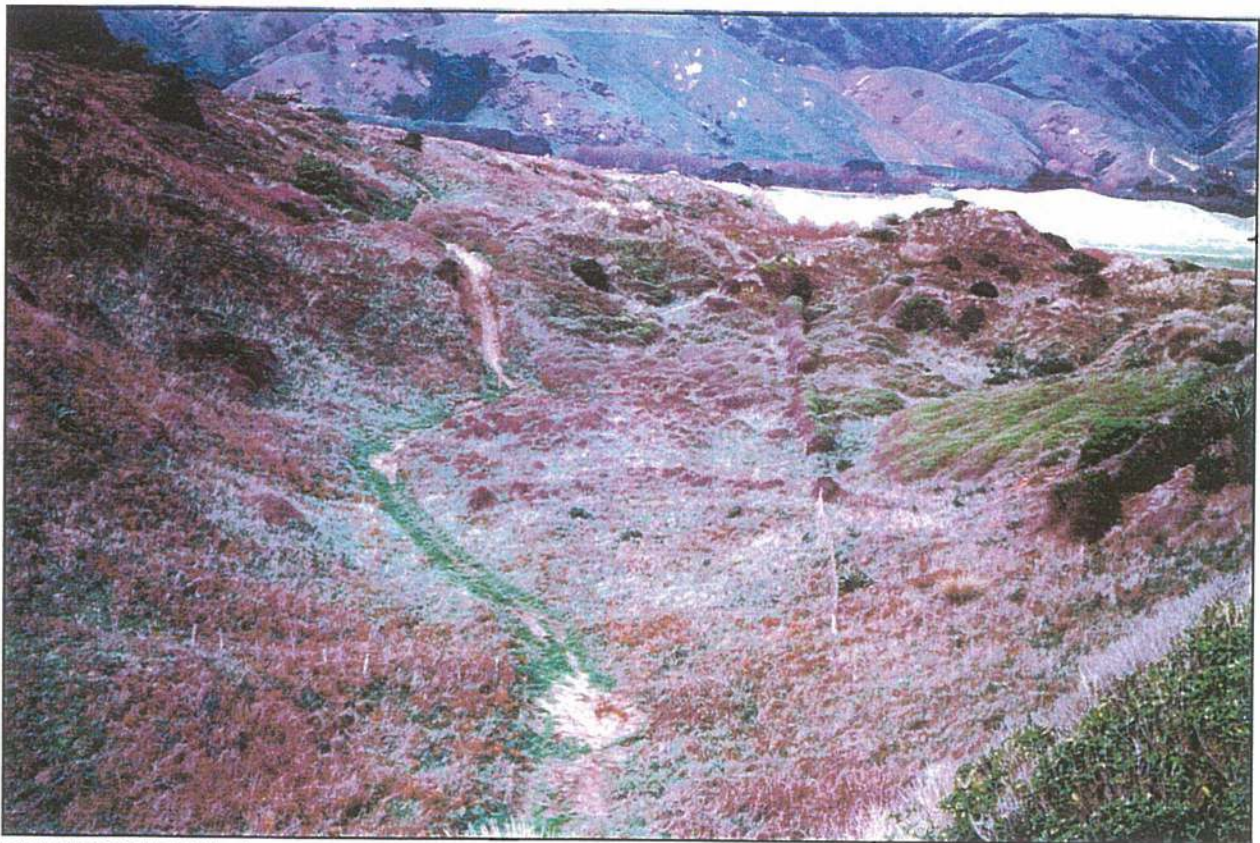
PHOTOGRAPH 7: Connecting track between coastal and inland tracks, northern side of Whareroa Trig. Note significant track erosion.

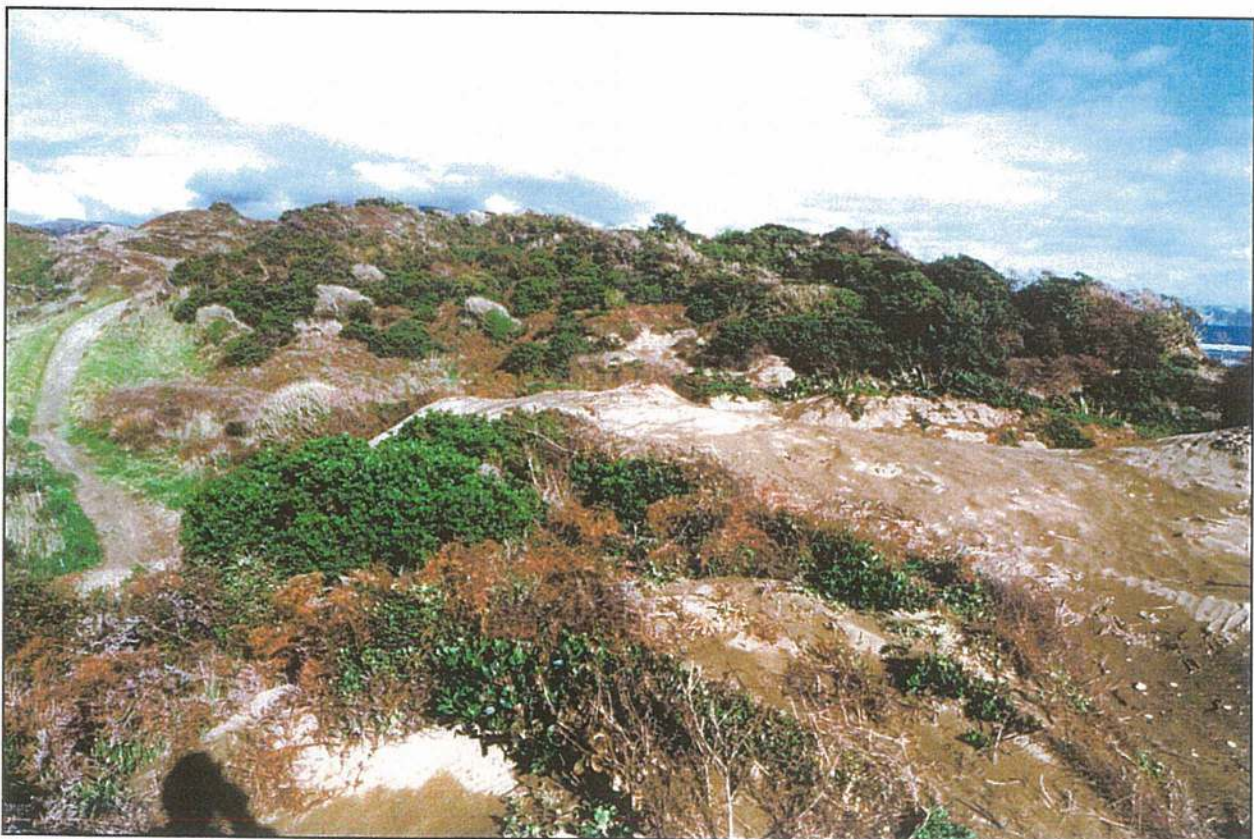
PHOTOGRAPH 8: Inland edge of foredune migrating inland, near Raumati end. Much of deep green canopy is boneseed.

A possible restoration area at the northern end of the coastal zone is shown in Map 1 and Photo 8. There would also be a case for siting a restoration project in other parts of the coastal dune area. For example, at the mouth of the Whareroa Stream, where there are important cultural as well as natural values, or near the southern end, in proximity to southern end residents, and in a more stable part of the coastline. No specific recommendations are made for which, if any, of these areas should be chosen, as this decision would be dependent on many factors beyond the biophysical ones discussed in this report. However, the resources required to successfully complete a restoration project such as this, suggest that it would be preferable to concentrate efforts on one well-planned and integrated restoration project, at least initially, rather than dissipate effort on a number of projects. Planning of a restoration project in the coastal dune area should be coordinated with restoration and conservation management in other parts of the Park.

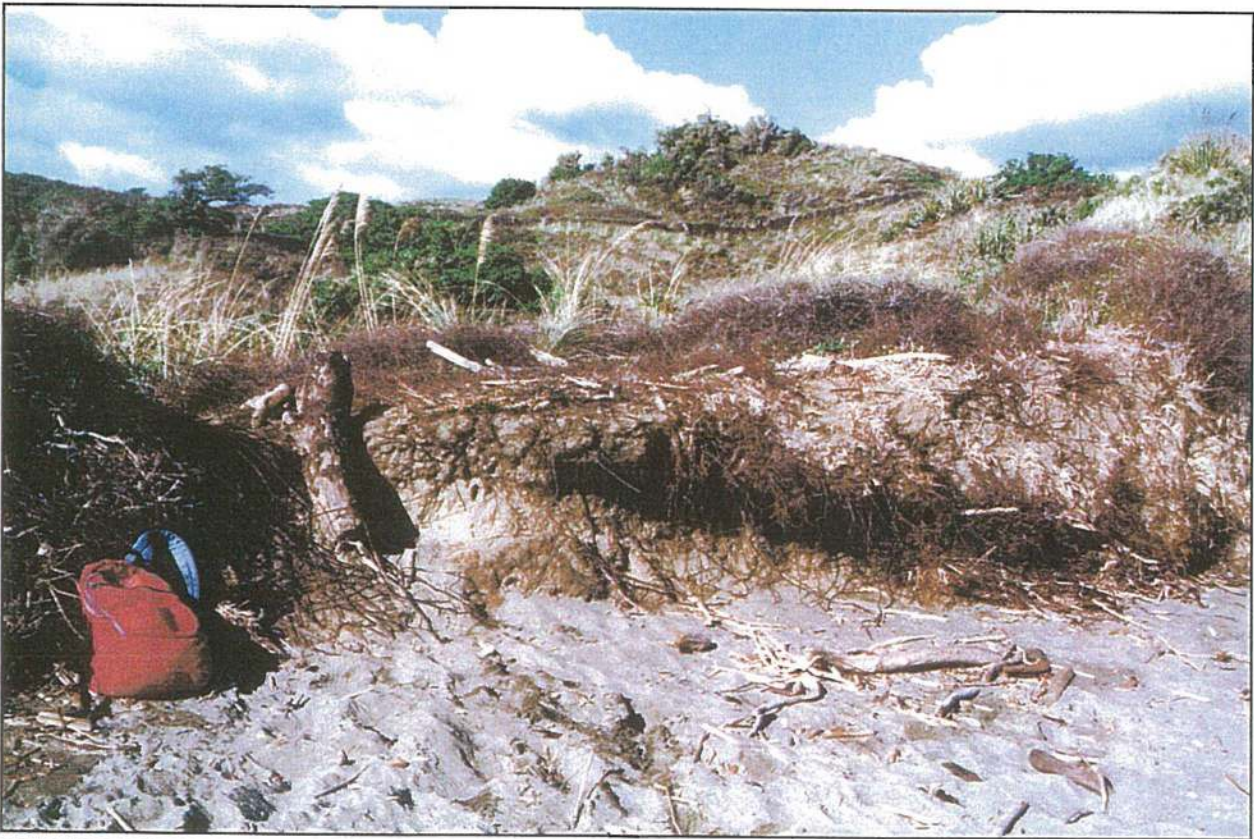
PHOTOGRAPH 10: Simple wooden stepped access could be provided here to avoid erosion at nick-point (behind log) which is present step down point.

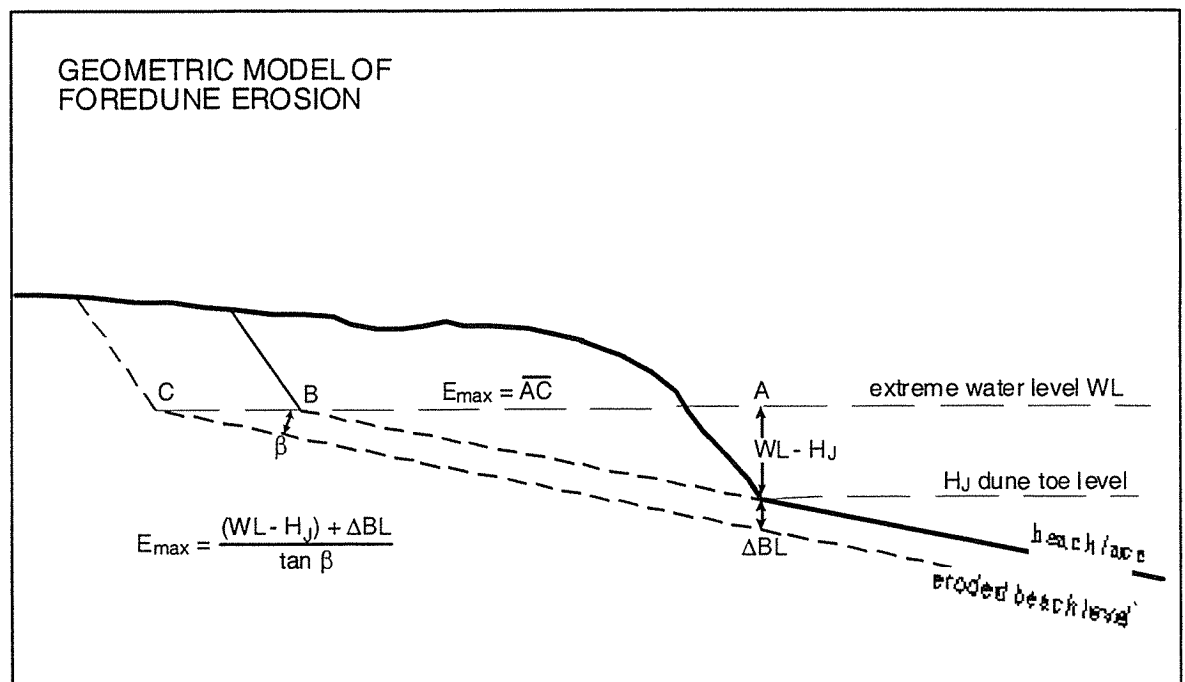
The geometric model developed for use in Oregon is depicted in Figure 2. The model also includes an assessment of the lowered elevation of the beach due to the presence of a rip current, a phenomenon known to occur along the Paekakariki coast.

Figure 2. Geometric model used to evaluate max. potential erosion during a storm.

Elevations are given with respect to Mean Sea Level. Important is the total water level, WL, which is the combined tidal elevation and storm-wave run-up. The erosion of the foredune is dependent on the water-level elevation compared with the elevation of the toe of the foredune, E_J , the junction with the beach face (Figure 1). At QE Park, where there is a relatively high energy coast, at any particular location the beach face dominated by wave swash is wide with a typical uniform slope angle, β (Figure 2). The model assumes
