**STATEMENT OF EVIDENCE OF TIMOTHY JAMES MARTIN
ON BEHALF OF ARNIM PIERAU**

ATTACHMENT TJM1

ATTACHMENT TJM2
SITE PHOTOGRAPHS

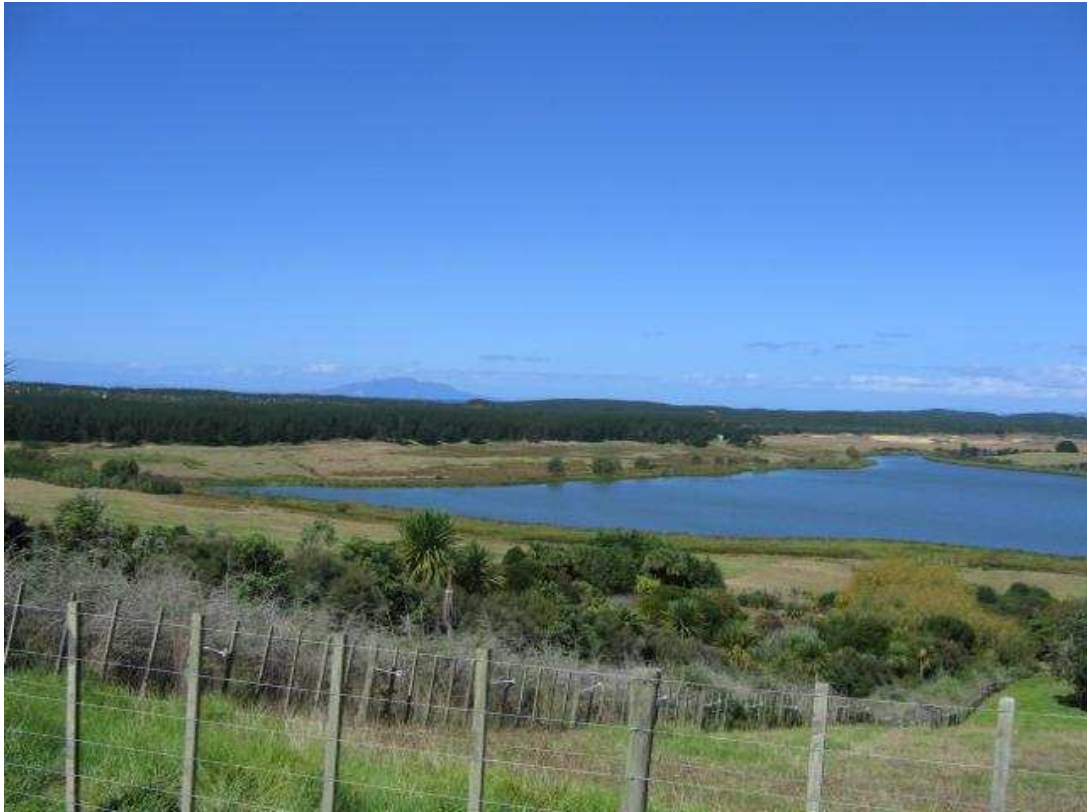
Plate 1: View from Ocean View Road across the northern end of Lake Spectacle showing a nearly continuous band of indigenous wetland along the shoreline.

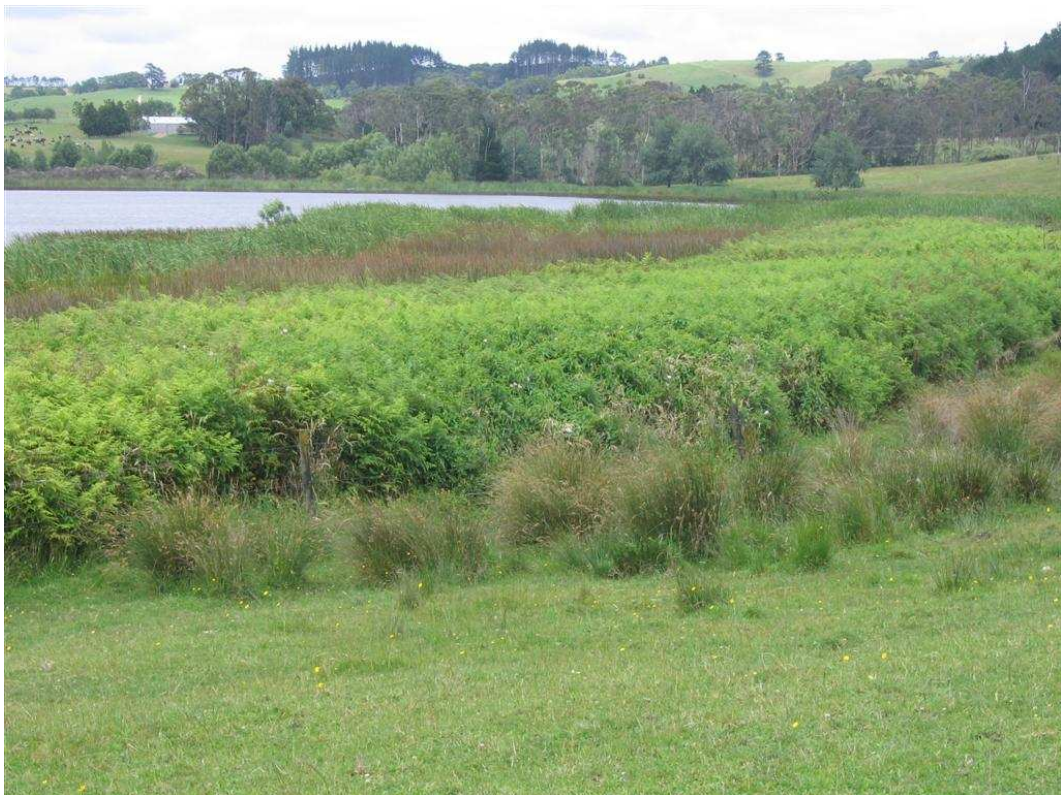
Plate 2: Wetland zonation on the western margin of Lake Spectacle. Water fern (*Histiopteris incisa*) fernland on the well-drained margin grades into wetland with *Baumea articulata* reedland (red-brown colour), which grades into raupo (*Typha orientalis*) reedland (green), which grades into kuta (*Eleocharis sphacelata*) (dark green) in the deeper water.

25. The margins of both lakes are vegetated with a band of raupo-dominant reedland, with locally dominant sedges (*Eleocharis sphacelata* and *Baumea articulata*) (Attachment TJM2 - Plates 1 and 2). Kiokio (*Blechnum novaezelandiae*) is common throughout. There is occasional tangle fern (*Gleichenia dicarpa*), harakeke (*Phormium tenax*), swamp millet (*Isachne globosa*), and an indigenous sedge (*Schoenoplectus tabernaemontanii*), with locally scattered stands of manuka (*Leptospermum scoparium*) and ti kouka (*Cordyline australis*). Occasional mature trees of willow (*Salix* sp.), and poplar (*Populus* sp.) are present on the landward edge of the wetlands on the margin of Lake Spectacle.

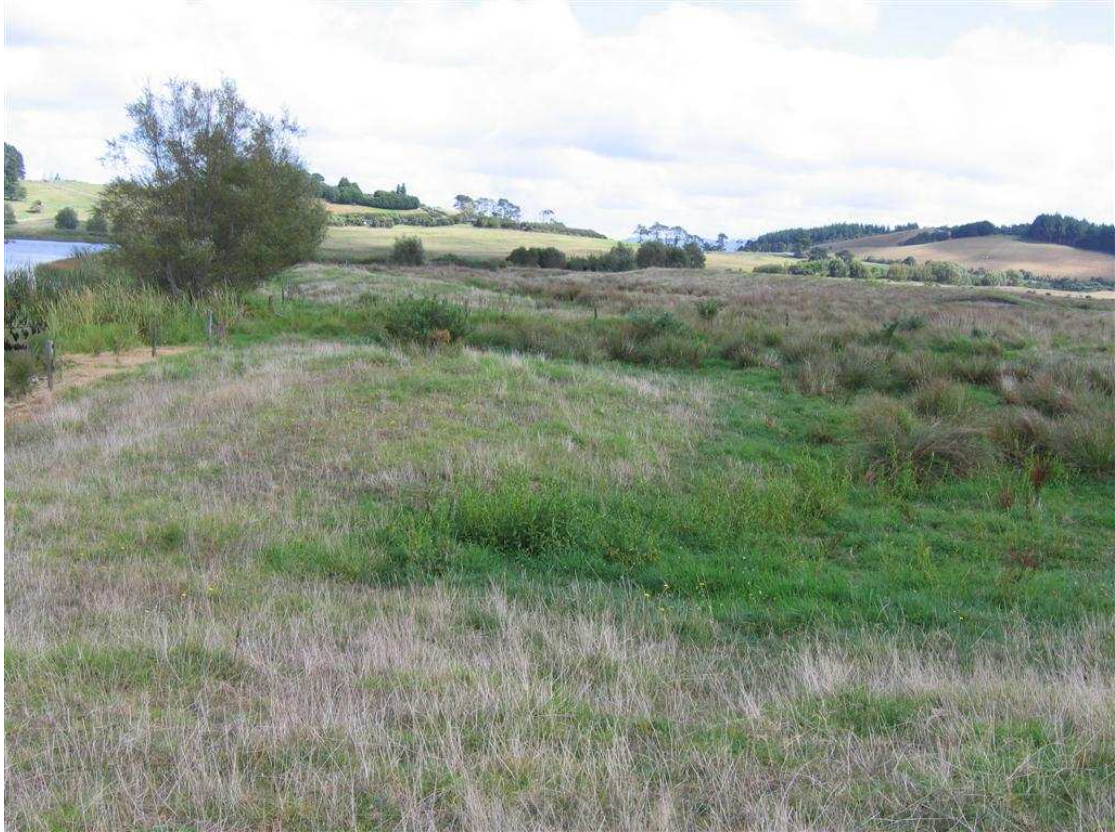
Plate 3: Eastern margin of Lake Spectacle with pasture on well drained dune ridges alternating with Edgar's rush (*Juncus edgariae*), mercer grass (*Paspalum distichum*), and willow weed (*Persicaria decipiens*) in dune slacks.

32. On the eastern side of Lake Spectacle, the lowest-lying dune slacks are often contiguous with wetlands on the lake margin (Attachment TJM2 - Plate 3). The ground is wet to slushy underfoot, with occasional small pockets of open water. Edgar's rush (*Juncus edgarii*) is common, with frequent mercer grass (*Paspalum distichum*), Yorkshire fog (*Holcus lanatus*), willow weed (*Persicaria decipiens*), and a native sedge (*Isolepis prolifer*), and occasional primrose willow (*Ludwigia peploides*). Further to the east the dune slacks are well drained and species indicative of wetland environments, such as sedges, are absent.

33. The wet dune slacks currently do not meet the Rodney District Plan criteria for wetland quality. They have been highly modified by vegetation clearance, followed by a long history of grazing. With appropriate management (e.g. blockage of drainage ditches, and planting and weed control as per Wildland Consultants Contract Report No. 1909 – February 2008), this area may meet the criteria in the future. However this improvement is unlikely to be met within the 2-3 year time frame stipulated for Criterion 3 (f) Potential in Appendix 7C.
