**DRURY – OPAHEKE STRUCTURE
PLAN BACKGROUND
INVESTIGATIONS
GEOTECHNICAL AND COASTAL
EROSION ASSESSMENT**

Report prepared for: Auckland Council

Report reference: 170275-C

Date: 28 July 2017

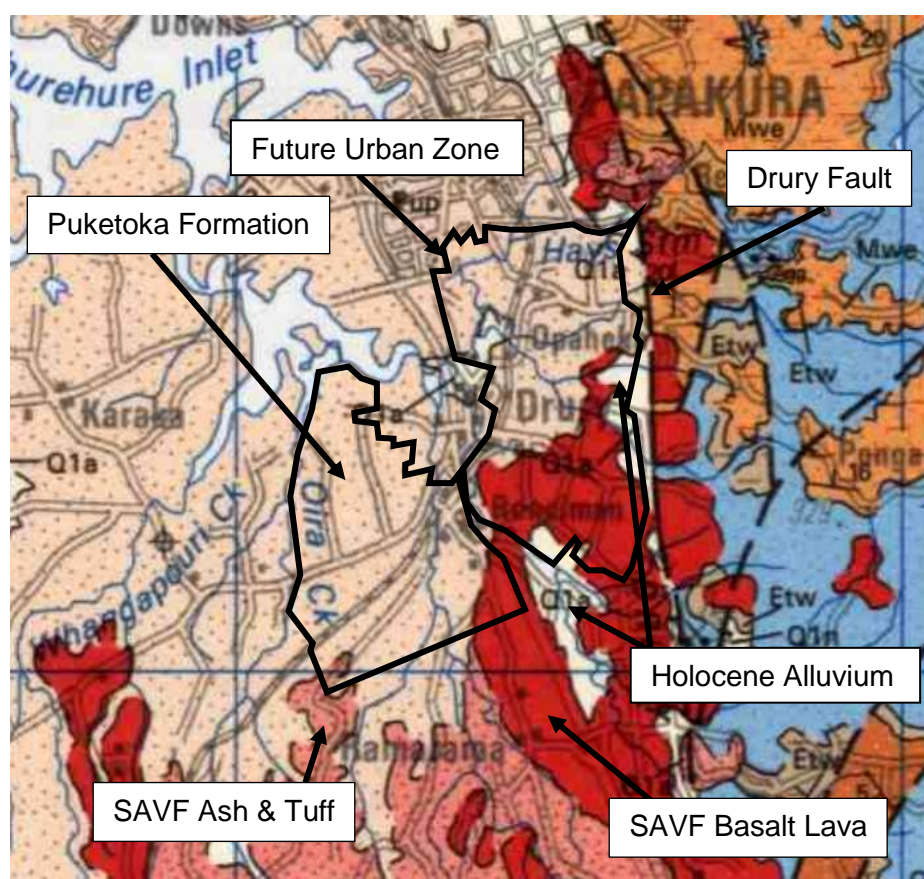
Figure 2: Extract from Auckland 1:250,000 scale geological map (sheet 3), Edbrooke 2001

The study area is situated on a mixture of volcanic derived and alluvial materials. Their distribution is shown in Figure 2. The mapped geological distributions are a simplification of the ground conditions.

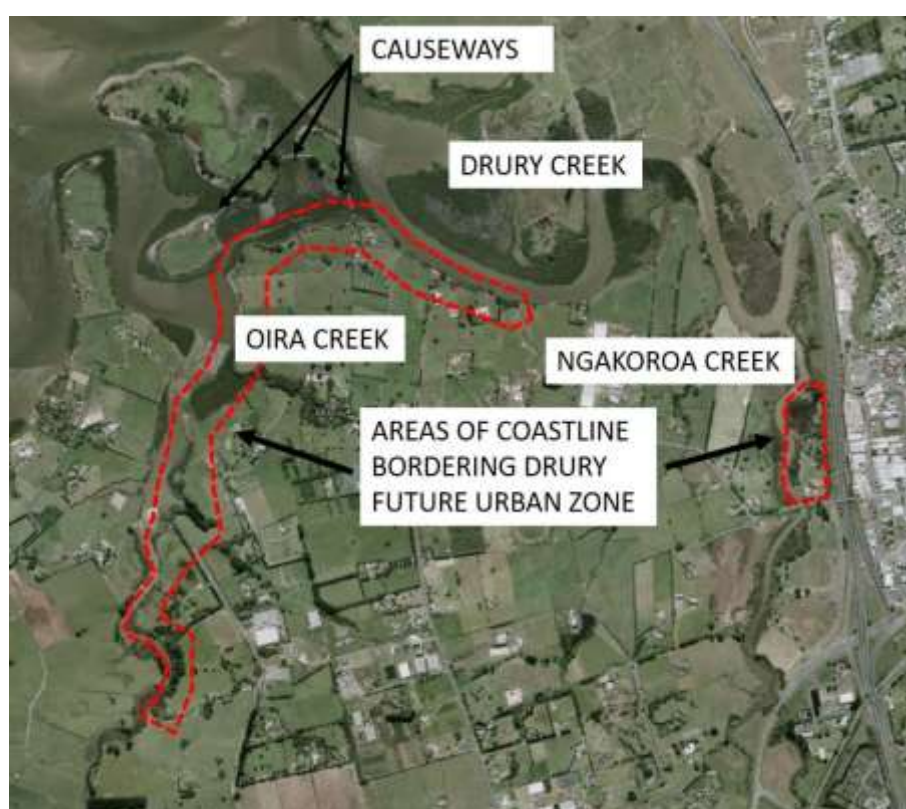
Figure 3: Coastline bordering Drury FUZ

Two small areas, comprising approximately 3.2km of coastline, border the Drury FUZ (Figure 3). These stretches of coastline are tidal areas of the upper Manukau Harbour comprising parts of the Drury, Oira and Ngakaroa Creeks.

The morphology of the coastline, with a meandering river channel and platform to the base of steep and slumped fringing cliffs, suggests an area subject to progressive retreat. The low tide channel is relatively incised, with intertidal flats comprised primarily of very weathered rock to firm very stiff soils overlain with a veneer of soft estuarine silt. The depth of veneer increases at the outside of bends and embayed areas. The alignment of the shore line cliffs with the channel, and intensification of erosion based on the meander of the river, indicate that the coastline is dominated by fluvial and tidal current processes with deposition tending to occur on the inside of river bends, and erosional processes occurring on the outside. This is consistent with the remoteness from open ocean swells and lack of long fetches to develop wind waves.

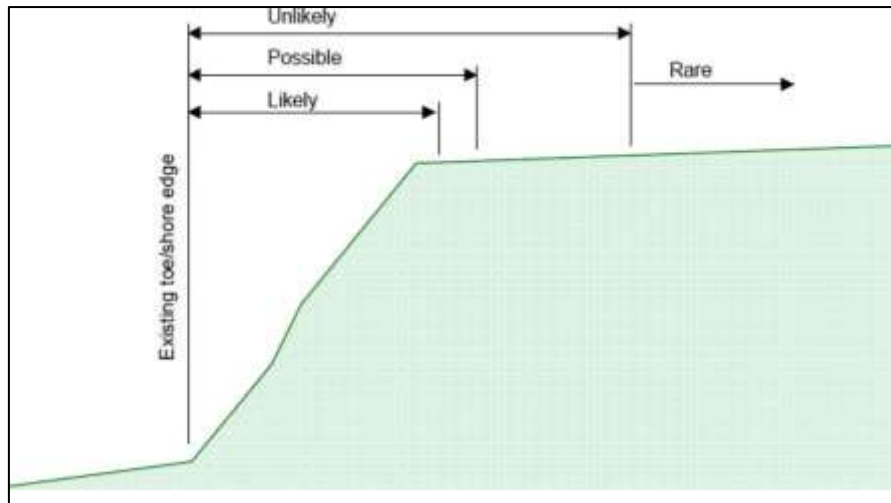
Figure 4: Risk-based approach to area susceptible to erosion over the next 100 years

- **Likely:** Probably will happen during the 100-year timeframe
- **Possible:** Might occur during the 100-year timeframe
- **Unlikely:** Unlikely to occur but possible during the 100-year timeframe

These relative risk areas are shown in the schematic figure below. A 'rare' category, defined as 'highly unlikely, but conceivable' was also included in the RAASCE, however, that has not been included in this report.

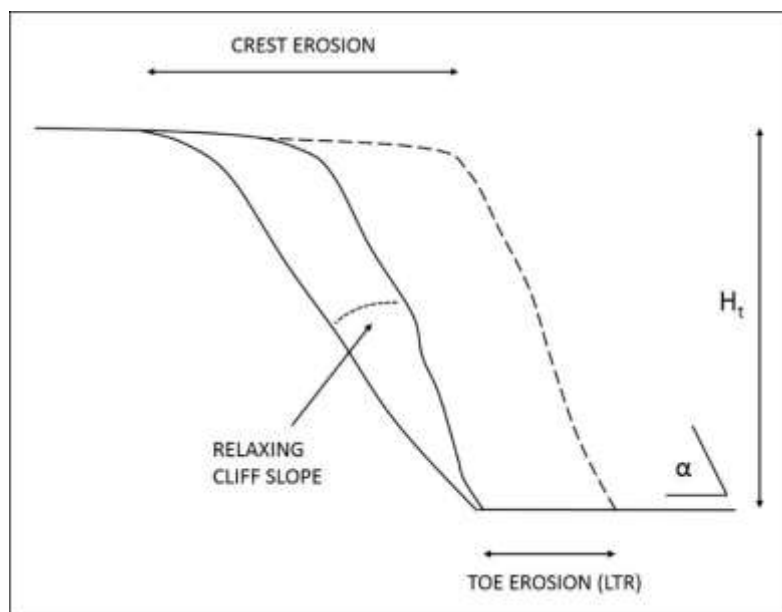
Figure 5: Long-term retreat of cliff assuming uniform lithology and structure (adapted from ARC, 2006)

The distance from the toe of the cliff that is at risk from Coastal Retreat can be considered as comprised of two parts (Figure 5).

1. **Long-Term Retreat (LTR)** of the toe of the cliff – this is assumed to increase in as a result of future accelerated sea level
2. **Cliff Slope Angle (α)** – relaxation (lessening) of the cliff slope due to weathering and/or geotechnical failure following toe retreat will cause retreat of the crest.

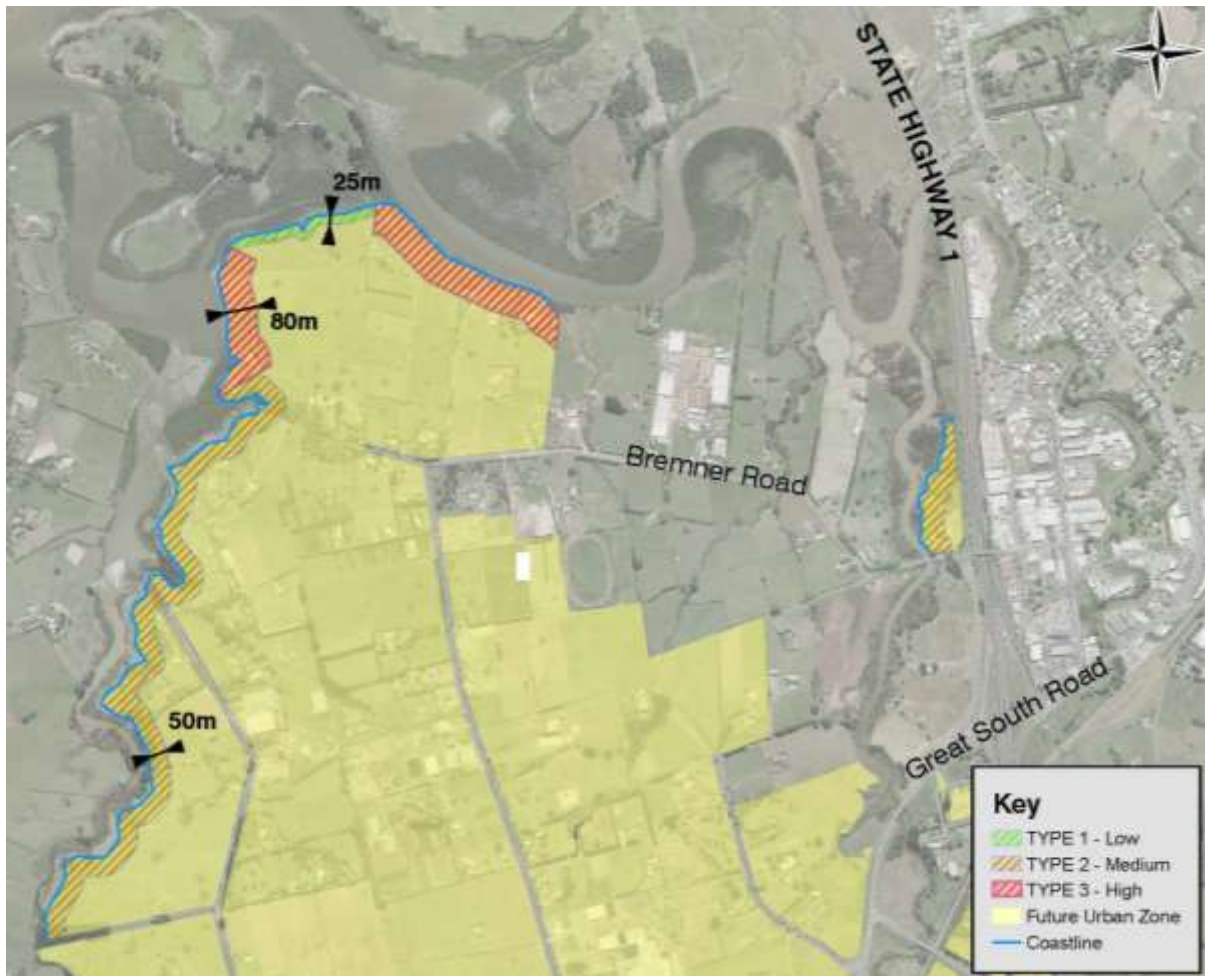
Figure 6: Areas susceptible to coastal erosion

The **adopted** area (Figure 6) susceptible to coastal erosion for each Type is shown in Table 5.

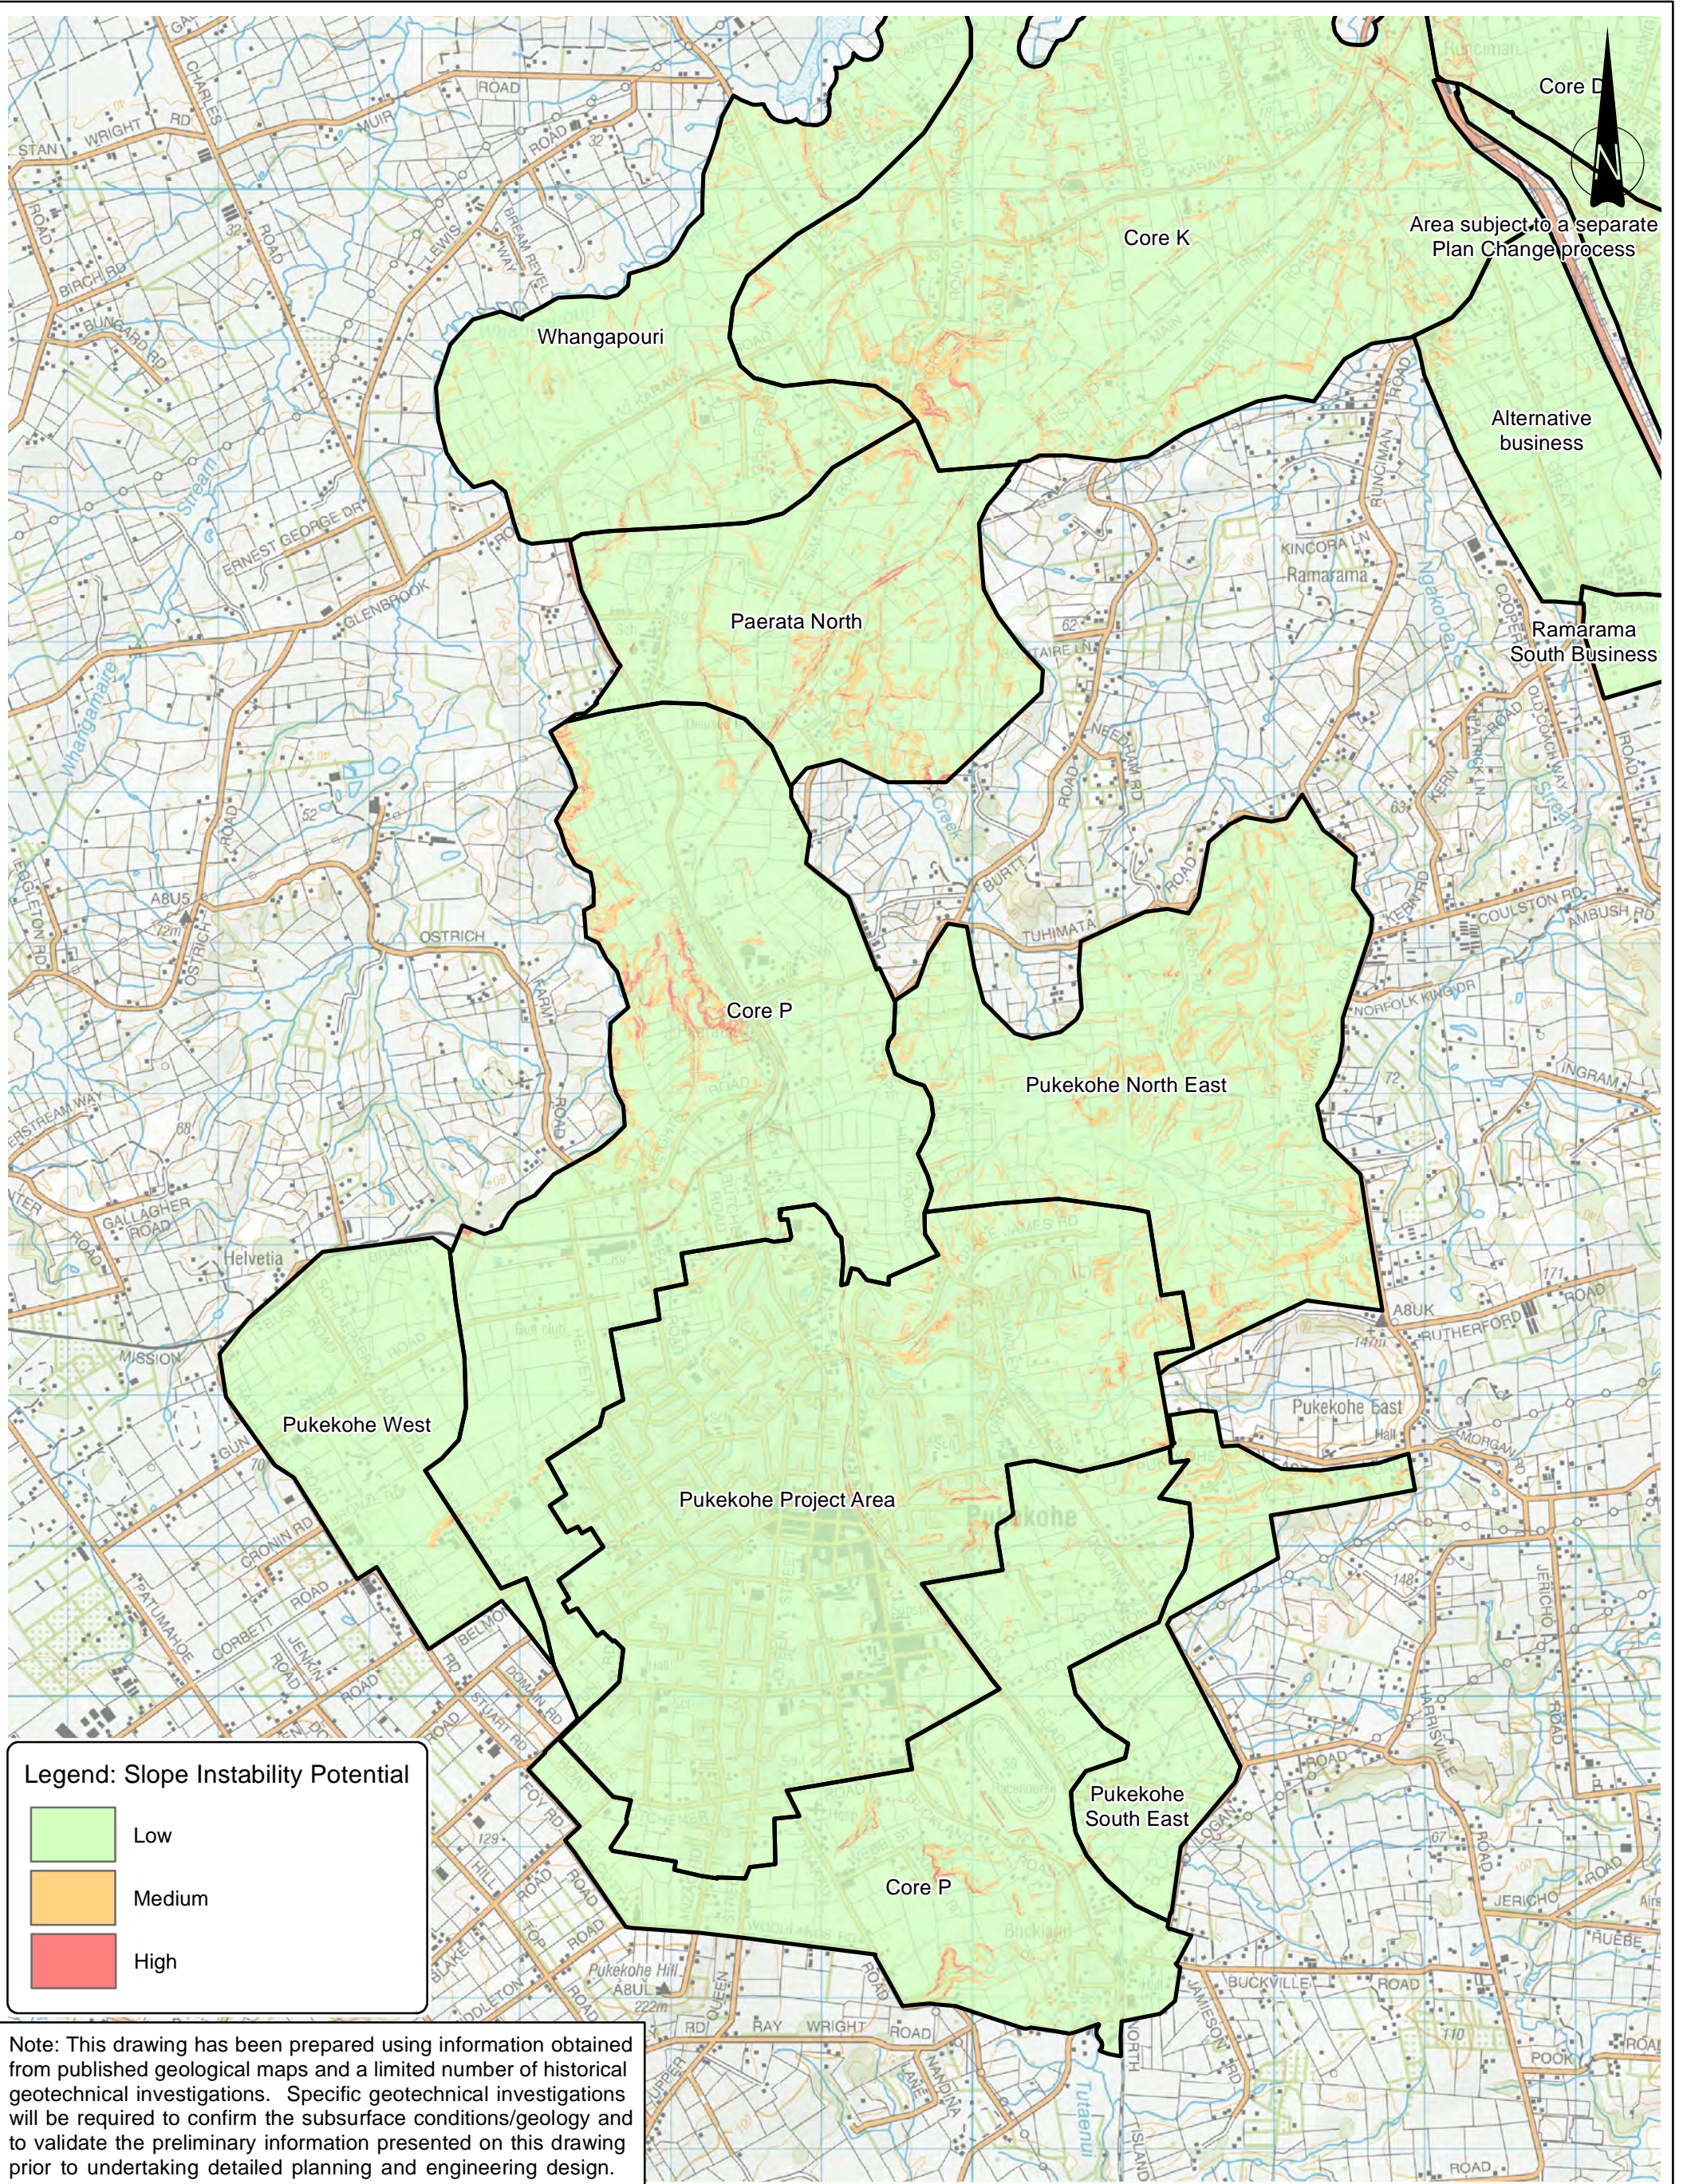
FIGURE No. Figure 9

Legend: Slope Instability Potential

- Low
- Medium
- High

Auckland Council
South Auckland RUB Project
Slope Instability Potential

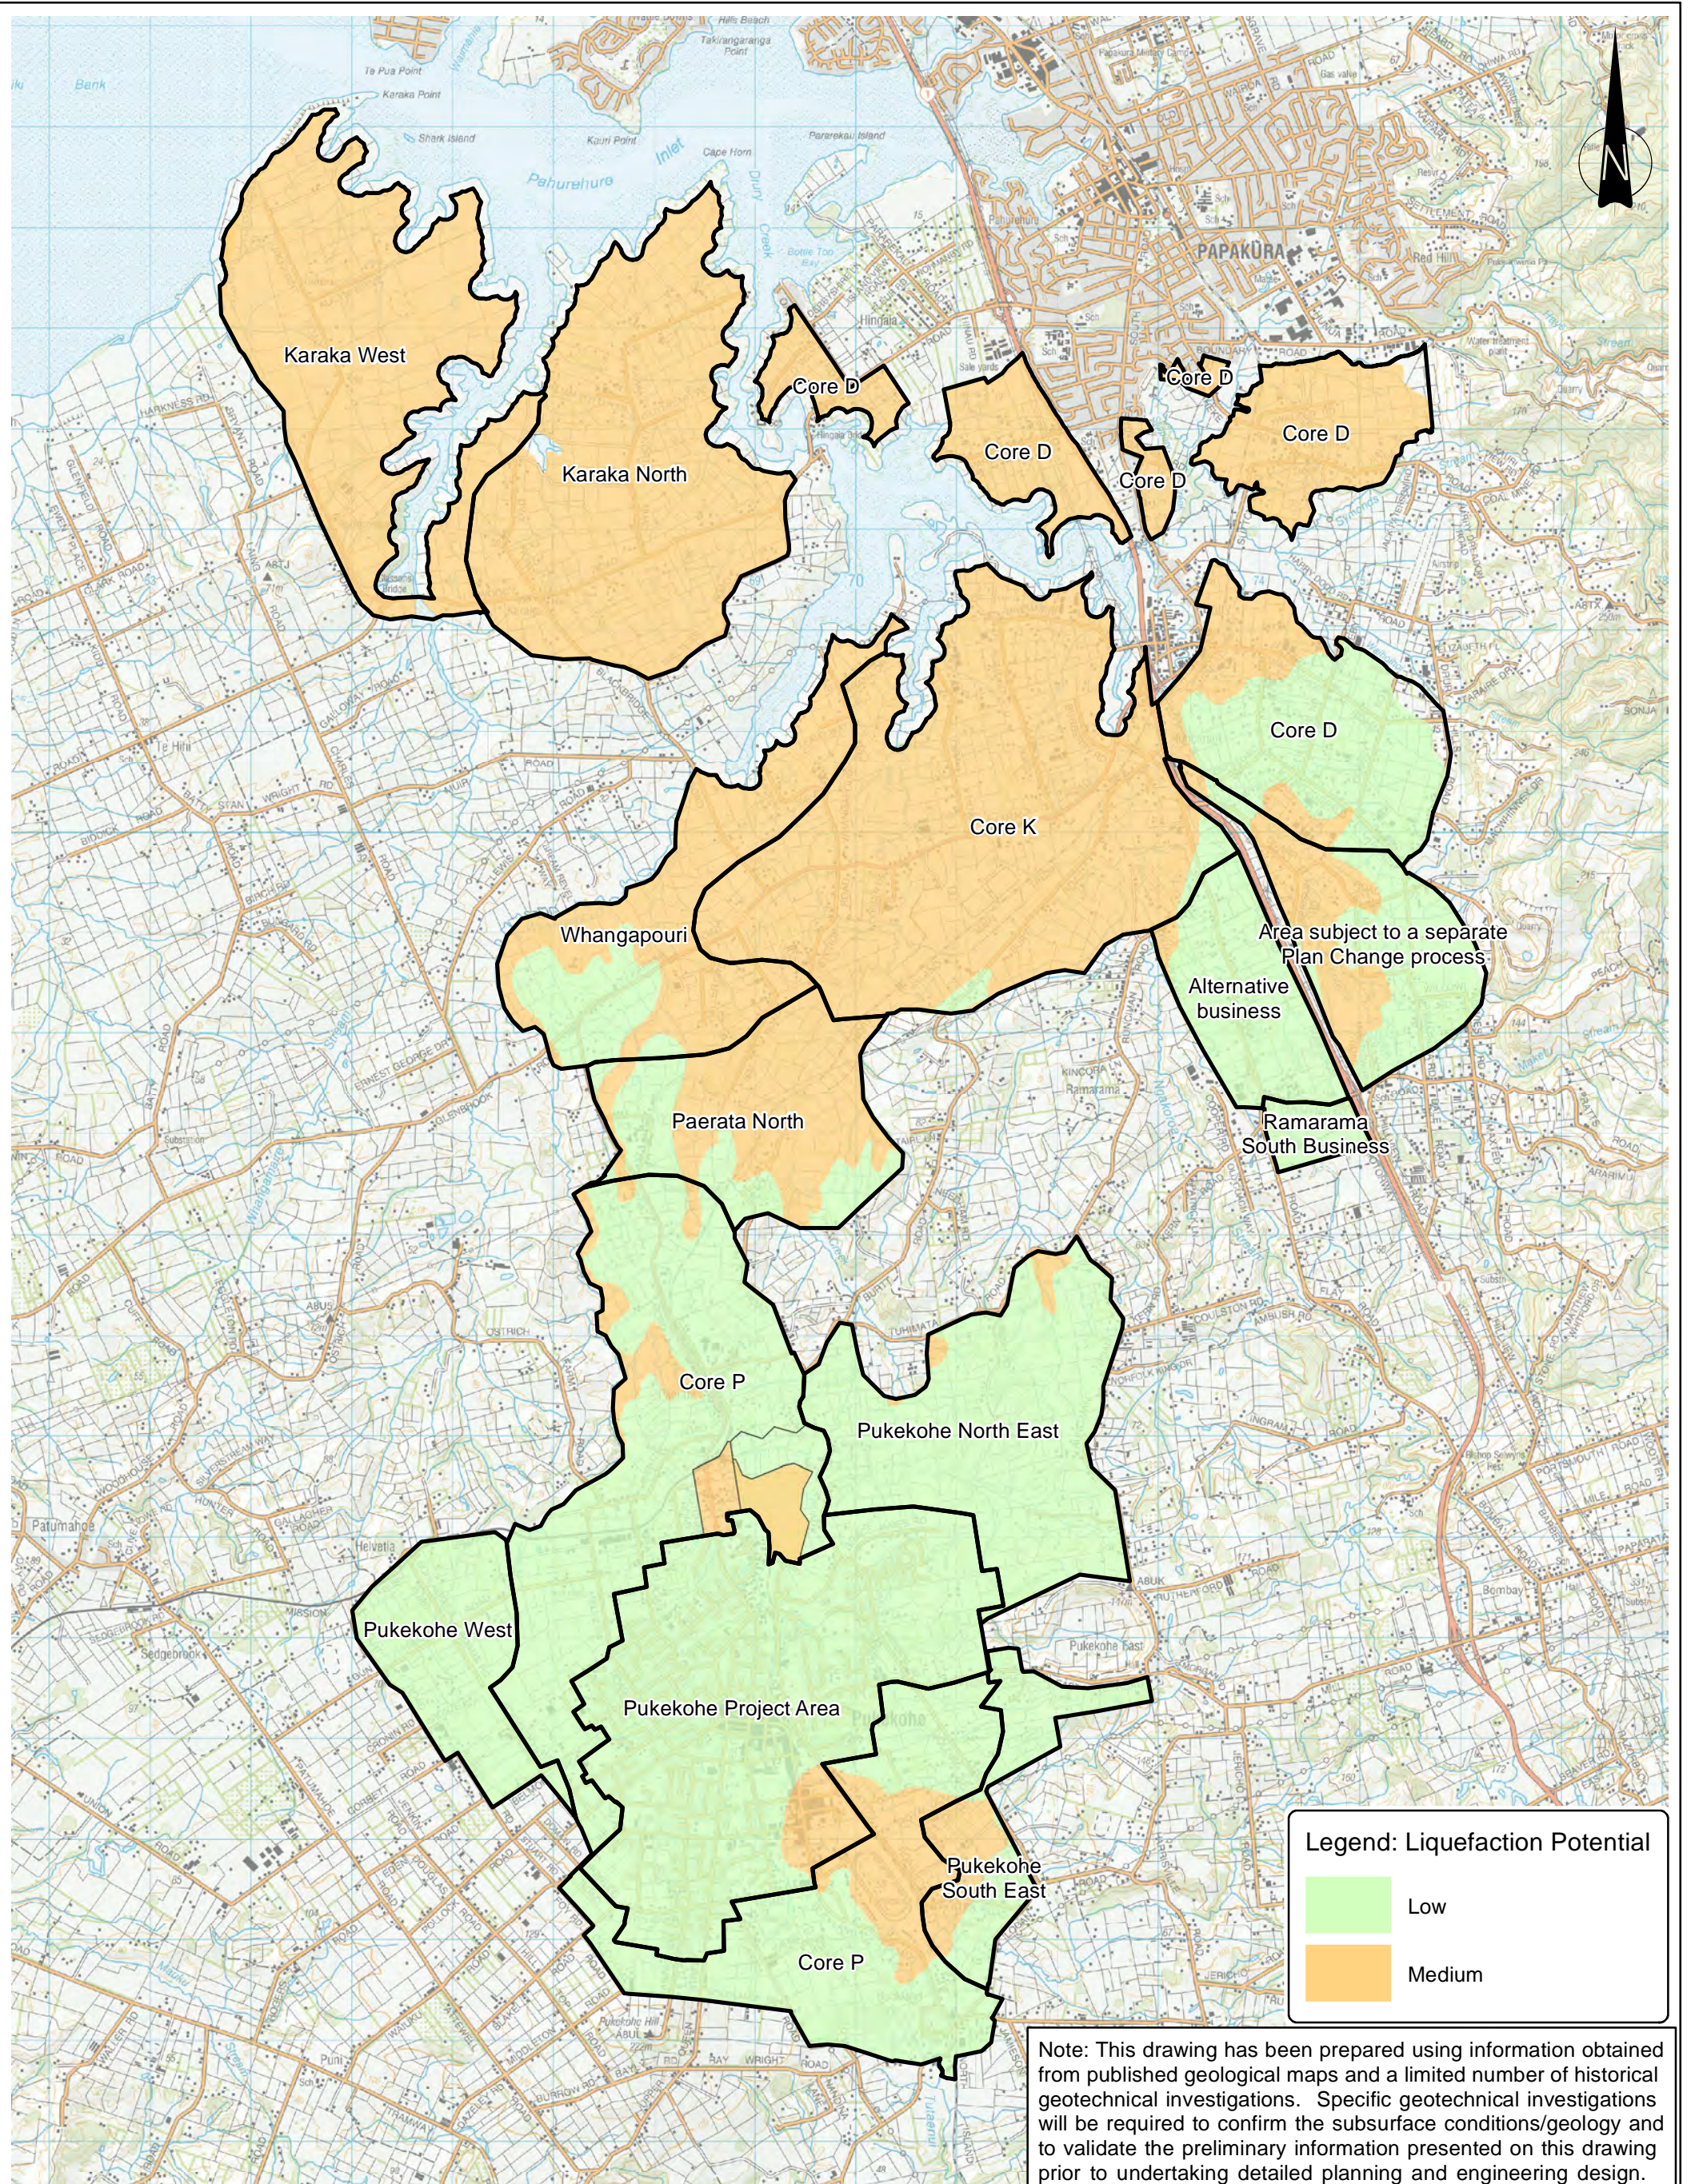
Legend: Liquefaction Potential

- Low
- Medium

Auckland Council
South Auckland RUB Project
Liquefaction Potential

We consider the liquefaction potential map (T+T Figure 10) adequately captures the likely hazard with the exception of the Holocene alluvium where historical boreholes indicate the presence of highly plastic soils potentially implying a low liquefaction potential. With respect to Puketoka Formation materials a moderate assessment over the whole area is conservative but considered appropriate as localised liquefaction is possible. The T+T assessment does not explicitly assign a lateral spread potential within the coastal foreshore area. We consider the potential for lateral spread as a result of liquefaction to be moderate based on the criteria outlined by T+T and Beca.

Liquefaction Potential	The liquefaction potential map (T+T Figure 10) is considered to adequately capture the likely hazard based on current information available. The coastal foreshore and adjacent to streams we consider an assessed moderate liquefaction potential is appropriate. See RILEY Dwg 170275-7 attached	Investigation and assessment as per T+T recommendations. Moderate liquefaction potential is considered likely equivalent to TC1 and TC2-type foundations (MBIE guidelines), which are not envisaged to have a significant effect on development and construction costs, subject to specific assessment as recommended.

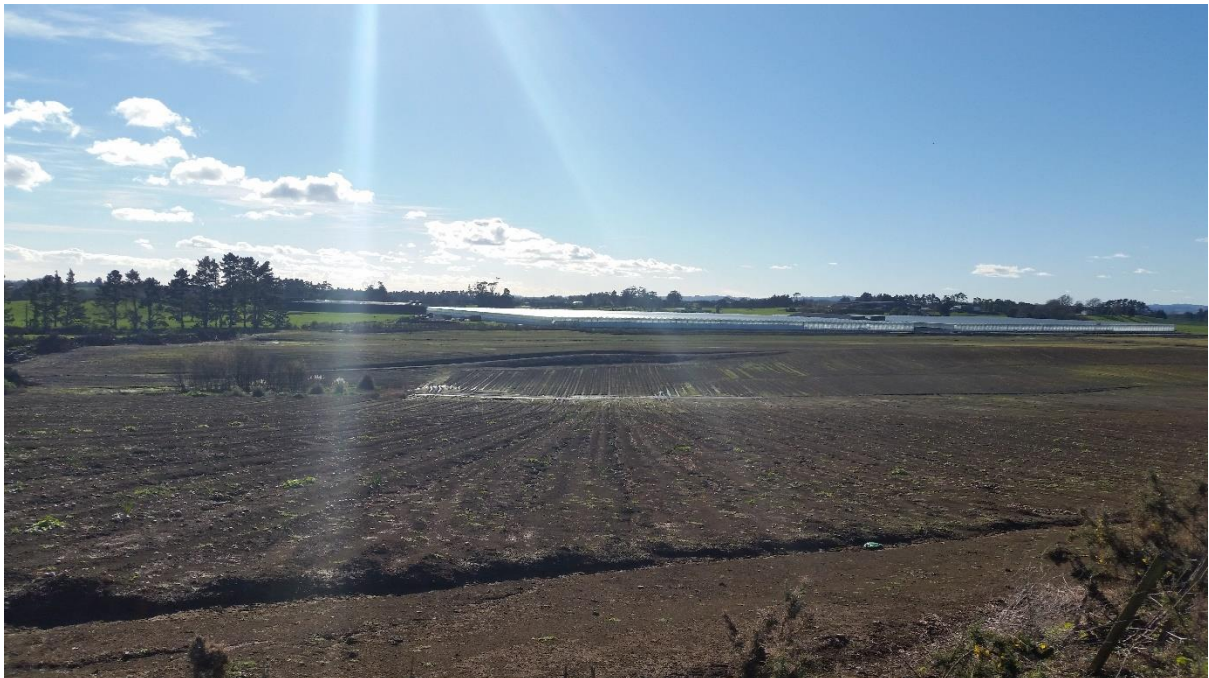
Photo 1: Looking north near the intersection of Cheriton Road and Burt Road. Mapped as being underlain by SAVF ash with Puketoka Formation in the lower lying and undulating areas in the distance.

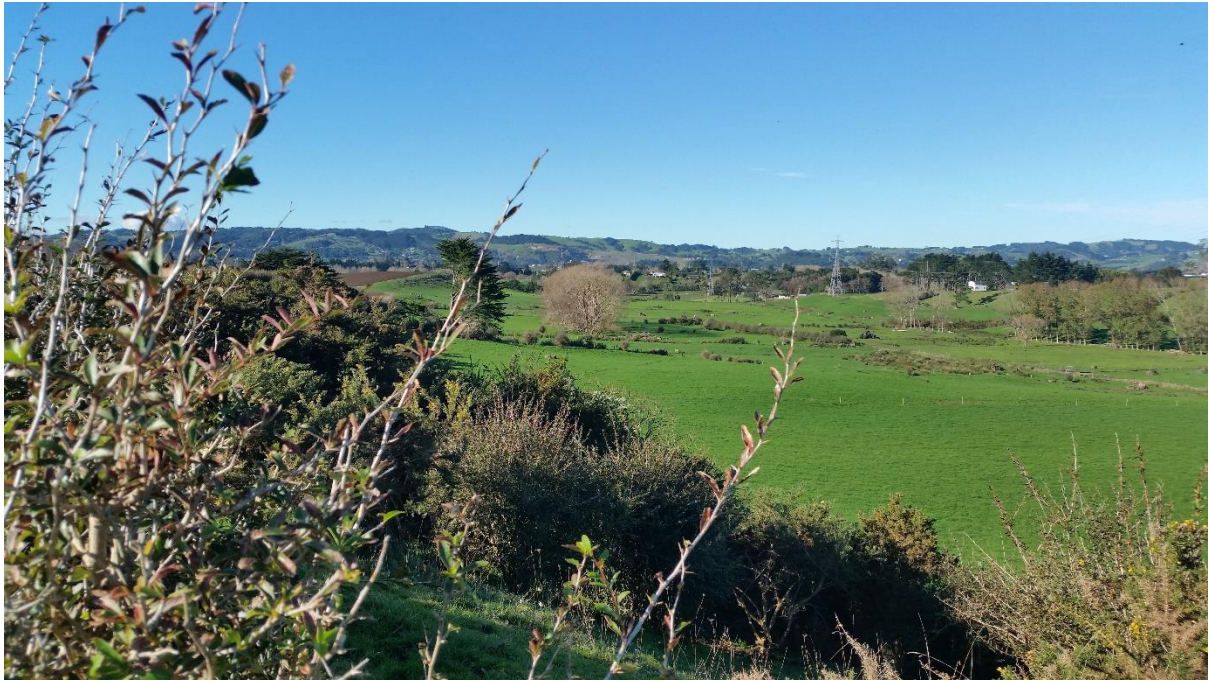
Photo 2: Looking east near the intersection of Cheriton Road and Burt Road. The slope in the foreground is mapped as being underlain by SAVF ash (note the steep contour) and has an assessed high slope instability potential. The flat land in the distance is mapped as being Puketoka Formation but is low lying and may have portions of Holocene Alluvium.

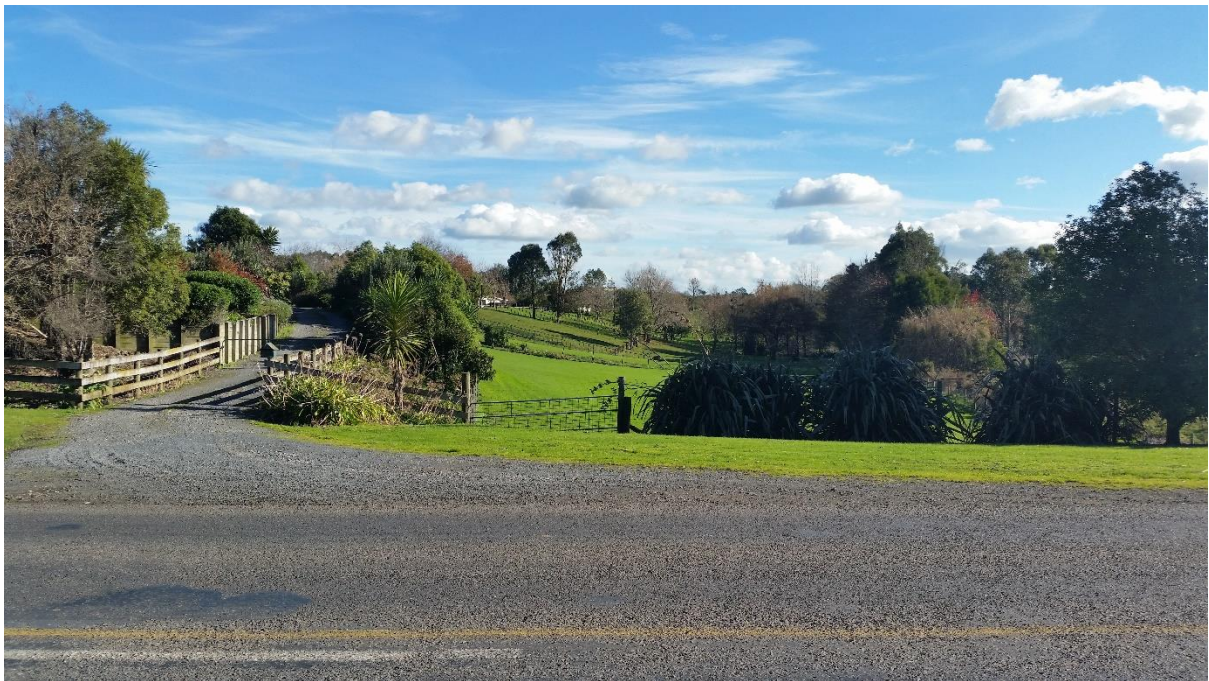
Photo 3: Looking west from Great South Road near the intersection with Quarry Road. The locality is underlain by Puketoka Formation deposits. Note moderate to steep gradients in the distance.

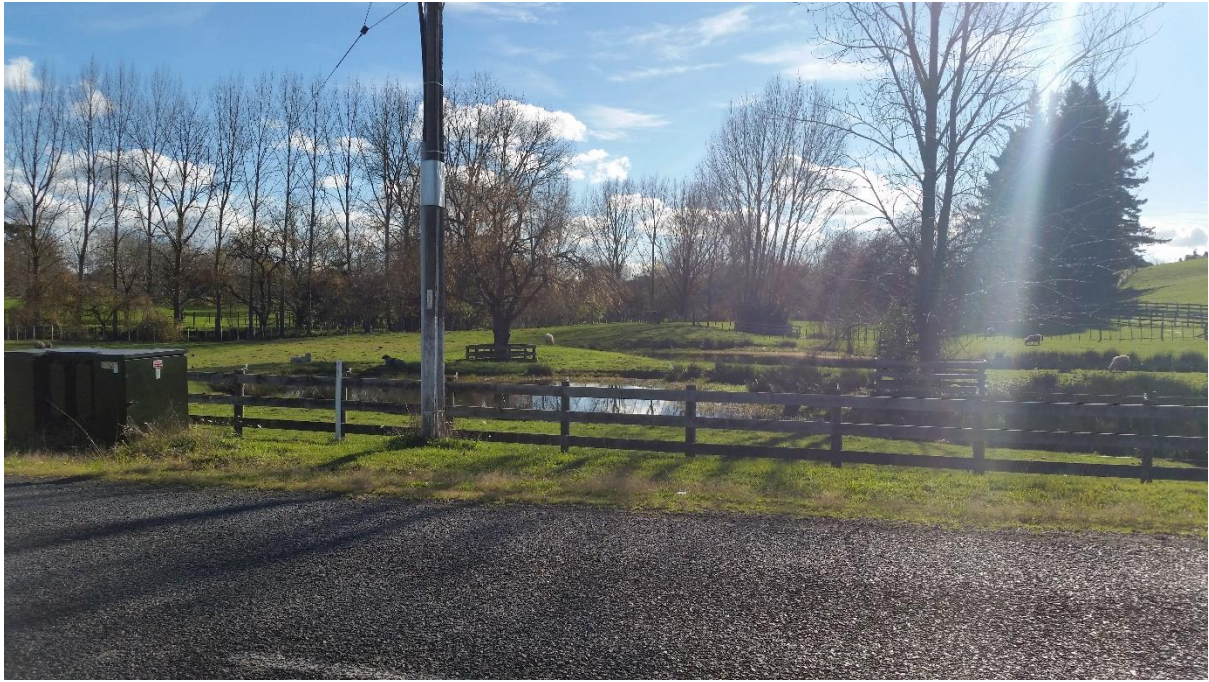
Photo 4: Looking north from Runciman Road. Low-lying land mapped as Puketoka Formation. Holocene Alluvium may also be present.

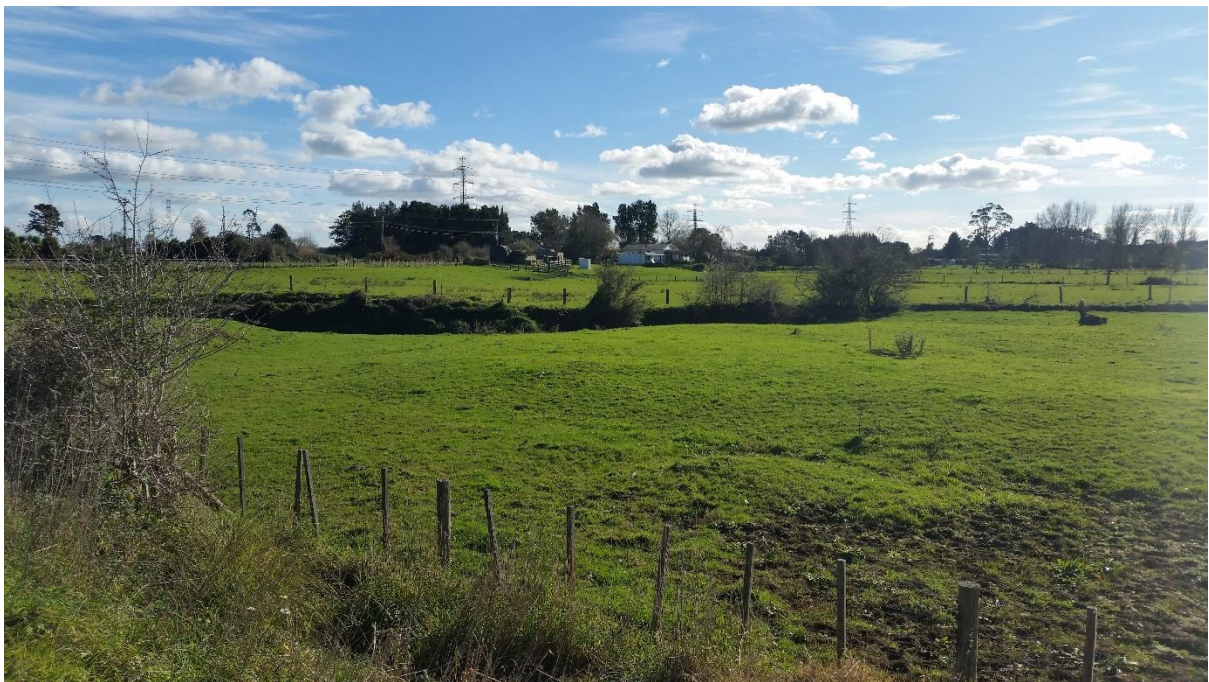
Photo 5: Looking north from Quarry Road near the intersection with Harrison Road. Area is underlain by Holocene Alluvium. It has a subdued contour with a creek in the middle ground.

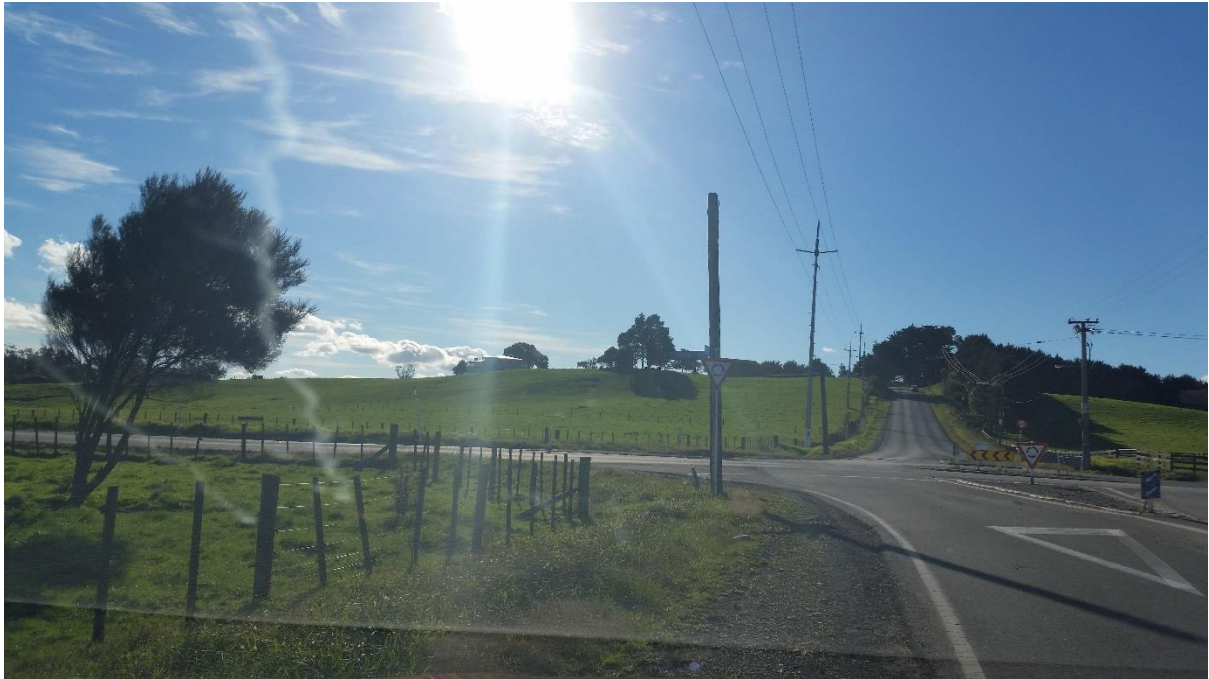
Photo 6: Looking north at the intersection of Quarry Road and Fitzgerald Road. The land in the foreground is underlain by Holocene Alluvium, while the rising ground in the distance is underlain by SAVF ash and basalt.

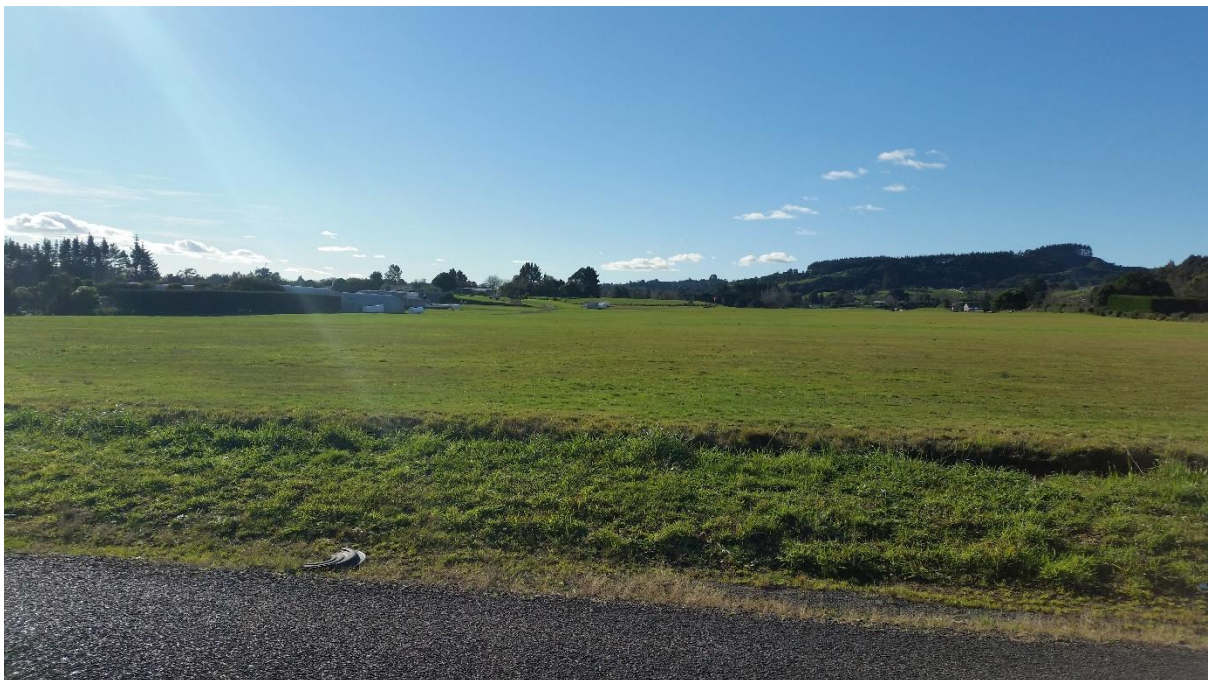
Photo 7: Looking north from Appleby Road. Has a flat contour similar to the Holocene Alluvium but is mapped as being underlain by Puketoka Formation.

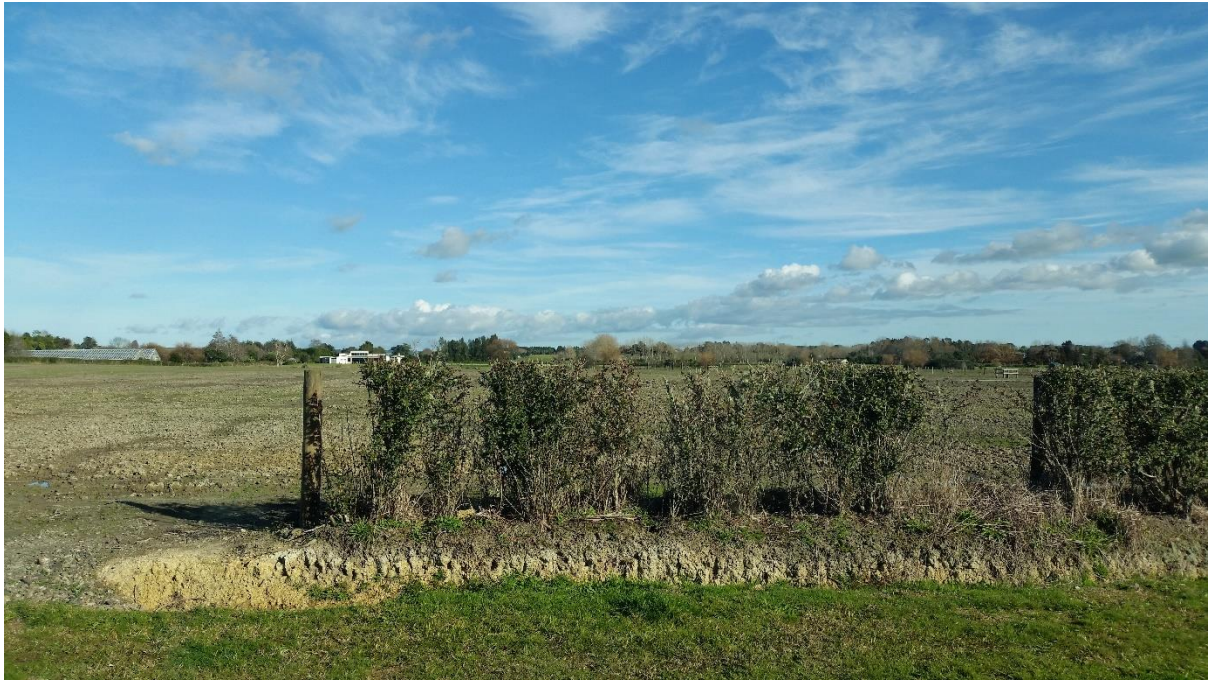
Photo 8: Looking South from Appleby Road. Has a flat contour similar to the Holocene Alluvium but is mapped as being underlain by Puketoka Formation.

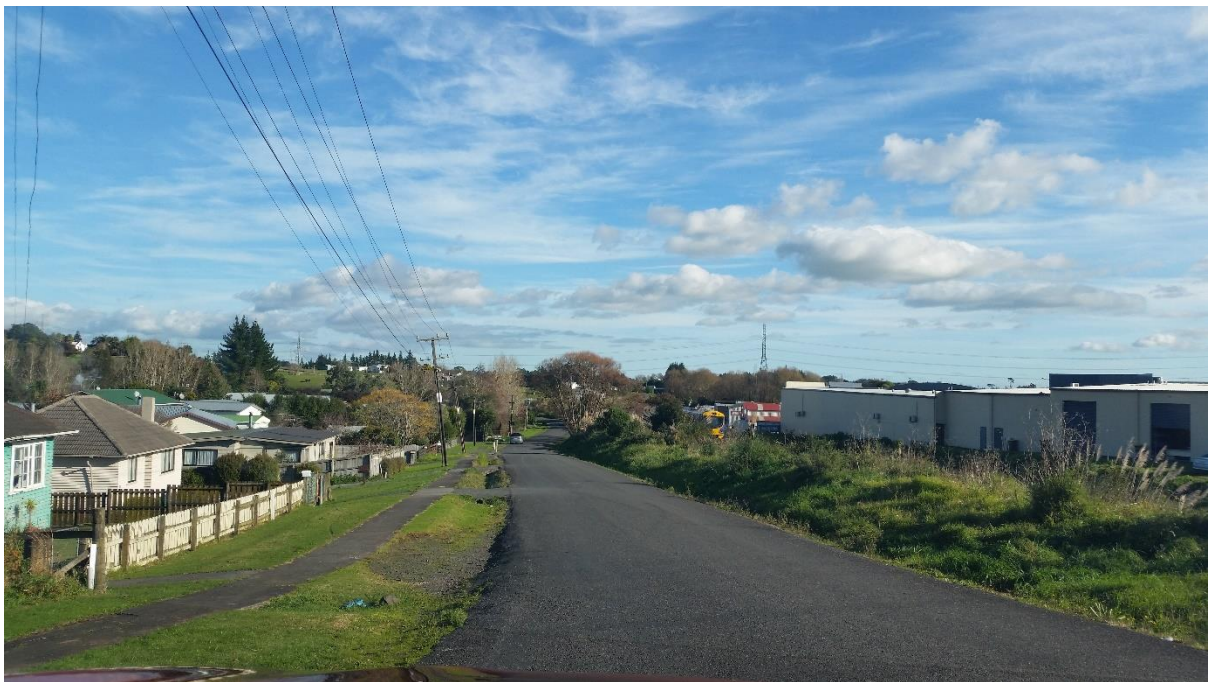
Photo 9: Looking south west down Flanagan Road. The land falls gently to the south west and is underlain by Puketoka Formation.

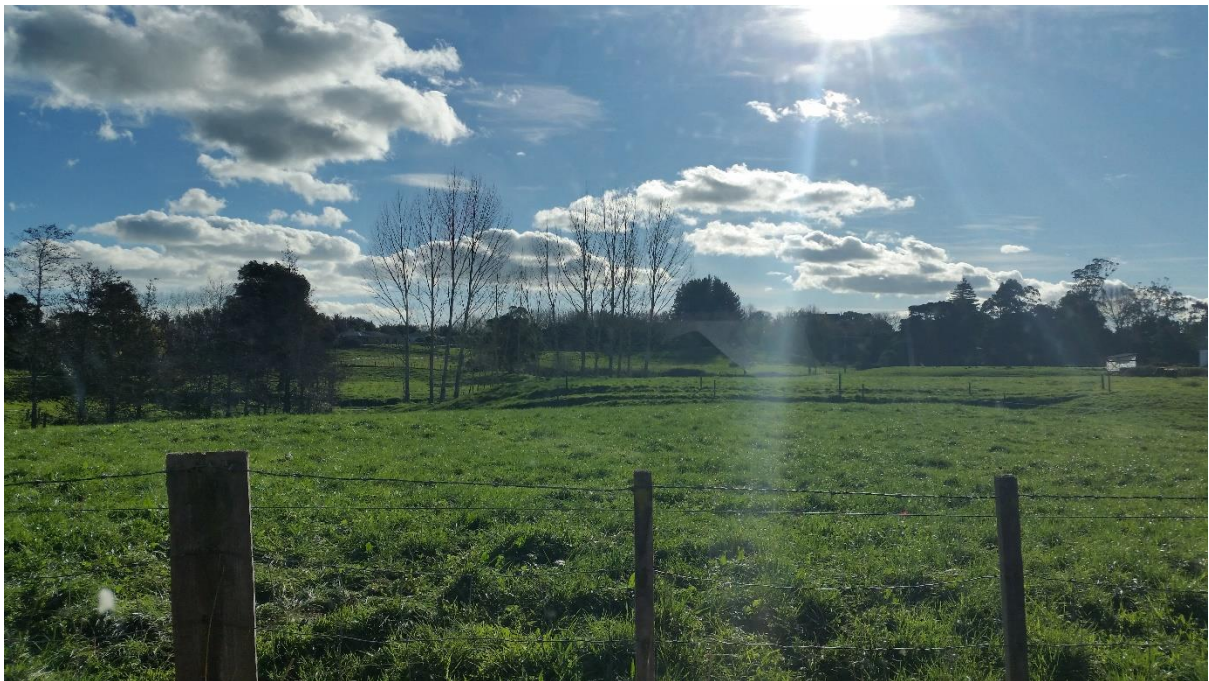
Photo 11: Looking north towards Slippery Creek from Sutton Road. Mapped as being underlain by Puketoka Formation. The land has a flat contour with steep slopes adjacent to the creek.

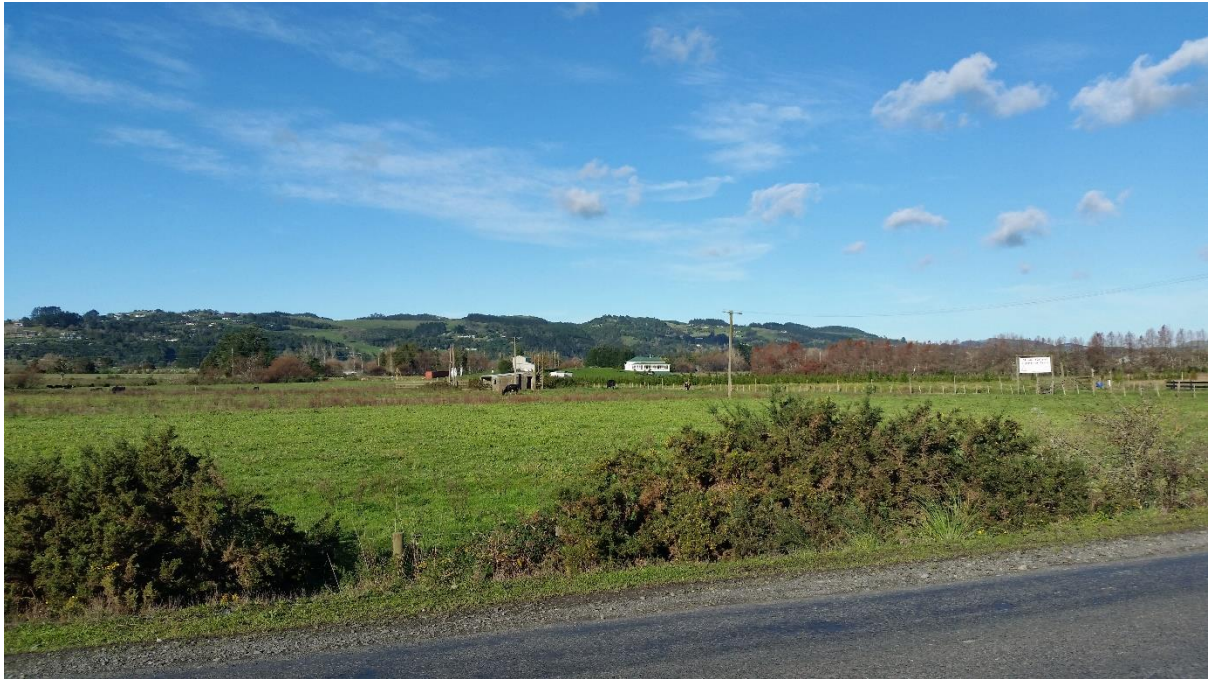
Photo 12: Looking east from Sutton Road near the railway crossing. The land has a flat contour and is mapped as being underlain by Puketoka Formation.

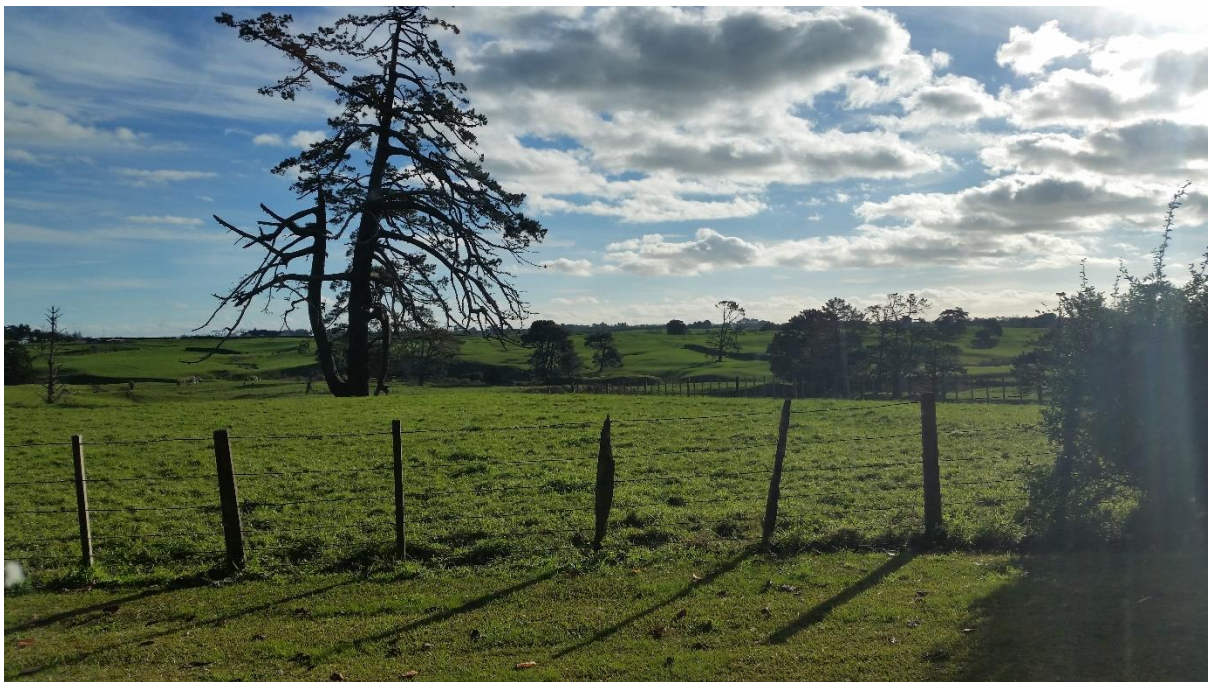
Photo 15: Looking west from Oira Road to Oira Creek. Flat land visible in the foreground rolling down to Oira Creek. Note the local instability features in the western creek bank outside the study area.
