**DRURY – OPAHEKE STRUCTURE
PLAN BACKGROUND
INVESTIGATIONS
GEOTECHNICAL AND COASTAL
EROSION ASSESSMENT**

Report prepared for: Auckland Council

Report reference: 170275-C

Date: 28 July 2017

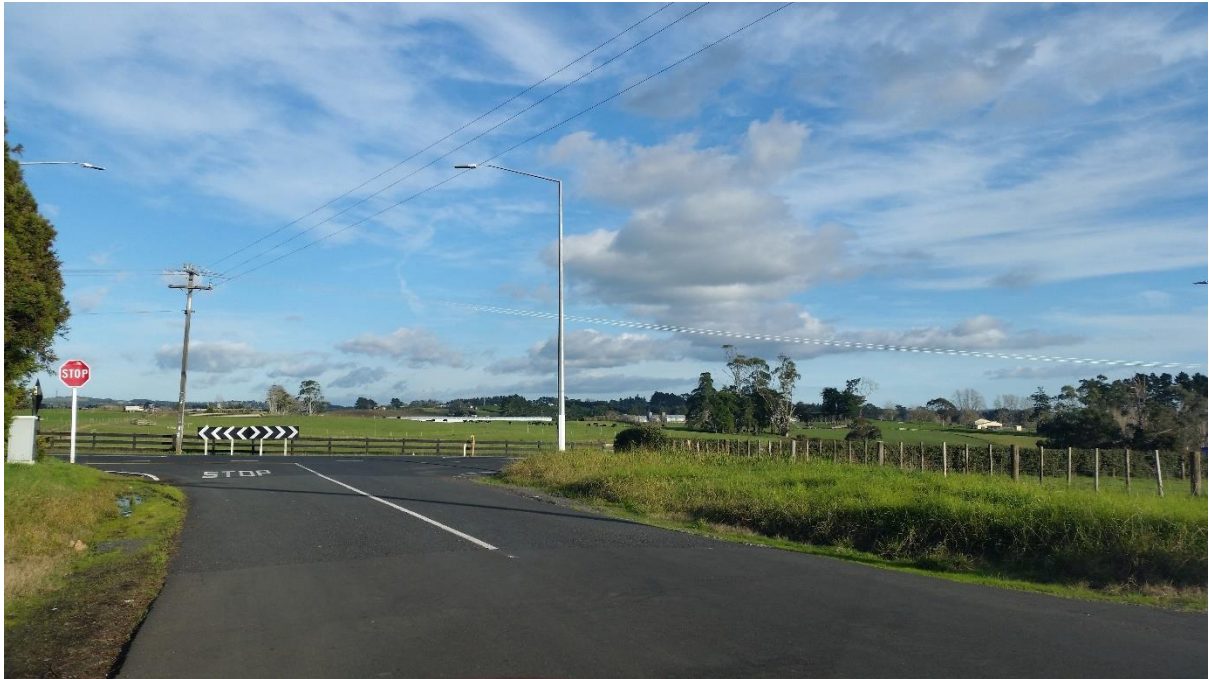
Photo 16: Looking south at intersection of Oira Road and Karaka Road. The land is mapped as being underlain by Puketoka Formation and is undulating.

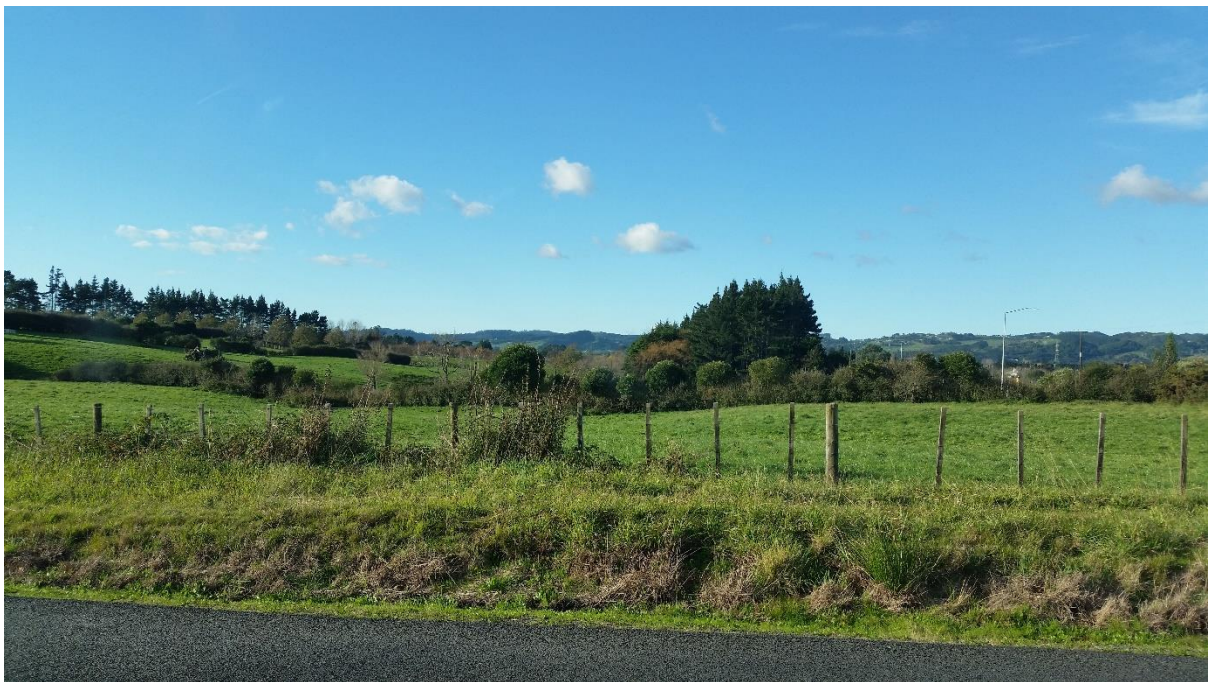
Photo 17: Looking east from Jesmond Road near the Karaka Road intersection. Note the undulating contour of the land. Mapped as being underlain by Puketoka Formation.

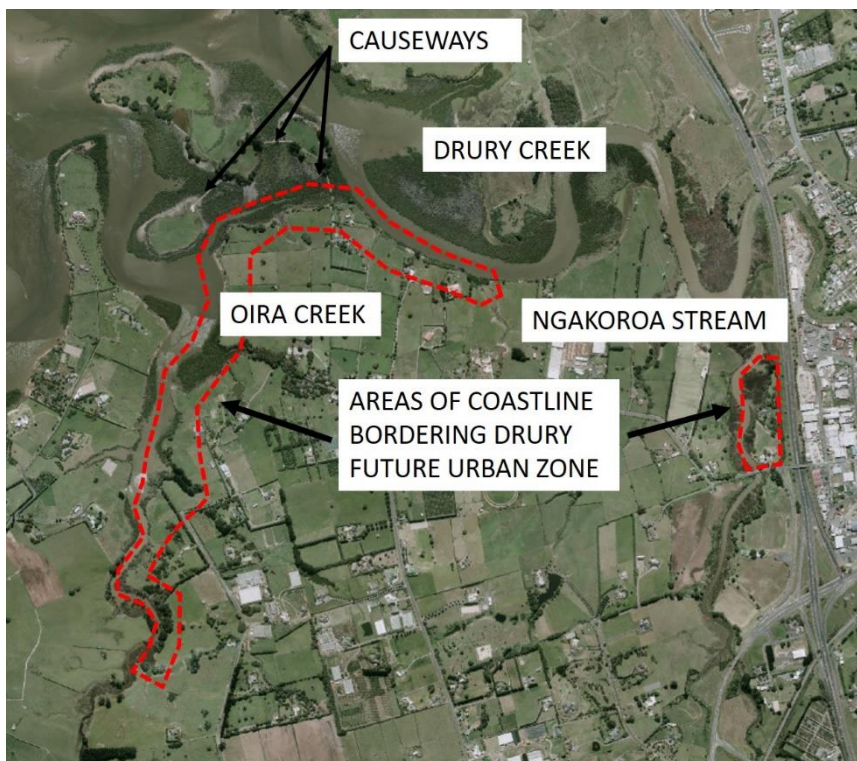
Figure 3.0a: Areas of coastline bordering Drury FUZ

The subject site is located in the upper reaches of the Manukau Harbour, and consists of two small areas comprising approximately 3.2km of coastline bordering the Drury FUZ (Figure 3.0a). It includes approximately 500m of shoreline on the western bank of the Ngakoroa Stream immediately downstream from the Bremner Road Bridge, and 2.7km of shoreline at the confluence of the Drury and Oira Creeks.

The water courses meander through the site and are characterised by small low tide channel widths in the order of 10 – 40m, increasing to 50 – 100m at high tide with wide mangrove covered flats outside this in places.

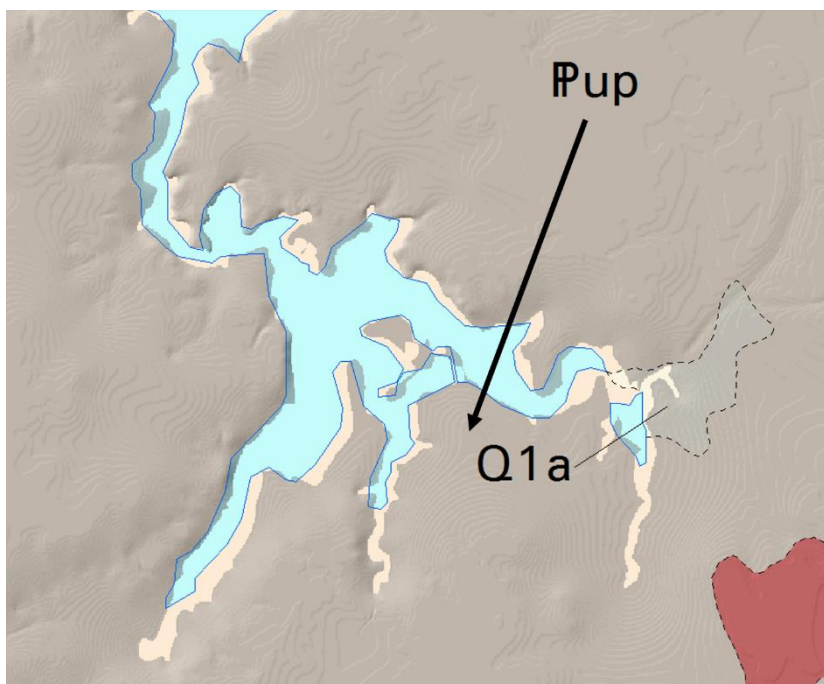
Figure 3.0b: Excerpt from Geology of the Auckland Urban Area showing subject site

The coastal margin is comprised of soft cliffs in the order of 4 – 7m high, comprised of a depth of 0.5 – 2m of highly weathered volcanic ash overlying firmer underlying material. The underlying geology is defined in the 1:50,000 Geological Map ‘Geology of the Auckland Urban Area’ published by GNS as belonging to the Puketoka Formation, a non-marine substrate containing pumiceous mud, sand and gravel with tephra and alluvia (Figure 3.0b). The area landward of the cliffs is relatively flat, rising to a height of RL 10 approximately 500m from the cliffs.

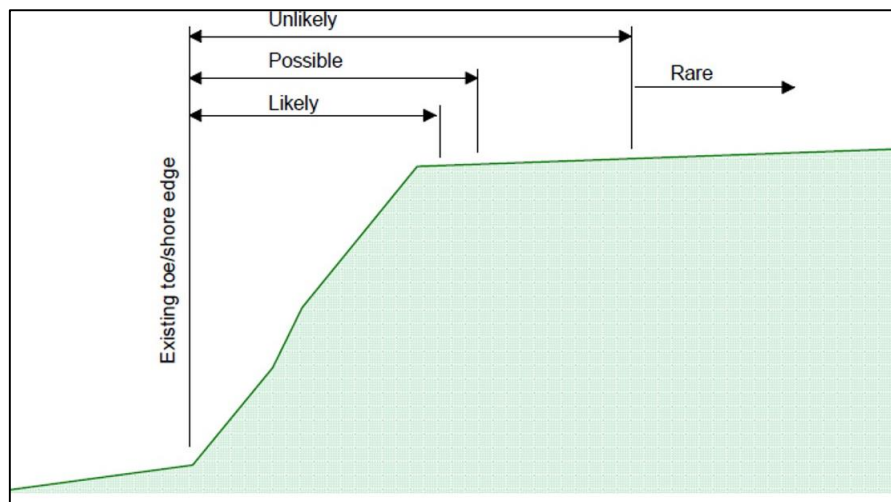
Figure 6.0a: Risk-based approach to area susceptible to erosion over the next 100 years

- **Likely:** Probably will happen during the 100 year timeframe
- **Possible:** Might occur during the 100 year timeframe
- **Unlikely:** Unlikely to occur but possible during the 100 year timeframe

These relative risk areas are shown in the schematic below (Figure 6.0a). A 'rare' category, defined as 'highly unlikely, but conceivable' was also included in the RAASCE, however that has not been included in this report.

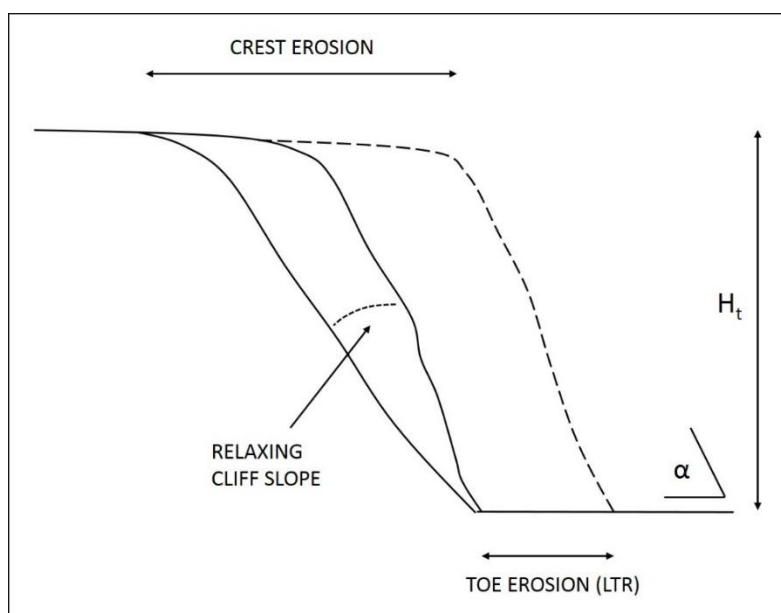
Figure 6.0b: Long term retreat of cliff assuming uniform lithology and structure (adapted from ARC, 2006)

The distance from the toe of the cliff that is at risk from Coastal Retreat can be considered as comprised of two parts (Figure 6.0b)

1. Long Term Retreat (LTR) of the toe of the cliff – this is assumed to increase in as a result of future accelerated sea level
2. Cliff Slope Angle (α) - relaxation (lessening) of the cliff slope due to weathering and/or geotechnical failure following toe retreat will cause retreat of the crest .

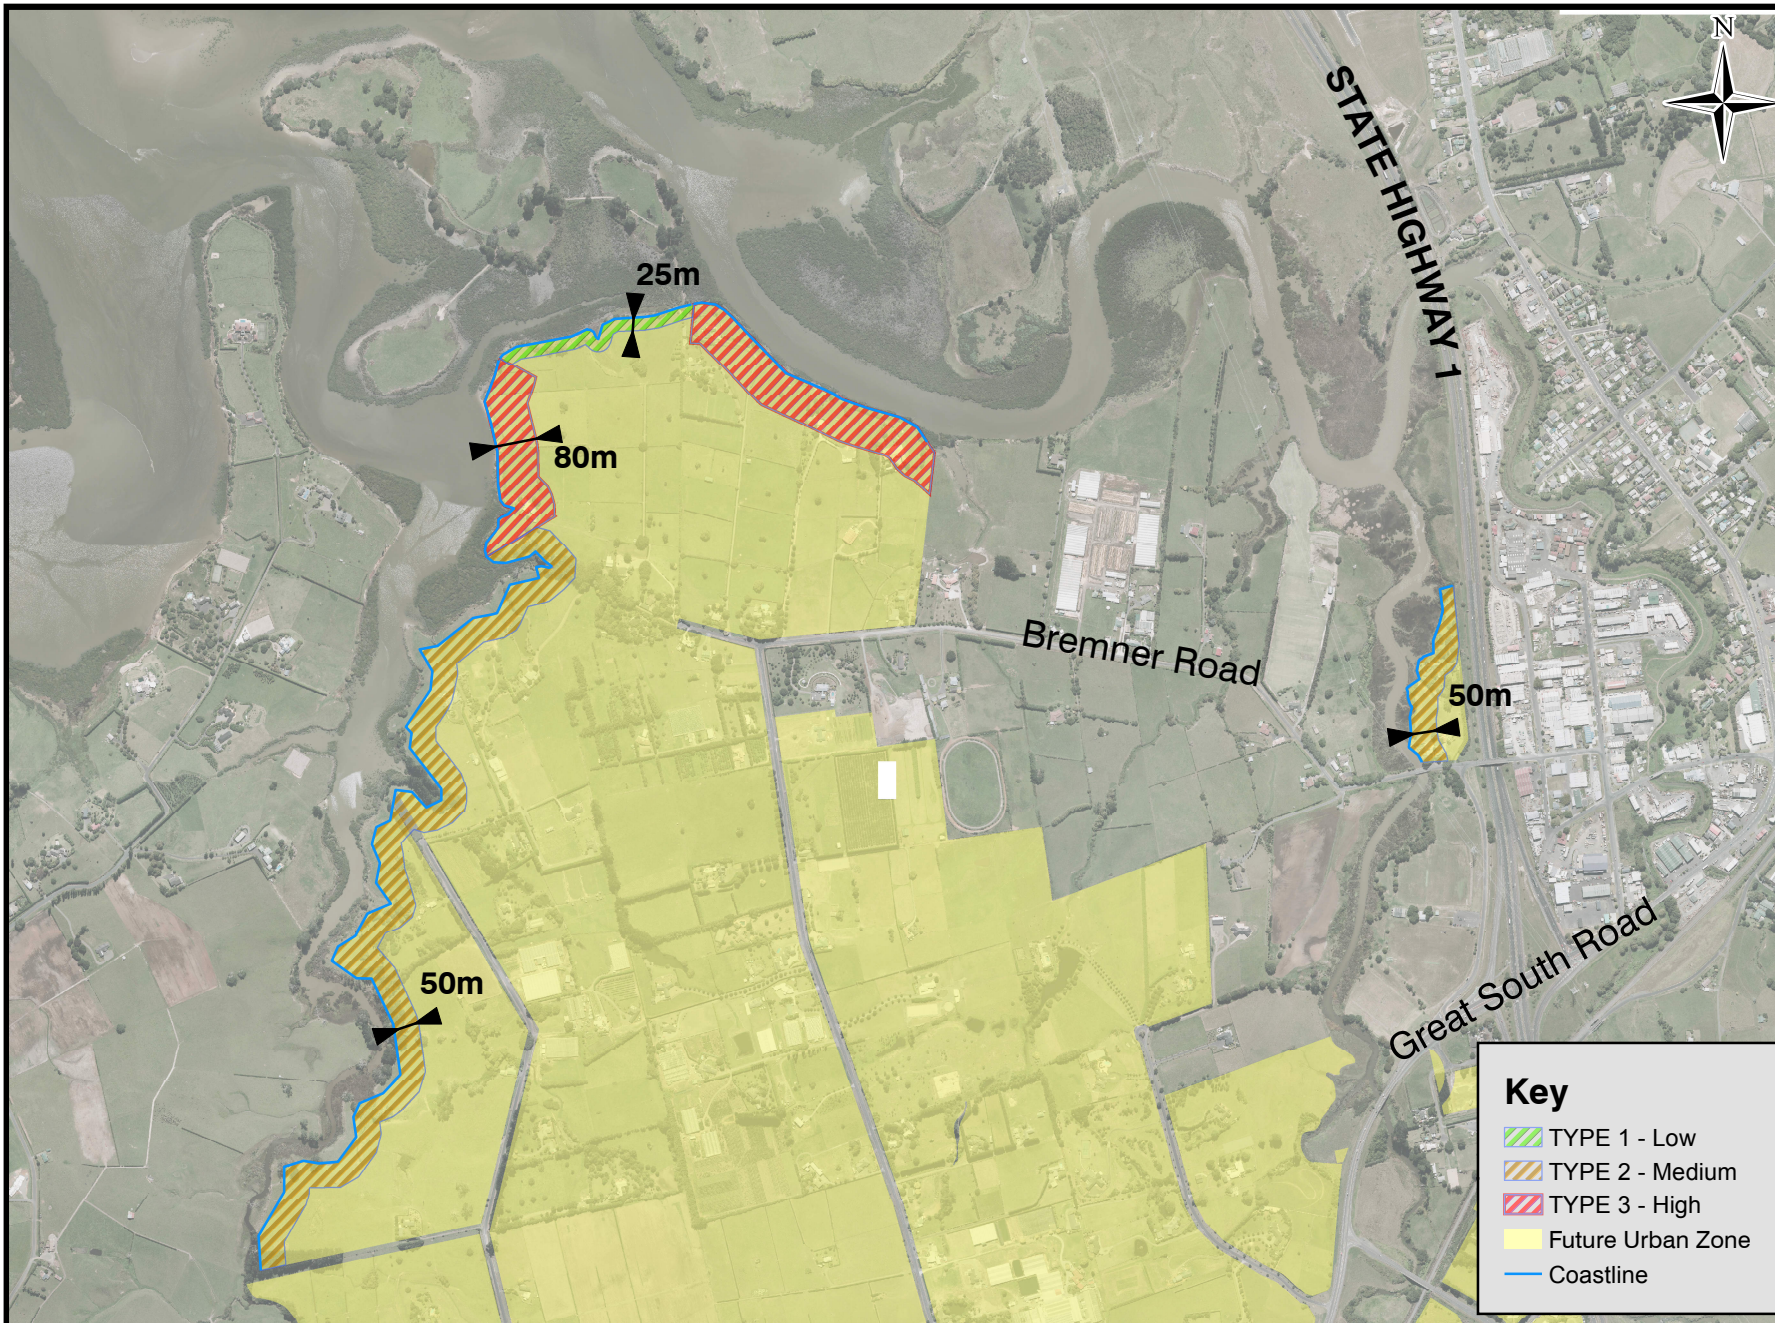
**DRURY FUTURE
URBAN ZONE -
COASTAL EROSION
SUSCEPTIBILITY
PLAN**

Key	
	TYPE 1 - Low
	TYPE 2 - Medium
	TYPE 3 - High
	Future Urban Zone
	Coastline
